## Executive Director's Recommendation

<b>PROJECT</b> <b>Building Envelope Repairs</b> Hirshhorn Museum and Sculpture Garden 700 Independence Avenue, SW Washington, DC	<b>NCPC FILE NUMBER</b> 7889
	<b>NCPC MAP FILE NUMBER</b> 1.71(38.00)44960
<b>SUBMITTED BY</b> Smithsonian Institution	<b>APPLICANT'S REQUEST</b> Approval of comments on concept plans
<b>REVIEW AUTHORITY</b> Federal Projects in the District per 40 U.S.C. § 8722(b)(1) and (d)	<b>PROPOSED ACTION</b> Approve comments on concept plans
	<b>ACTION ITEM TYPE</b> Consent Calendar

# Hirshhorn Museum and Sculpture Garden Building Envelope Repairs

Approval of Comments on Concept Plans

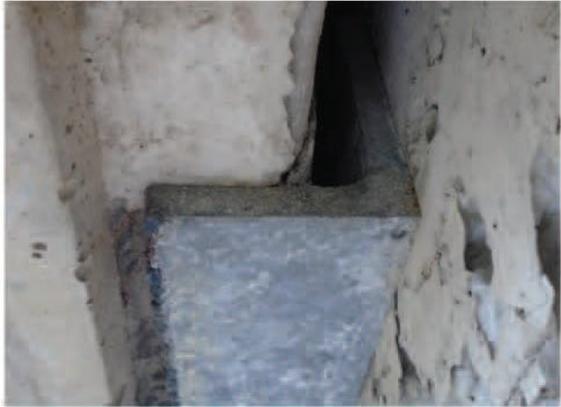
**CRACKED CONCRETE  
AT THE RELIEVING ANGLE**

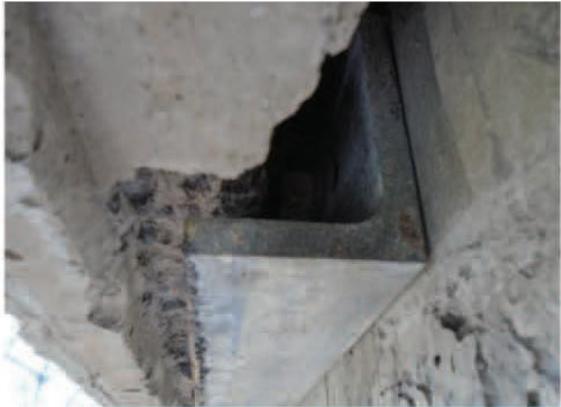
**SPALLED CONCRETE  
AT THE RELIEVING ANGLE**

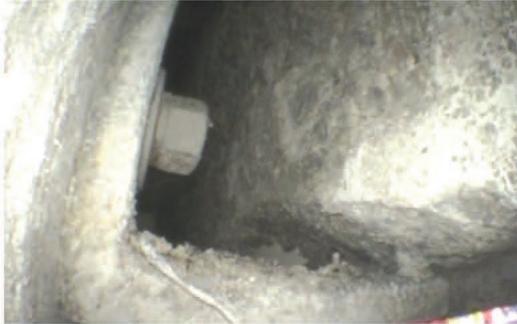
Irregular bearing surface on bottom side of panel not fully in contact with relieving angle

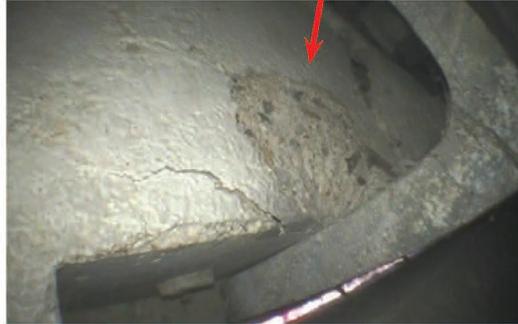
Backside of the concrete panel is cracked adjacent to the bearing surface on the relieving angle

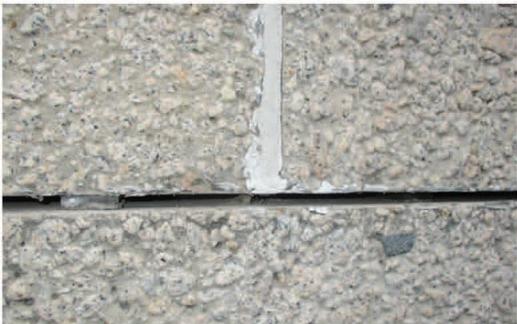
Hard plastic shims (ovals) between small panel (above) and large panel (below)

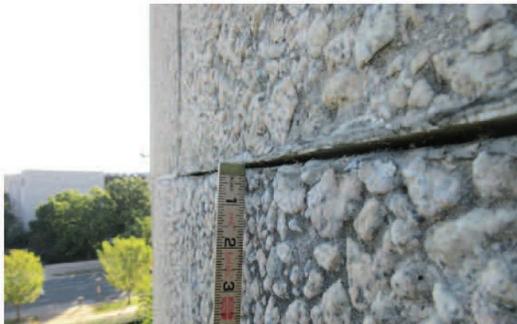
Large panel bearing on small panel below and uneven spacing between panels

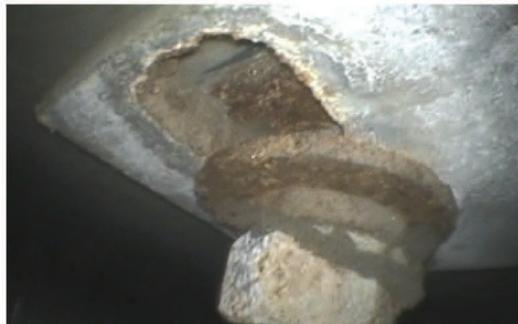
Flame cut slotted hole in strap plate connection to backup wall

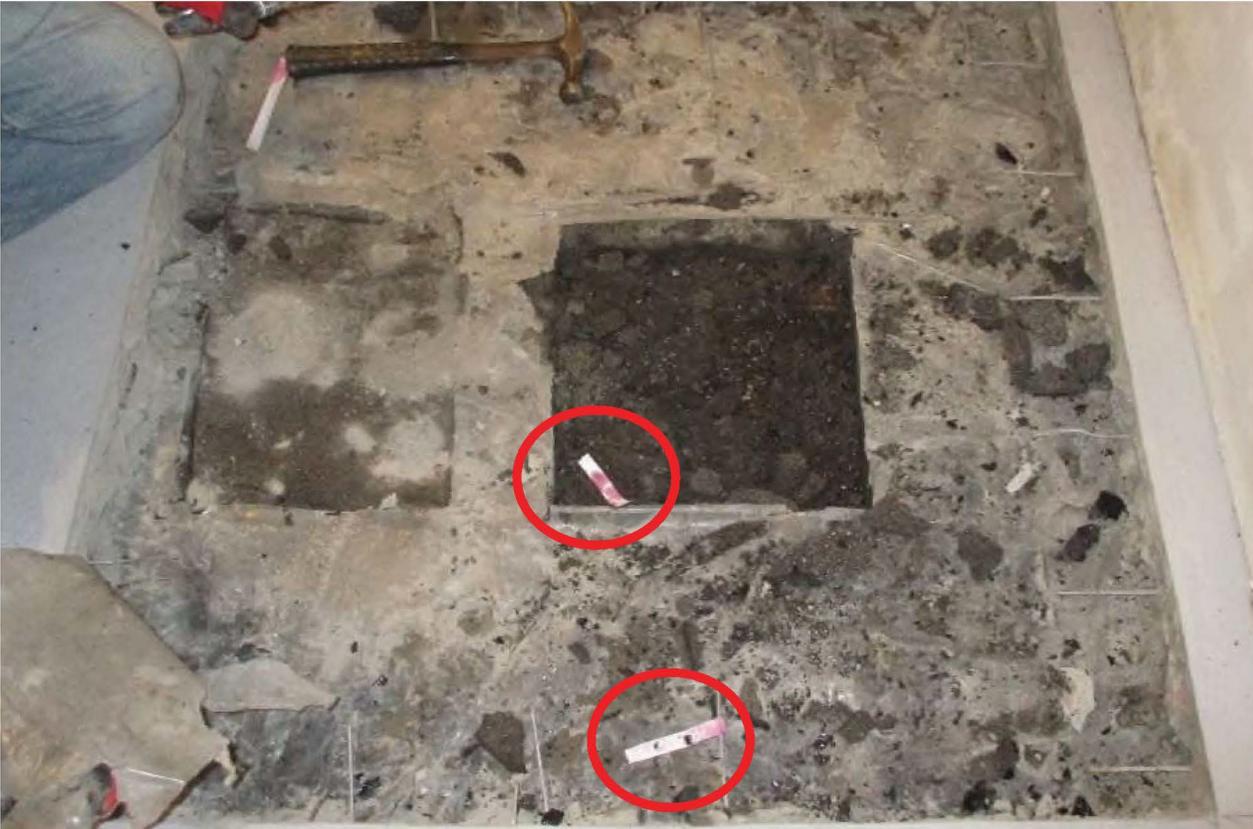
Pink discoloration of water finding test paper indicates moisture in the glass foam insulation of the Second Level Slab Assembly.

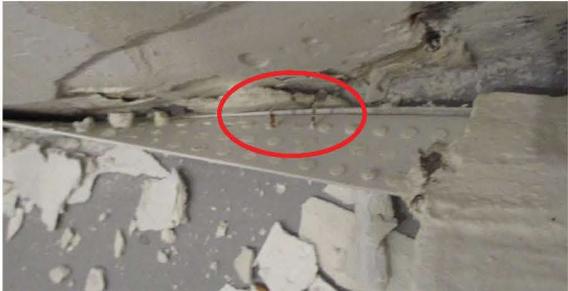
Delamination and flaking plaster at the base of the wall finishes at the second level gallery due to the moisture inside the wall assembly.

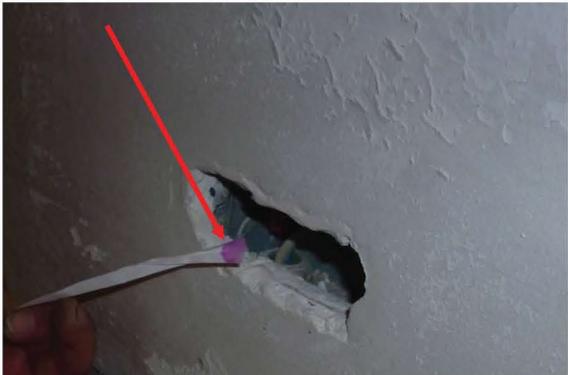
Water finding test paper indicates the presence of moisture on the interior face of the backup wall behind an electrical outlet.

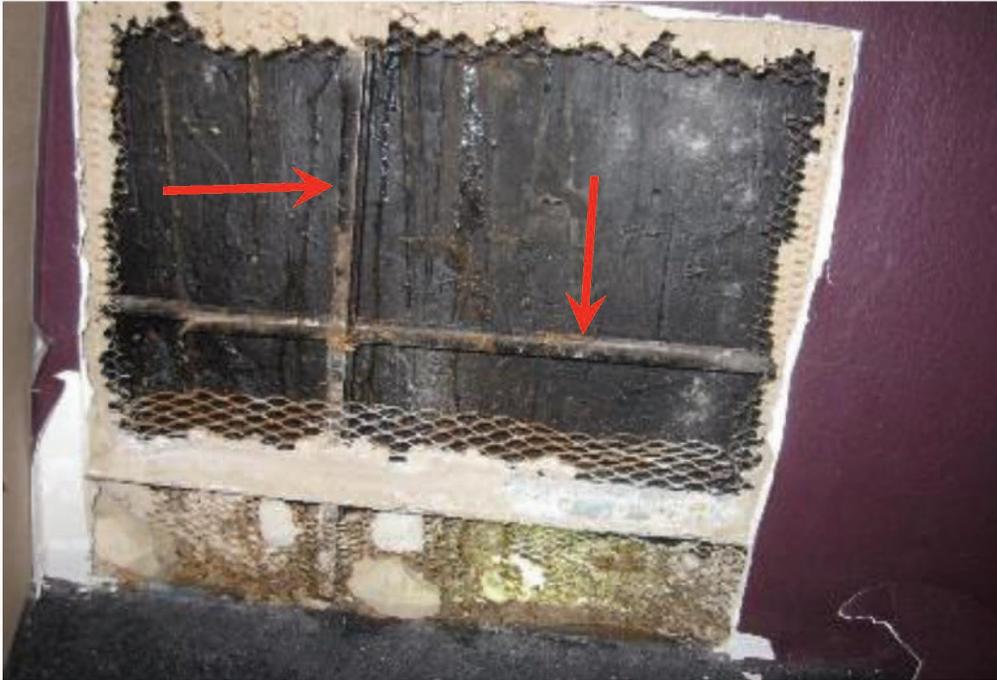
The interior plaster finishes are applied to expanded metal lath that is supported by steel framing (arrows). The framing and lath have surface corrosion and the backup wall is covered with a black coating that is stained.

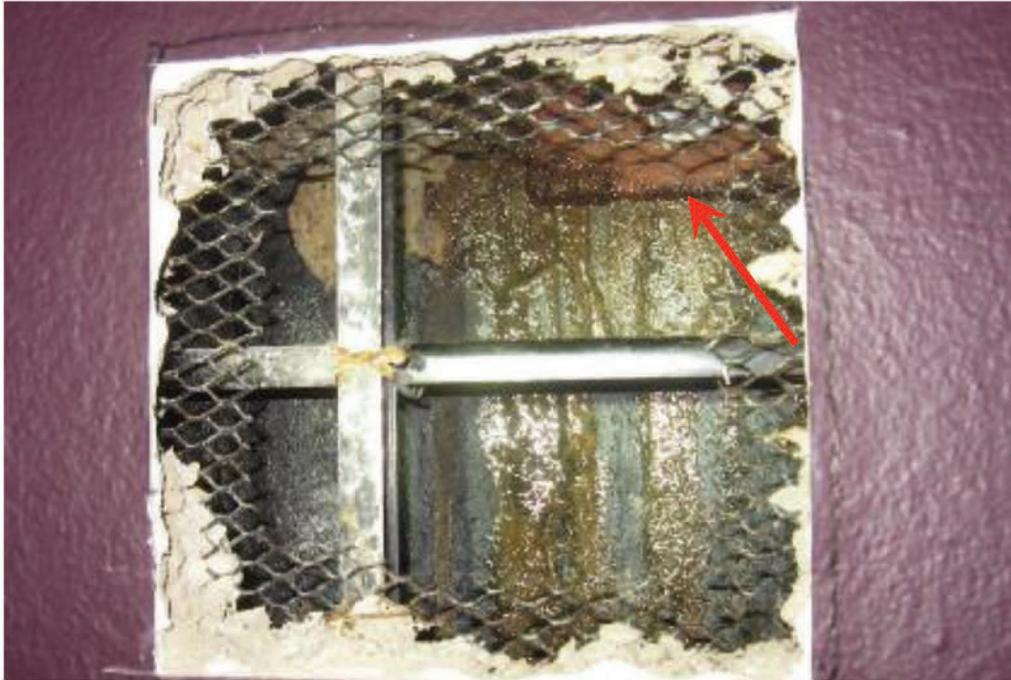
The backup wall is covered with water stains and organic growth emanating from the top of the second level wall. The bottom edge of the steel angle support is visible (arrow).

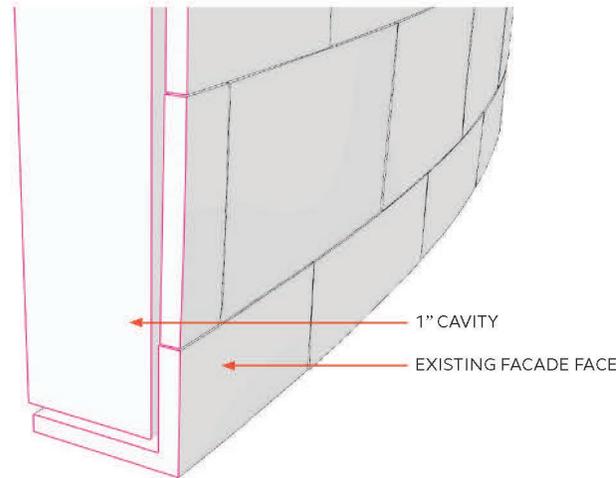
### EXISTING CONDITION

The Hirshhorn's existing enclosure system completely lacks a vapor, air, or water-resistive barrier, and insulation. This condition results in ongoing water infiltration and condensation during the cold months of the year along the interior side of the solid concrete structural back-up wall. The field survey confirmed the minimum existing average cavity dimension is one inch.

The cavity between the existing precast panels and the back-up structural wall varies. The minimum existing average dimension is one inch.
