NATIONAL AIR AND SPACE MUSEUM MALL BUILDING REVITALIZATION CONSULTING PARTIES MEETING #2

22 FEBRUARY 2016

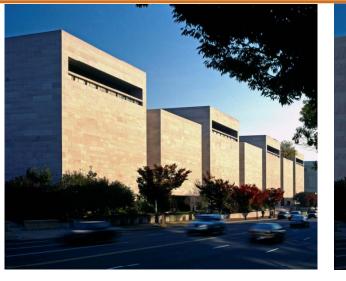
Tennessee Marble: Match Original

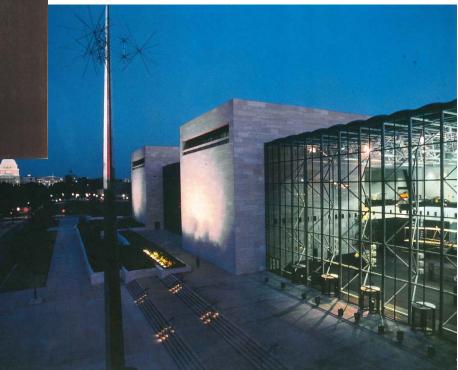
Original 1976 Construction

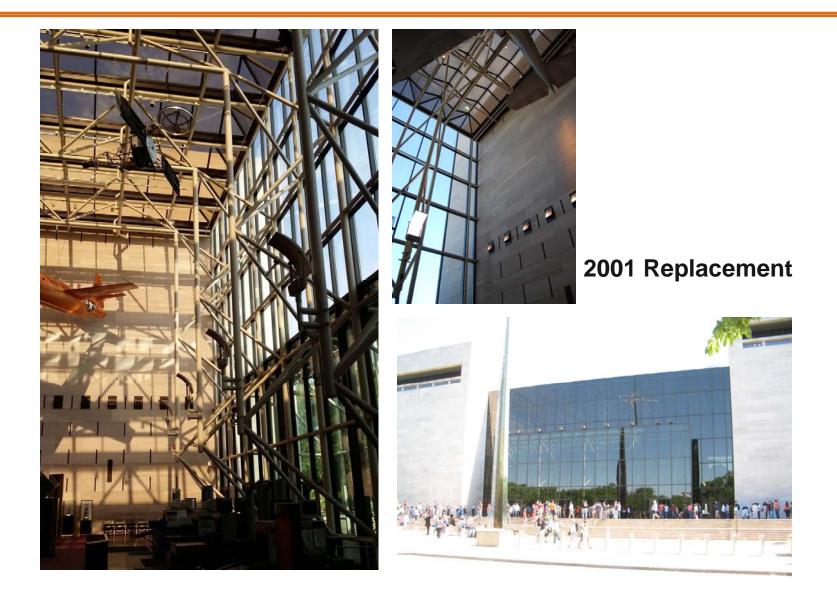
GLAZING EXISTING CONDITIONS

- Protection of Exhibits
- Integrity of Original Design Concept
 - View of Exhibits from Exterior
 - View of National Gallery from Interior
- Mitigate Solar Heat Gain
- Prevent Condensation with Reintroduction of Humidification

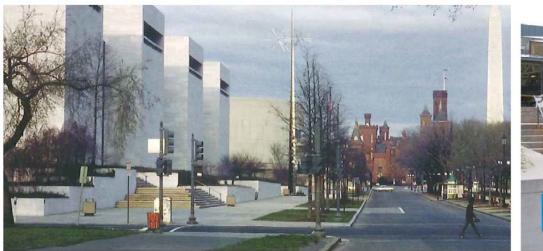
Monumental Stair (Northeast) – HOK 1976

Free-Standing Wall (West stair) - HOK 1988

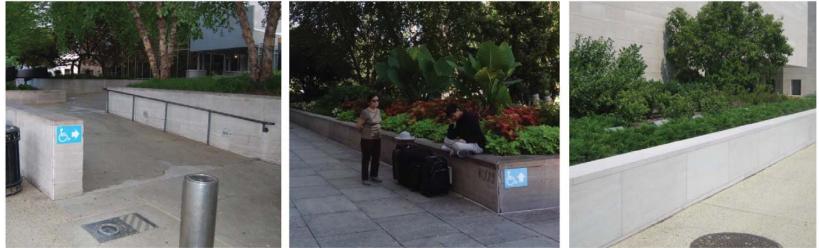
Ramp (Northwest) - 1991

Seat Wall (North Entrance Plaza) – HOK 1976 Low Perimeter Wall (SOUTH) – HOK 1976

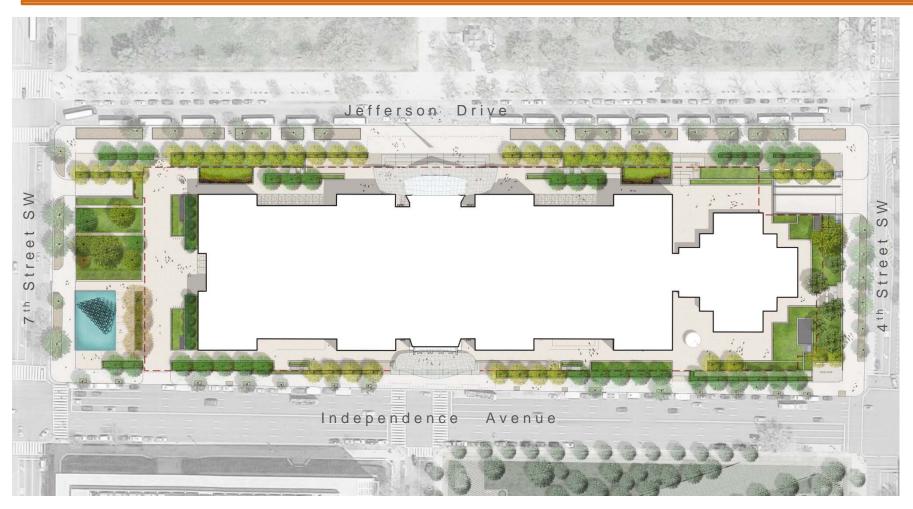
TERRACE IMPROVEMENT ALTERNATIVE: PROPOSED SITE PLAN

NORTH - Basement Level

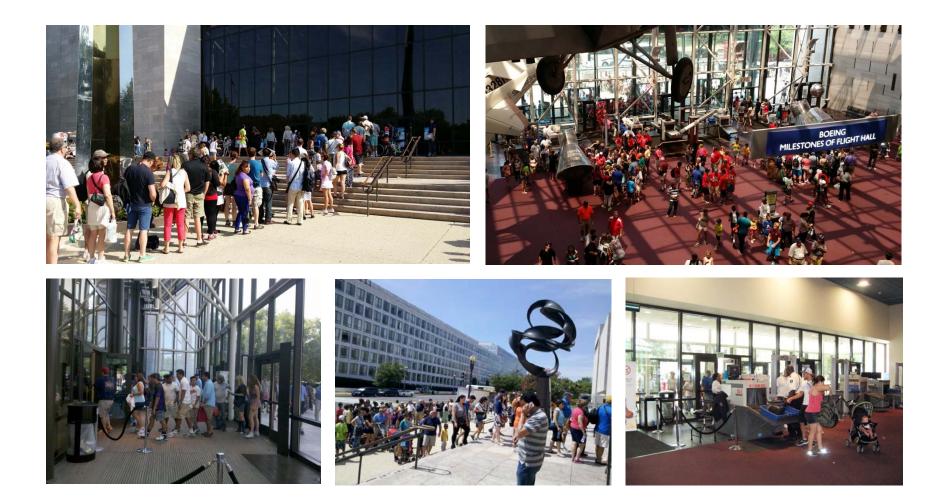
VESTIBULES EXISTING CONDITIONS

- Mall Side: 4 Lanes
- Independence Ave Side: 3 Lanes
- Inside Queuing
 - Maximum Wait Time: 5 Minutes Inside
 - Mall Side: 2,000sf Vestibule
 - + 480sf Screening Equipment
 - Independence Side: 1,500sf Vestibule
 + 360sf Screening Equipment

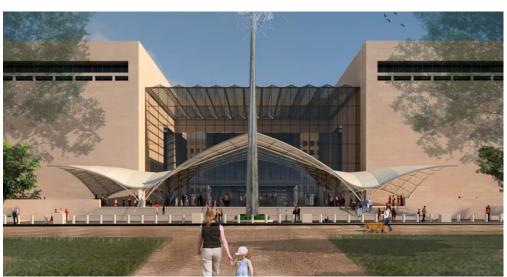
FLIGHT

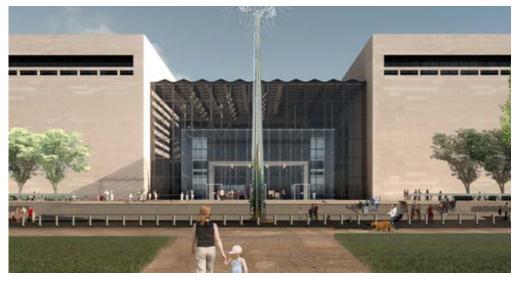
GLASS BOX

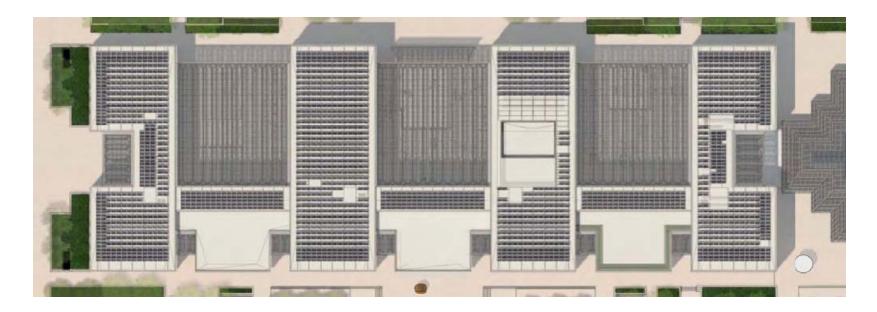
SOLAR PANEL ALTERNATIVE: ROOF-MOUNTED PHOTOVOLTAICS

- 70,000 sf roof area
- 1,300 PV panels
- 21.5% efficient
- 345-watt each

- Could generate approximately 630,000 KWh/yr
- Equivalent of roughly 7% to 10% of electrical load of revitalized building

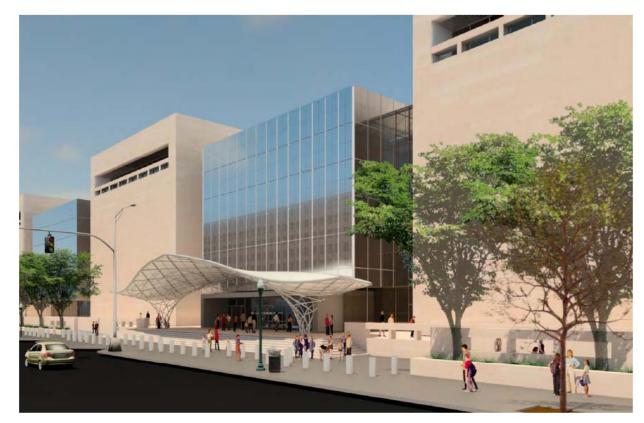
SOLAR PANEL ALTERNATIVE: SOUTH WALL BIPV'S

South Wall BIPV Applied to All Sides: Considered and Dismissed

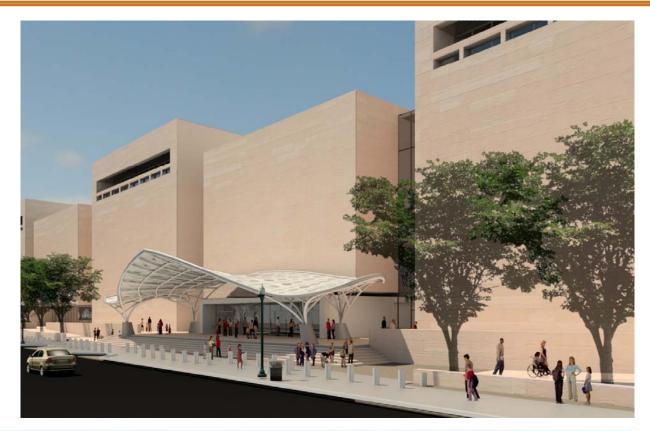
SOLAR PANEL ALTERNATIVE: SOLAR CANOPY

Thin Film PV's Applied to Canopy of South Vestibule
