# National Air and Space Museum

## Major Systems / Exterior Envelope Revitalization Project

### CLADDING EVALUATION UPDATE

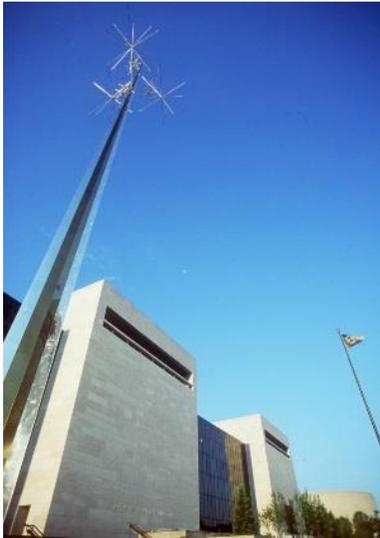
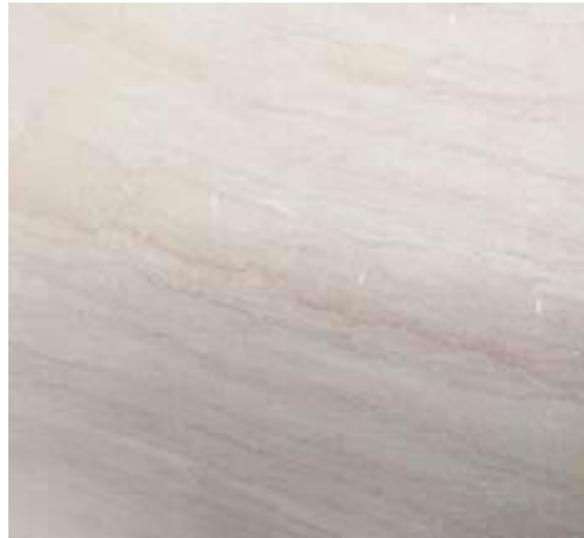
**Basis of Design: 3" Thick Tennessee Pink Marble**  
(formal name is Holston Limestone)

- Matches existing exterior cladding in kind (warm color tone and fine linear veining pattern modulates scale of monolithic façade) and intended to match NGA West Building
- Matches existing interior wall cladding that will remain
- High density limestone meets durability requirements with thickness at 3" and properly detailed wall section
- Stone has 100+ year longevity

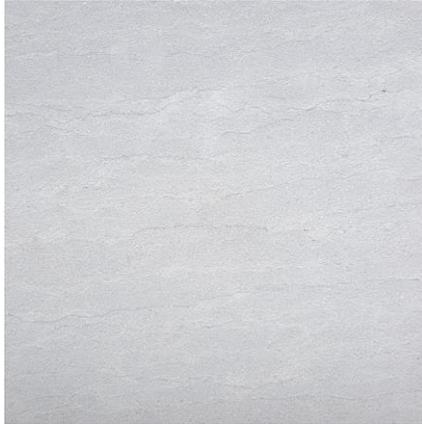
**ST CLAIR LIMESTONE**

- Fine, linear veining pattern comparable to TN Pink
- High density, durable limestone (100+ year stone longevity)
- Production time feasible

- Light gray color tone does not match existing pink tone

## Major Systems / Exterior Envelope Revitalization Project

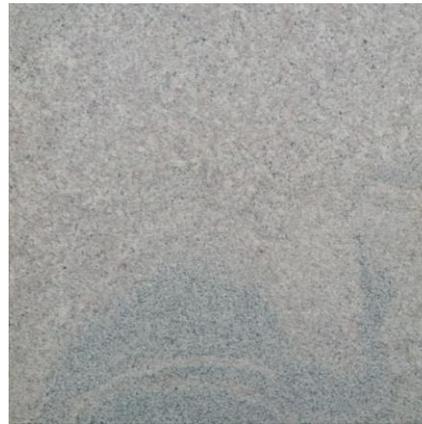
**ECHO LAKE GRANITE**

- Pink tone (when dry) comparable to TN Pink
- High density, durable granite (100+ year stone longevity)
- Production time feasible

- Fine, linear veining pattern not present (very busy swirling texture that is less compatible with interior Tennessee Pink)
- Darkens considerably when wet

### CLADDING EVALUATION UPDATE

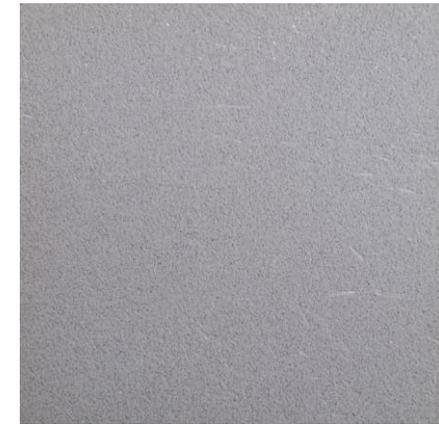
**ULTRA HIGH PERFORMANCE CONCRETE (UHPC)**

- Color and tone customizable
- High density and durable
- Production time feasible
- Can incorporate recycled aggregate salvaged from existing cladding

- Manufactured material relatively new – longevity promising but as yet unproven
- Man-made appearance may not be compatible with monumental, iconic buildings on the National Mall

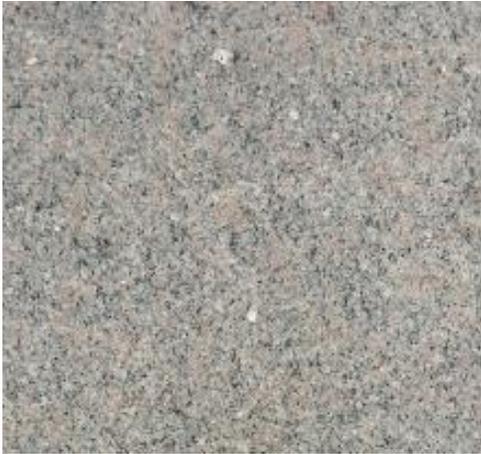
#### COLONIAL ROSE GRANITE

- Pink tone comparable to TN Pink
- High density, durable granite (100+ year stone longevity)
- Bands of color accents could be arranged in a horizontal orientation
- Production time feasible
- Resistant to blue green algae and pollutants

- Fine, linear veining pattern not present

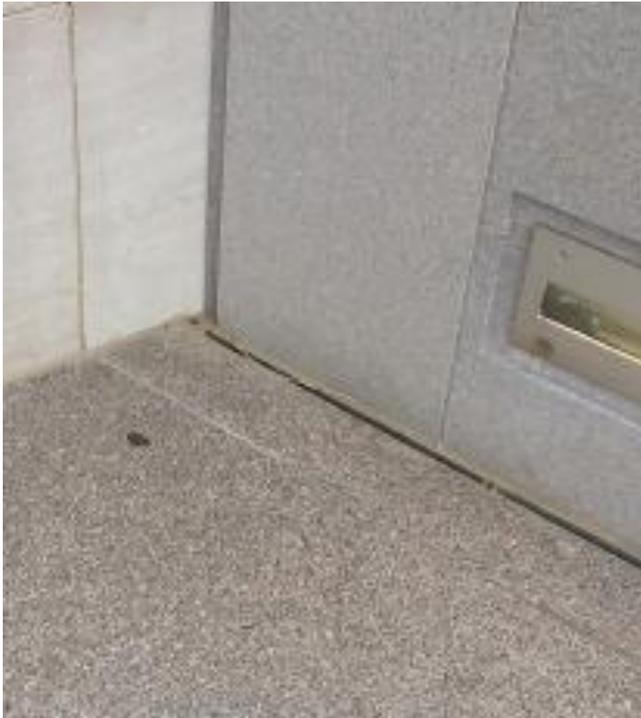
National Gallery of Art East Building Roof Terrace, Washington, DC. Completed in 2016. Colonial Rose Granite is the stone on the right and bottom of the image, with TN Pink visible at left.
