National Air and Space Museum Building Exterior, Vestibules and Site Improvements

Exterior Cladding Options

Smithsonian Institution

April 6, 2017

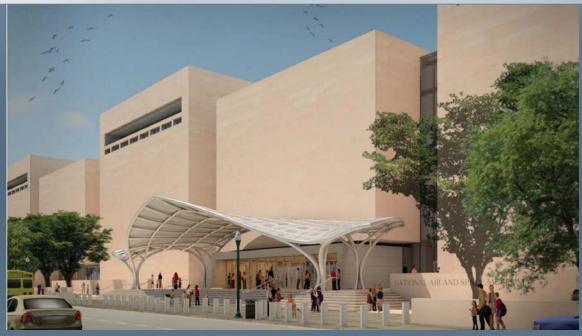
Proposed South Vestibule along Independence Avenue

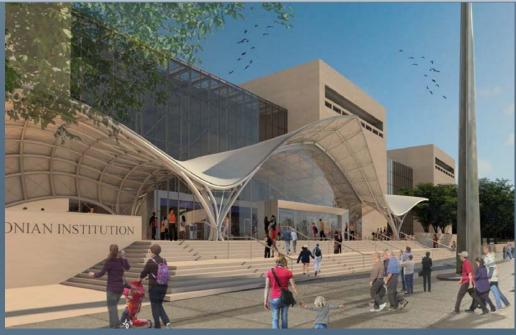
Proposed North Vestibule along Jefferson Drive

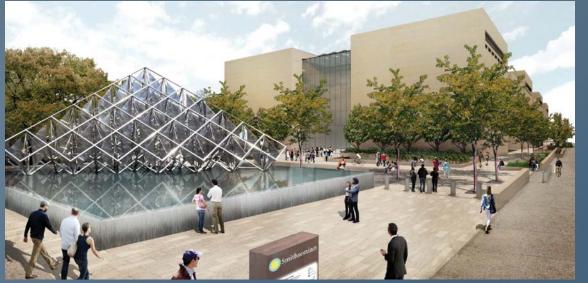
Proposed West Terrace - Delta Solar

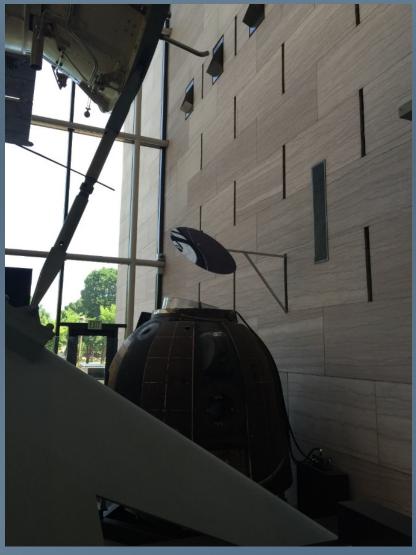
Interior-exterior stone cladding relationship

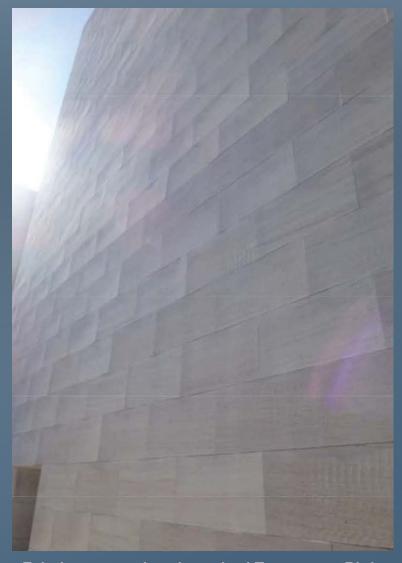
Existing warped and cracked Tennessee Pink

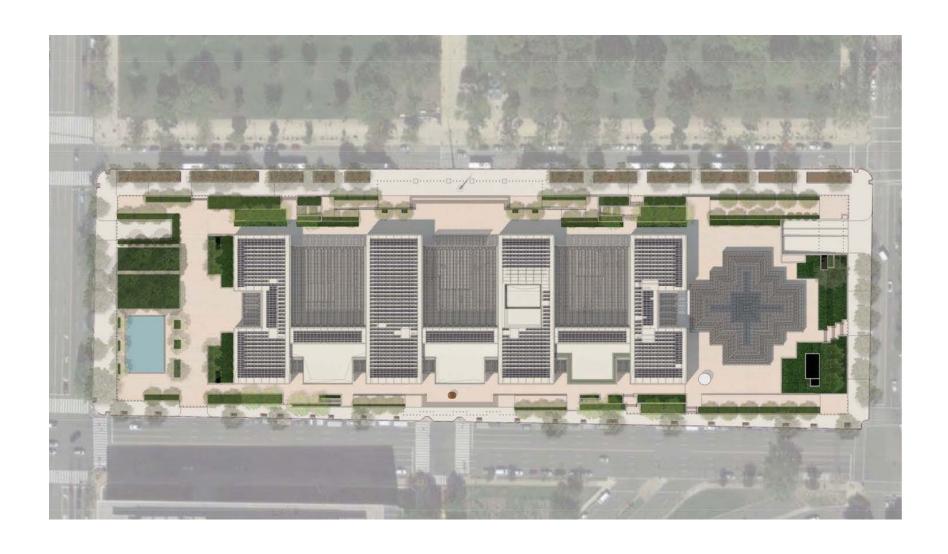
1300 Rooftop PV Panels

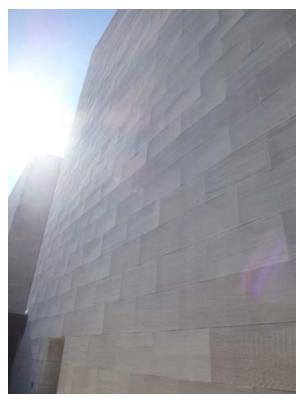
Existing Wall Section

- Thin stone is the only weather barrier
- Thin insulation sprayed directly on stone
- Stone is one face of return air plenum

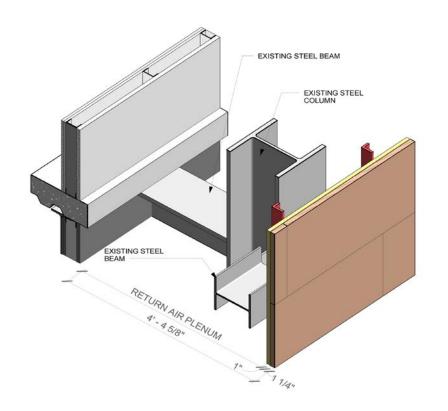
Proposed Wall Section

- tone or UHPC cladding
- Increased insulation
- Separate protected weather barrier inside wall
- Cladding not part of air plenum

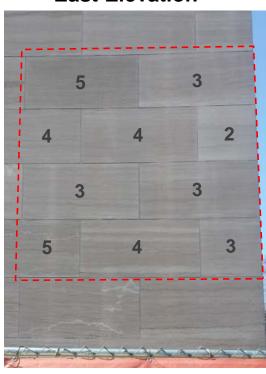
Existing TN Marble East Elevation

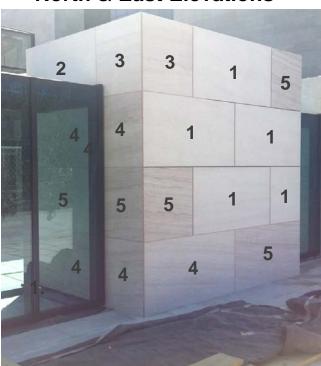
TN Marble Mockup North & East Elevations

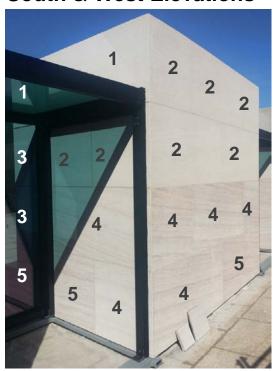
TN Marble Mockup

South & West Elevations

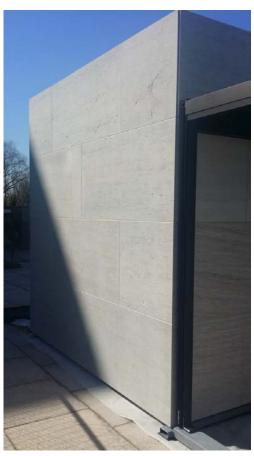
St Clair Mockup

South & East Elevations

- Fine, linear veining pattern comparable to TN Pink
- High density, durable limestone (100+ year stone longevity)

Light gray color tone does not match existing pink tone

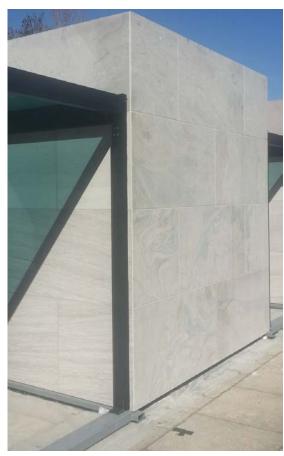
Echo Lake Mockup South & West Elevations

- Pink tone (when dry) comparable to TN Pink
- High density, durable granite (100+ year stone longevity)

- Fine, linear veining pattern <u>not</u> present (very busy swirling texture that is less compatible with interior Tennessee Pink)
- Darkens considerably when wet

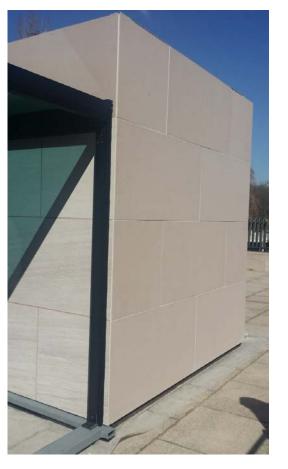
UHPC Mockup
South & West Elevations

- Color and tone customizable
- High density and durable
- Can incorporate recycled aggregate salvaged from existing cladding

- Manufactured material relatively new longevity promising but as yet unproven
- Man-made appearance may not be compatible with monumental, iconic buildings on the National Mall
