Information Presentation

Building Exterior, Vestibules and Site Improvements at the National Air and Space Museum Mall Building - Exterior Cladding Options

Major Systems / Exterior Envelope Revitalization Project

CLADDING EVALUATION – Information Presentation - NCPC

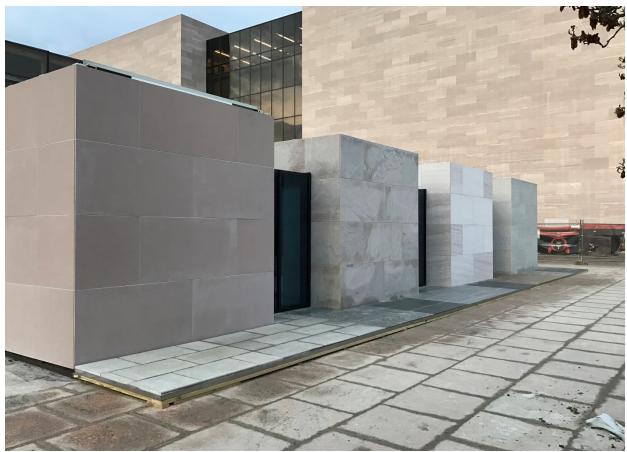
Mockup of the four cladding options under consideration constructed on the northeast corner of the NASM terrace, showing from left to right Ultra High Performance Concrete (UHPC), Echo Lake granite, Tennessee Pink marble and Saint Claire limestone.

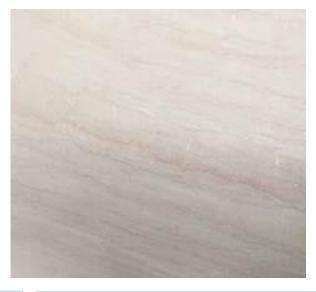
Replace-in-kind Option: 3" Thick Tennessee Pink Marble in lieu of existing 1 1/4" (formal name is Holston Limestone)

National Gallery of Art
West Building (1937-1941); East Building (1978)
Holston Limestone ("Tennessee pink marble")

National Air and Space Museum (1976) Holston Limestone ("Tennessee pink marble")

- Matches existing exterior cladding in kind (warm color tone and fine linear veining pattern modulates scale of monolithic façade) and intended to match NGA West Building
- Matches existing interior wall cladding that will remain
- High density limestone meets durability requirements with thickness at 3" and properly detailed wall section
- Stone has 100+ year longevity

- Requires additional quarry start-up
- Significant wastage in fabrication of large, thick panels due to nature of stone beds

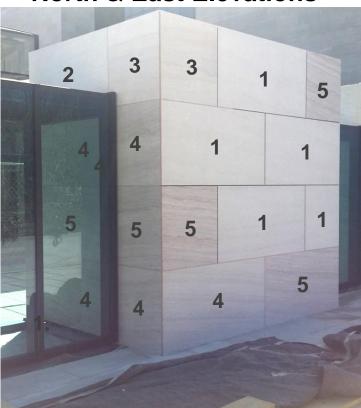
TN Marble Mockup North & East Elevations

TENNESSE MARBLE COLOR RANGE KEY

- 1. Light Pink
- 2. Medium Pink
- 3. Dark Pink
- 4. Light Cedar
- 5. Medium Cedar

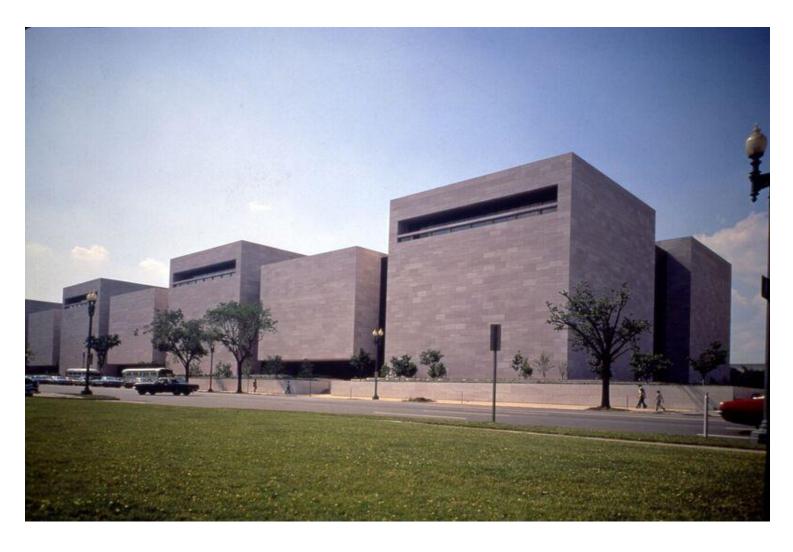
1976 Photo from Southeast illustrating original variation of Tennessee Pink
