## Executive Director's Recommendation

**National Gallery of Art East Building  
Exterior Improvements**

6th Street and Constitution Avenue, NW  
Washington, DC

Approval of preliminary and final  
site and building plans

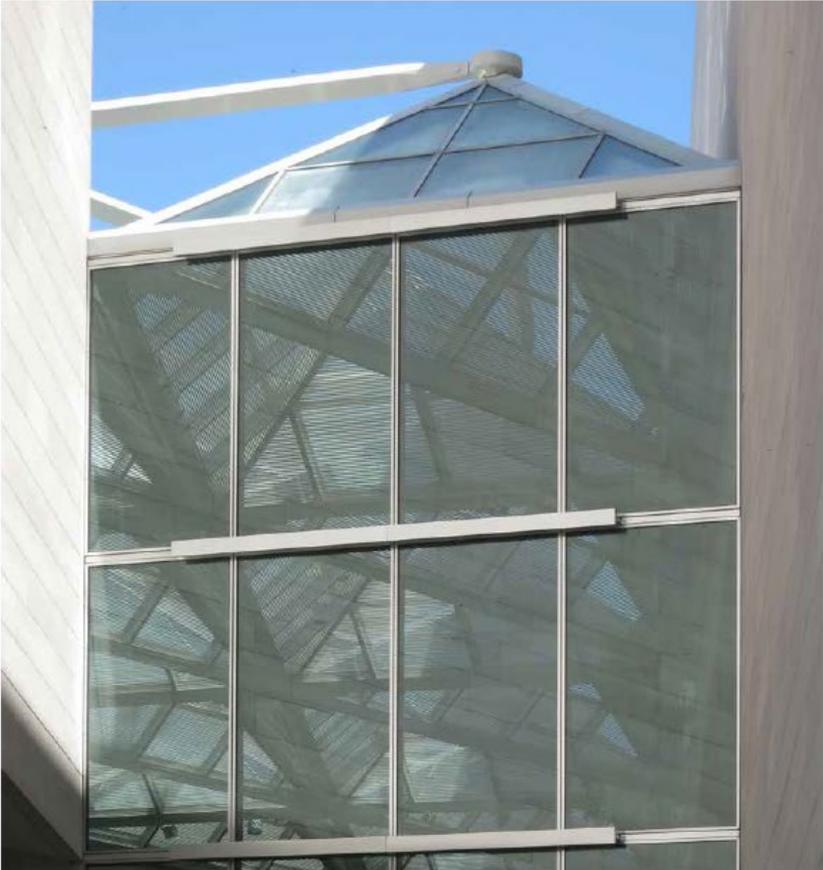
Existing Main Atrium Skylight With Purlin Snap Covers

The Main Atrium skylight is original to the building's construction and the glazing system is well beyond its anticipated lifespan. While the superstructure is robust, the glazing systems with its gasketing is failing. The original design with horizontal and vertical snap covers on the purlins has allowed water to be trapped against the glass. With freezing and thawing, the gaskets have deteriorated allowing water to be trapped between the panes of glass causing fogging and mineral deposits within the glazing assembly.

The proposed replacement skylight system will retain all of the original structure as well as the hips, ridges and purlin patterns of the original skylight design. On the exterior, snap covers will be retained on the vertical joints with a butt-joint of silicone sealant in the horizontal direction at the purlins. This will allow water to sheet down the glazing to the gutters without being trapped against the glass. The glass will match the recently replaced curtainwall glazing installed in 2013 as part of the East Building Exterior Stone Restoration project. The original interior framed aluminum sun screens will be replaced in kind to retain the shadow patterns that are a character defining feature of the building.

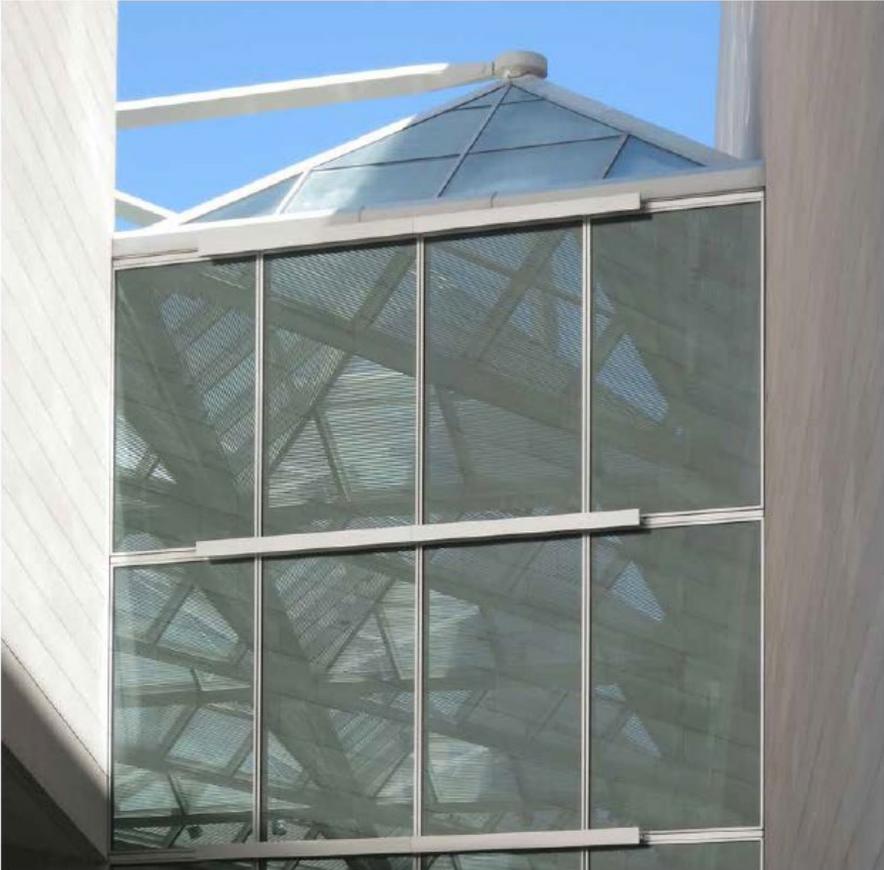
Proposed Main Atrium Skylight Without Purlin Snap Covers

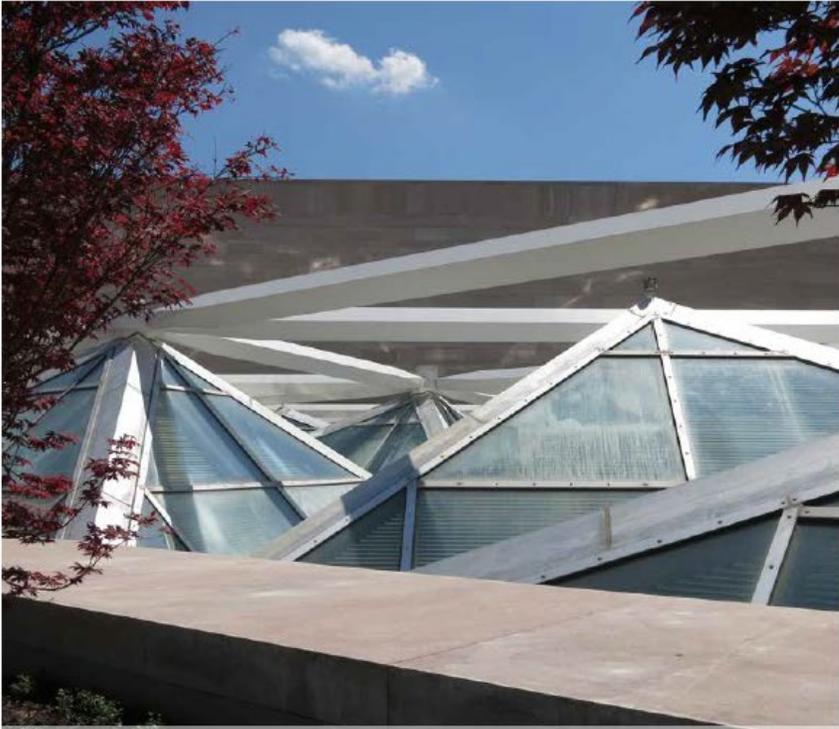
Existing Main Atrium Skylight With Purlin Snap Covers

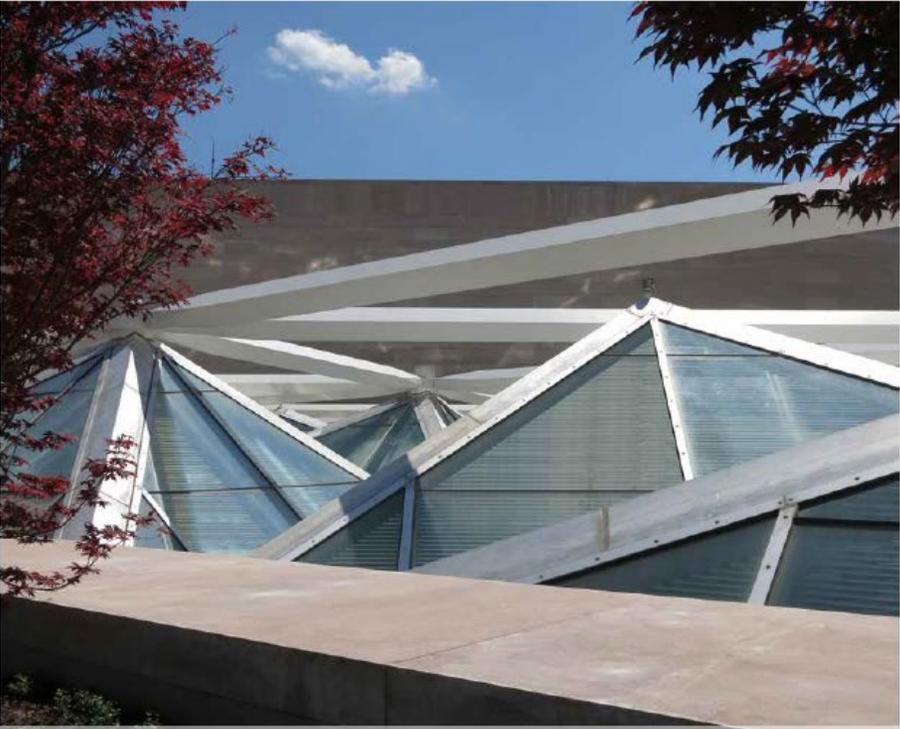
Proposed Main Atrium Skylight Without Purlin Snap Covers

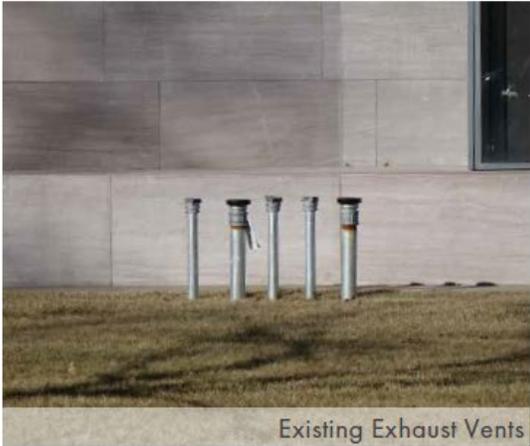
Existing Exhaust Vents

A new gas meter and heating hot water boiler plant will be installed in a vault below the South Lawn. At the surface, small vents for the gas meter will be installed pursuant to the requirements of Washington Gas. The vents will be similar in size and color to those that currently exist in the South Lawn for the underground storage tank for the emergency generator located in the same vault.

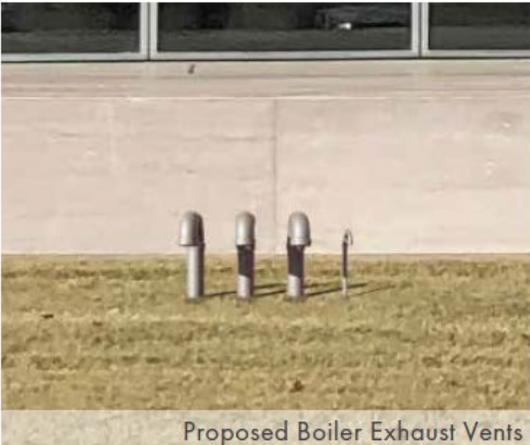
Proposed Boiler Exhaust Vents

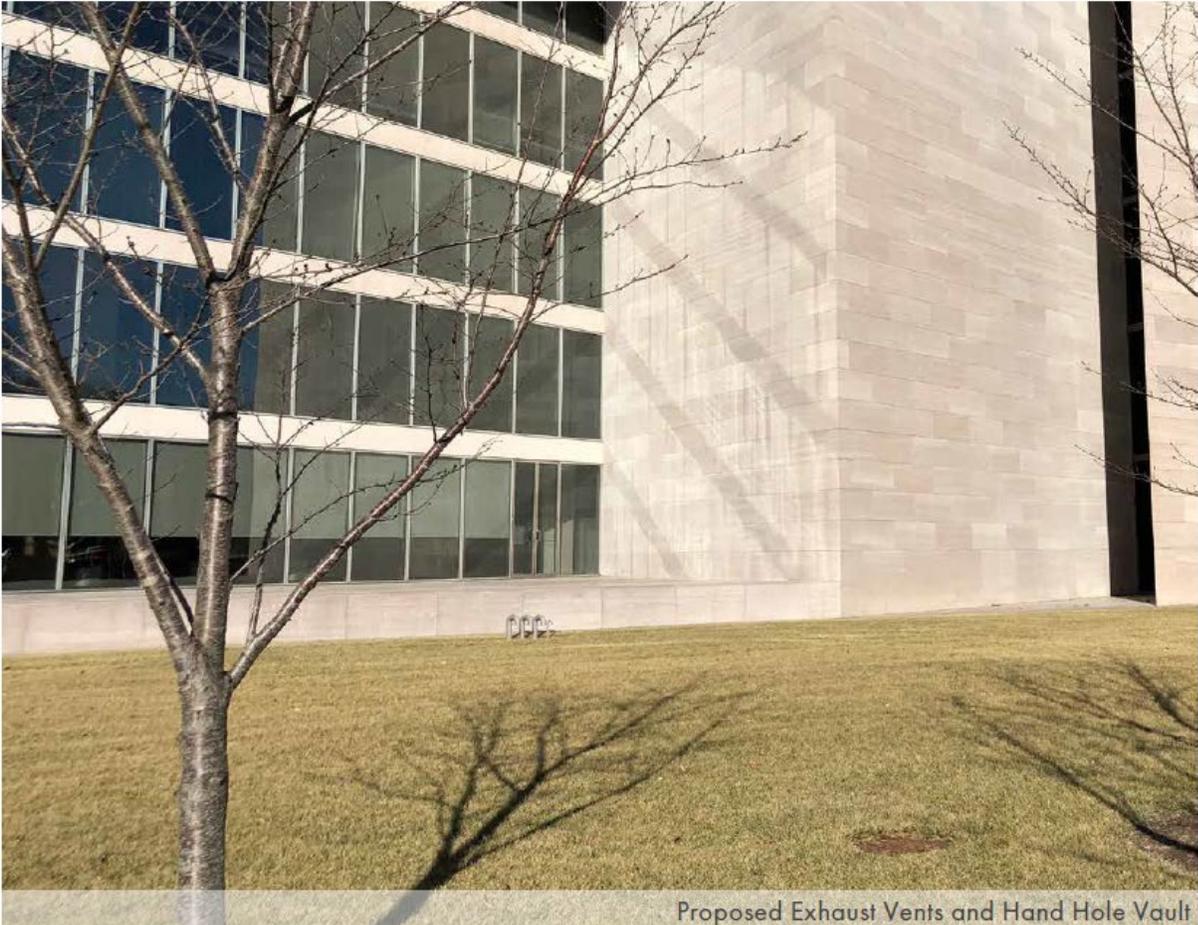
Proposed Exhaust Vents and Hand Hole Vault

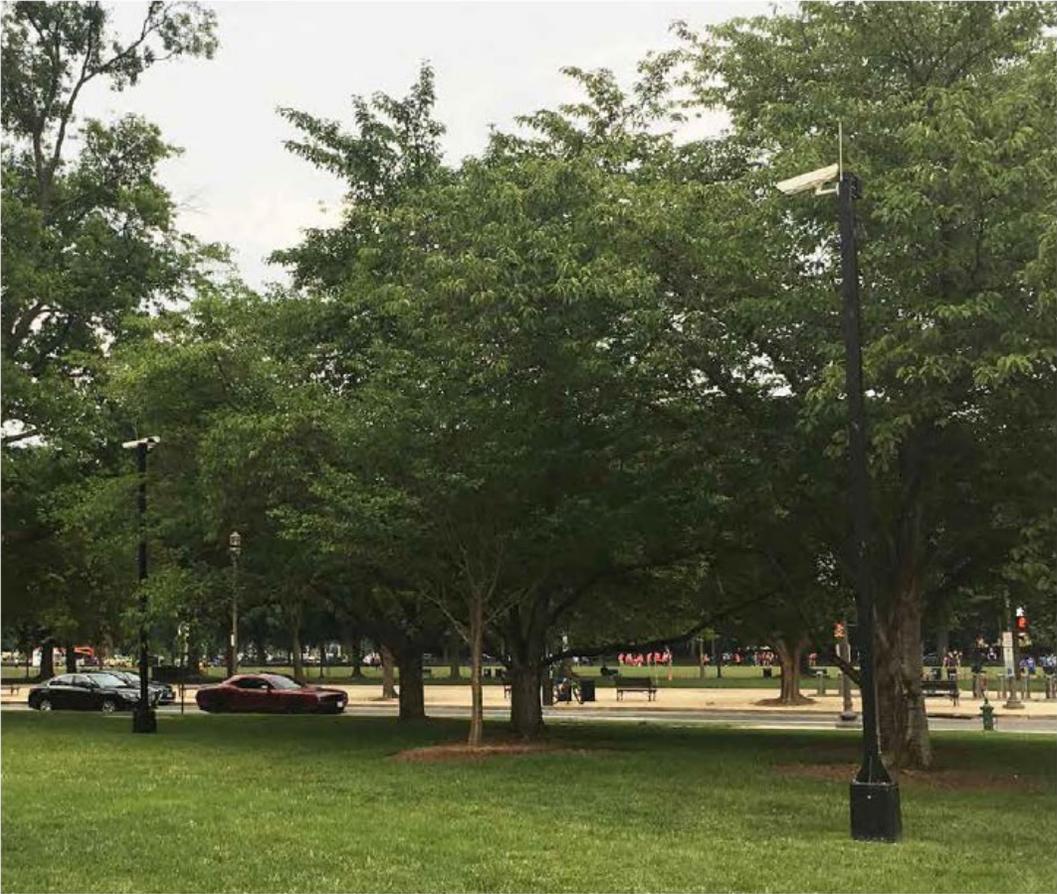
Existing Security Pole at the Southwest Corner

The Gallery proposes to install new custom site poles including structural footings to accommodate new surveillance cameras, radar detectors, notification horns, and security illumination fixtures around the site. The proposed color of the poles will match the existing PADC lighting poles on Pennsylvania Avenue.

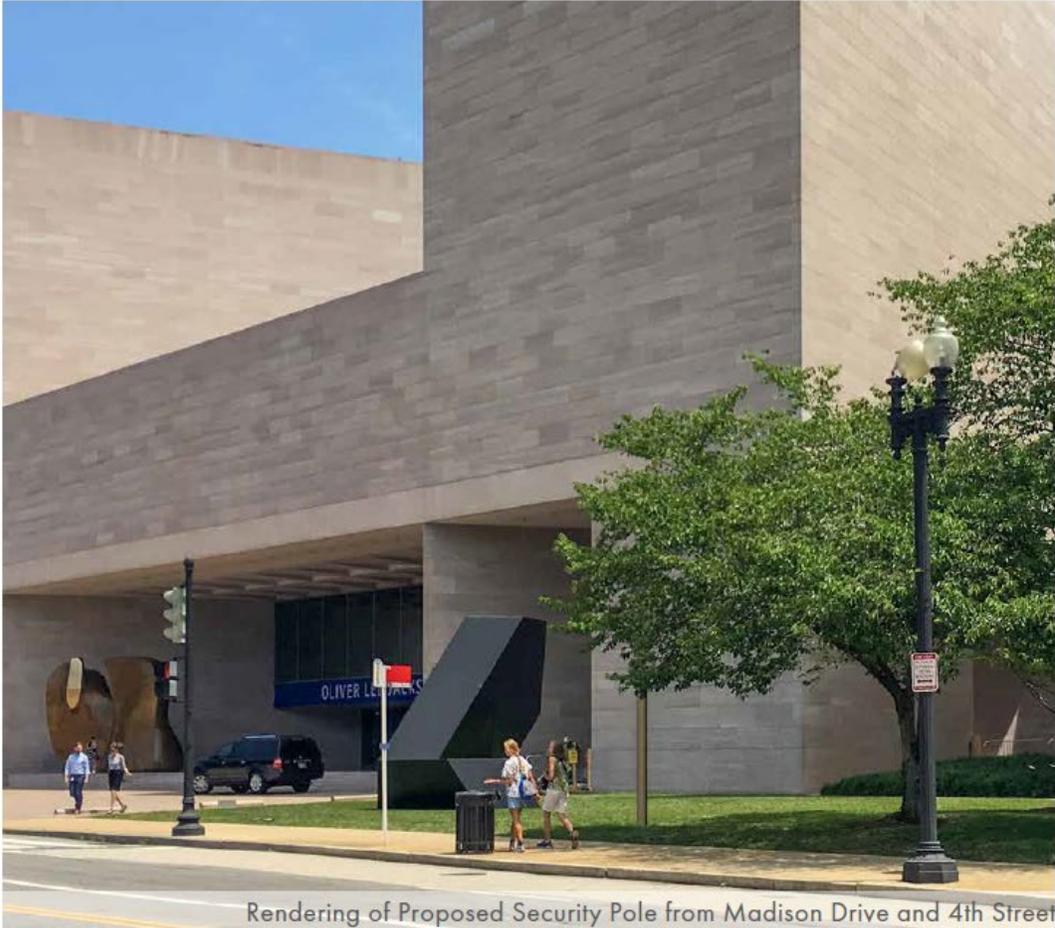
Rendering of Proposed Security Pole from Madison Drive and 4th Street

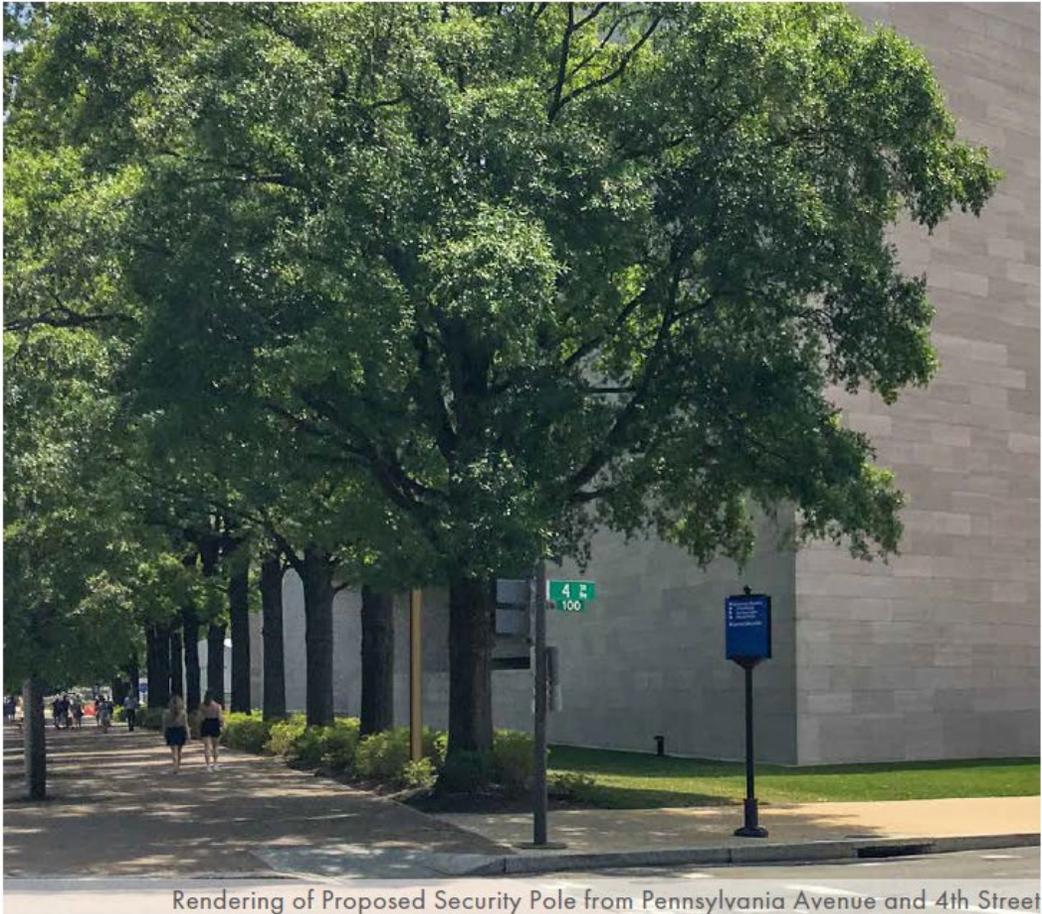
Rendering of Proposed Security Pole from Pennsylvania Avenue and 4th Street

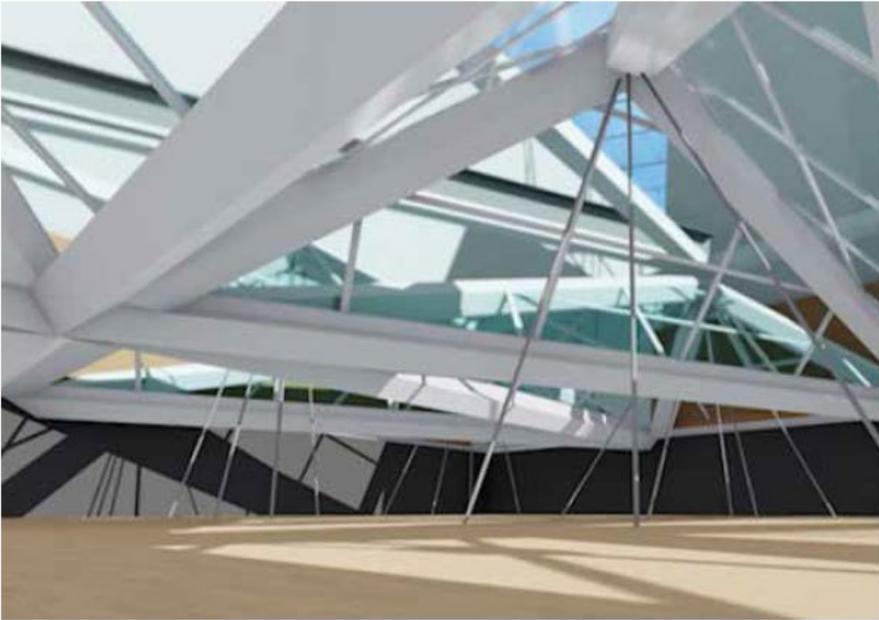
Skylight Temporary Protection

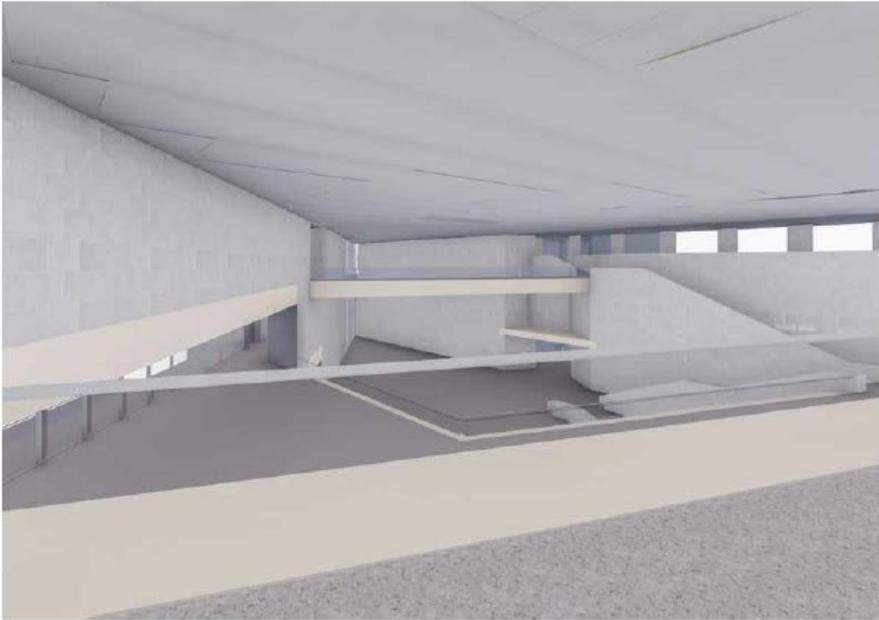
Main Atrium Temporary Protection

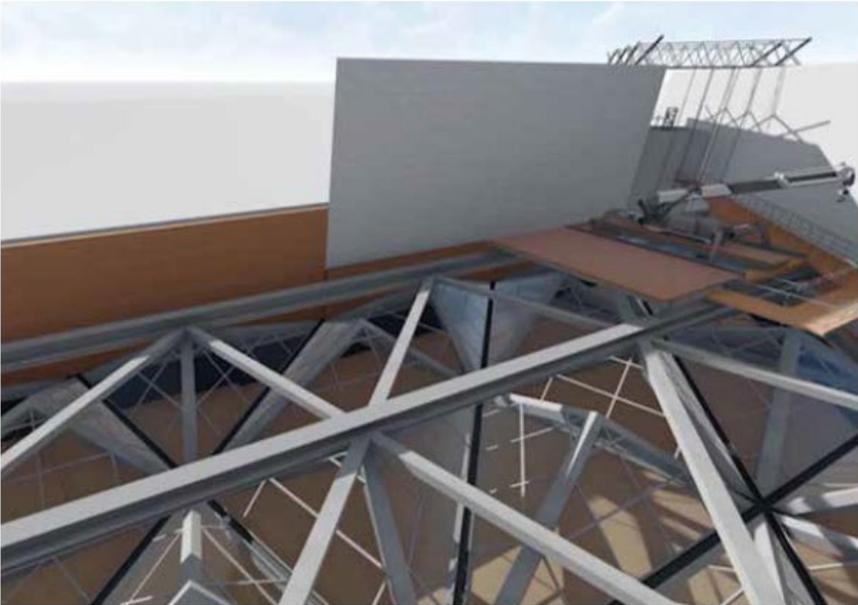
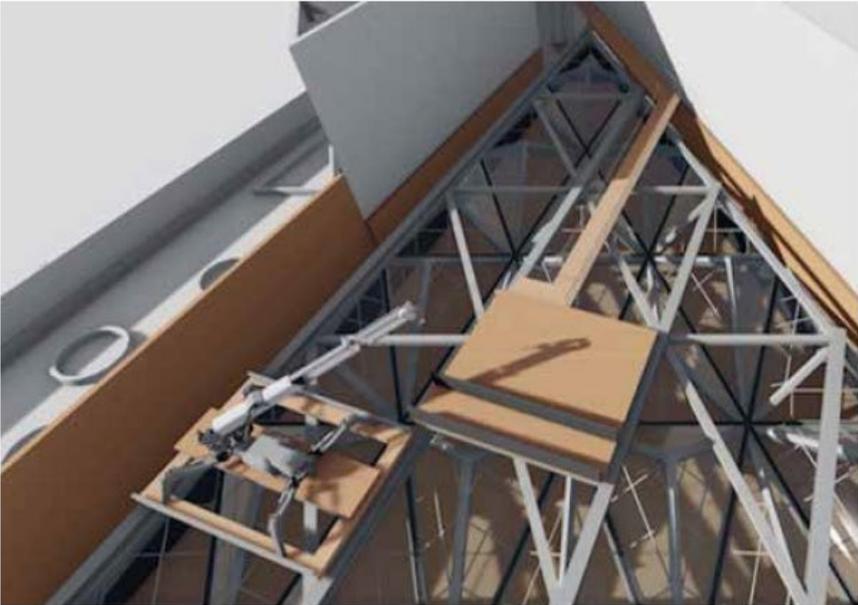
Main Atrium Skylight - Replacement of Frames, Glass, and Sunscreens
