Executive Director's Recommendation

PROJECT Freer Gallery of Art Courtyard Accessibility Improvements 1050 Independence Avenue, SW Washington, DC	NCPC FILE NUMBER 8182
	NCPC MAP FILE NUMBER 1.41(38.00)45147
SUBMITTED BY Smithsonian Institution	APPLICANT'S REQUEST Approval of comments on concept plans
REVIEW AUTHORITY Federal Projects in the District per 40 U.S.C. § 8722(b)(1) and (d)	PROPOSED ACTION Approve comments on concept plans
	ACTION ITEM TYPE Consent Calendar

Freer Gallery of Art Improve Courtyard Accessibility

Comments on Concept Plans

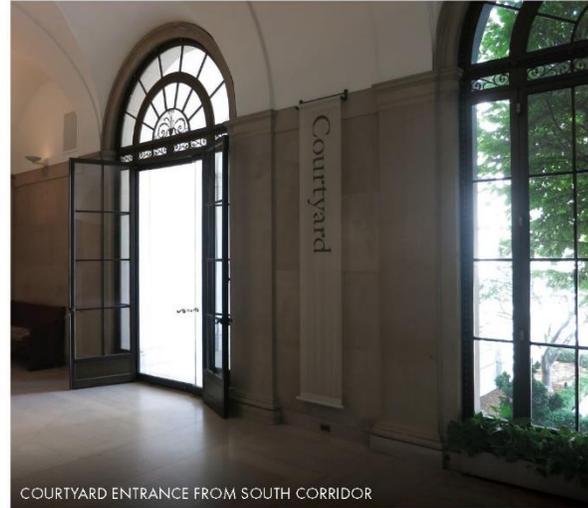
COURTYARD ENTRANCE FROM SOUTH CORRIDOR

In the late 1990s, a modification was made to the existing courtyard perimeter doors to add (2) contemporary glass door inserts at south corridor loggia door locations. The historic doors at these locations were retained and are left in the open position. The new doors were intended to provide improved visitor access to the exterior loggias, and each door is configured in a single leaf that swings in both directions and can be secured with a cylinder lock with bolt that inserts into the door threshold. There are no secondary doors to prevent outside air infiltration when the insert doors are in use, but observation suggests that the impact of the new doors on museum climate control has been minimal (except when doors are held or propped open for after-hours event staging).

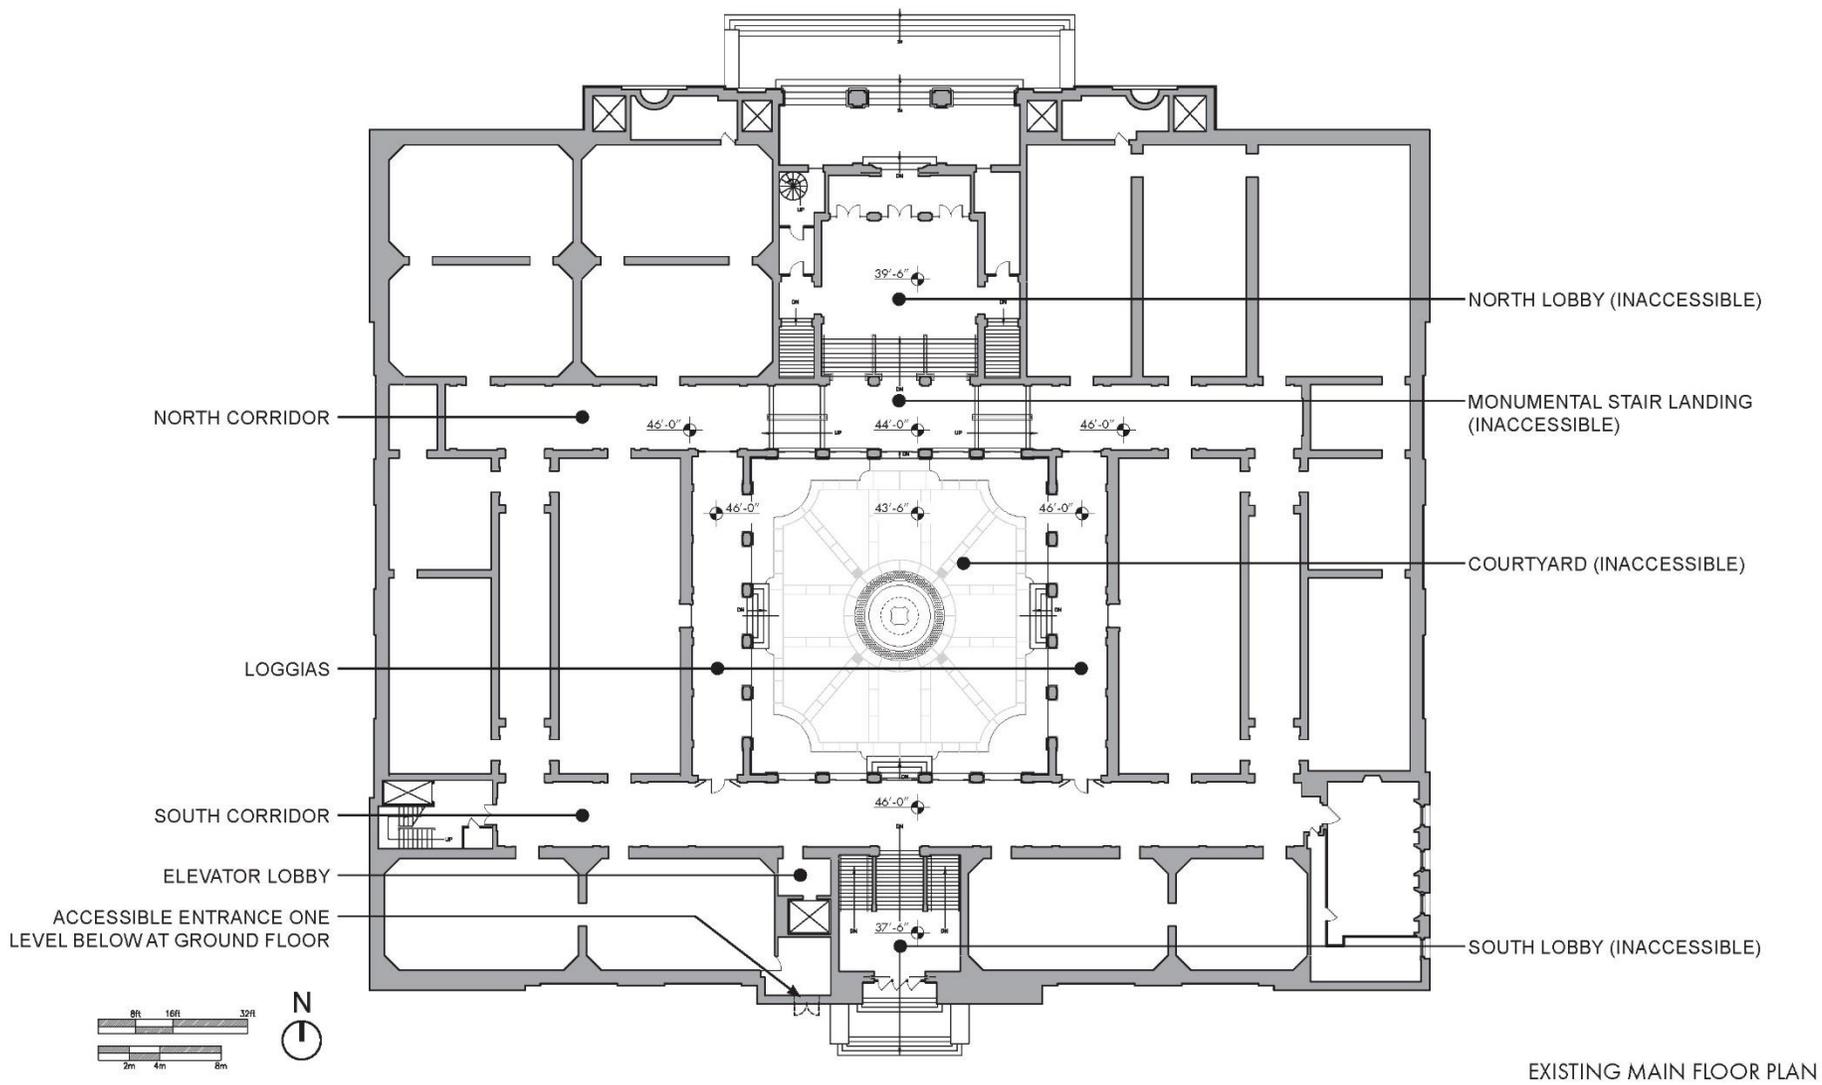
Existing Conditions - Accessibility

There are presently two accessible routes to the Main Floor of the Freer Gallery. One begins at a street level entrance from Independence Avenue into a mid-floor elevator lobby where an elevator can be taken to the Main Floor above or the Ground Floor below. The other accessible route originates from the Sackler pavilion through the Lower Level connection into the Freer via an elevator located adjacent to the open stair near the Meyer Auditorium. From there, the route continues through the South Corridor toward the Independence Avenue Lobby to the Ground Floor elevator lobby at which point a separate elevator (the same elevator serving the Independence Avenue entrance) can be taken to the Main Floor.

In either route, the visitor arrives at the South Corridor of the Main Floor on its south side from an elevator lobby located next to the Independence Avenue Lobby and stair.

With the exception of the Courtyard, the Main Floor is almost fully accessible except for where the North Corridor is interrupted by two pair of steps in series. While this sunken section of Corridor is itself inaccessible, the more significant limitation is that it prevents many visitors from circulating continuously through the Gallery resulting in a horseshoe-shaped circulation pattern.

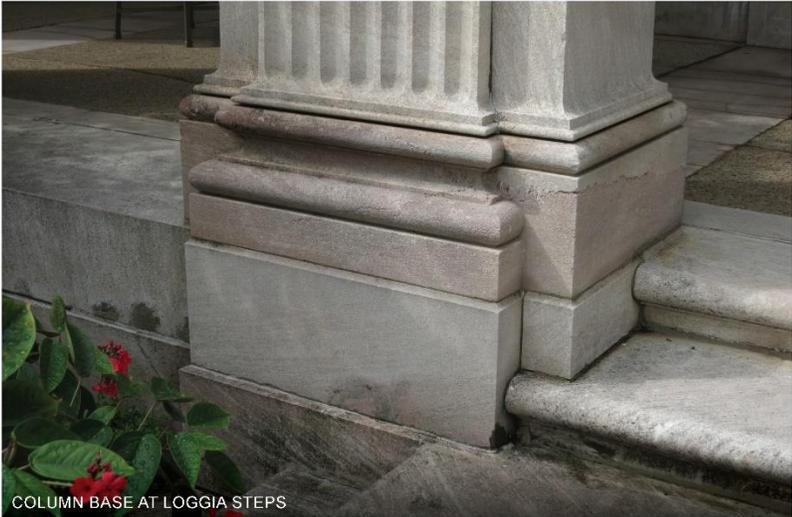
COLUMN BASE AT LOGGIA STEPS

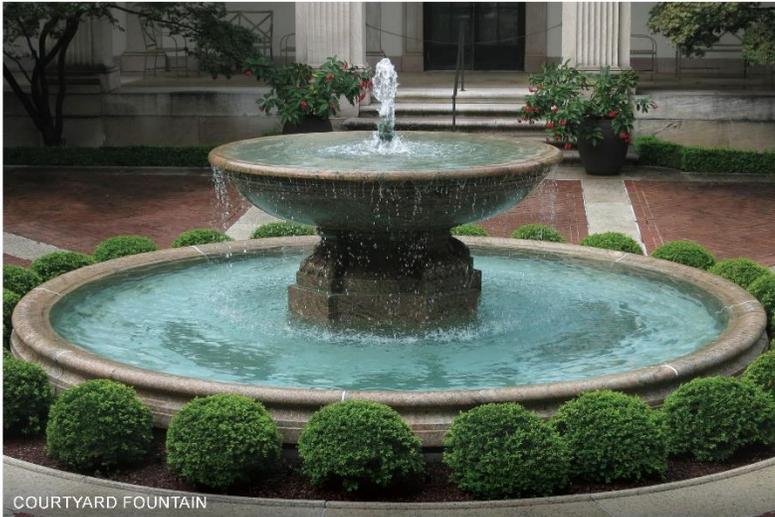
COURTYARD FOUNTAIN

The paving consists of red clay brick pavers in a herringbone pattern bordered and divided by granite bands, with a granite border framing the central paved space. The central fountain basin and coping are granite. It is expected the fountain will remain in place and protected during the waterproofing repairs unless further issues are discovered during the initial evaluation that would require removal and reinstallation of the fountain system.

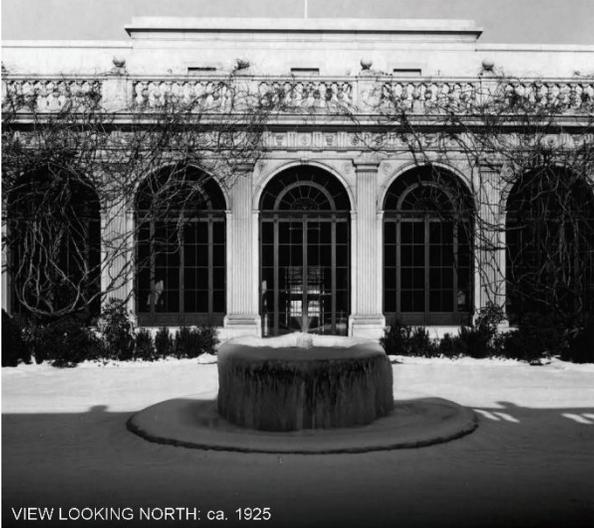
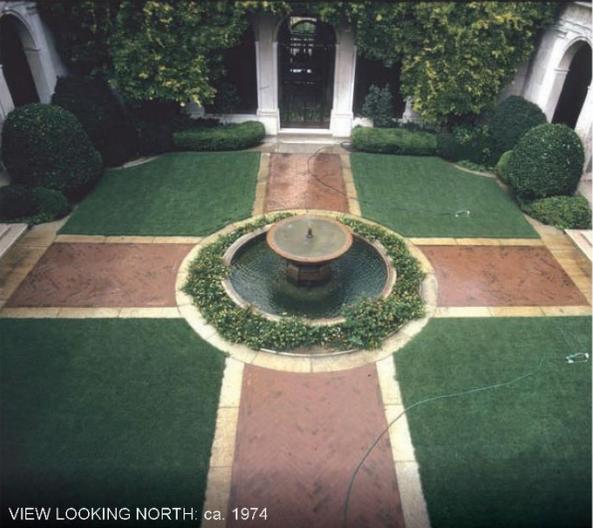
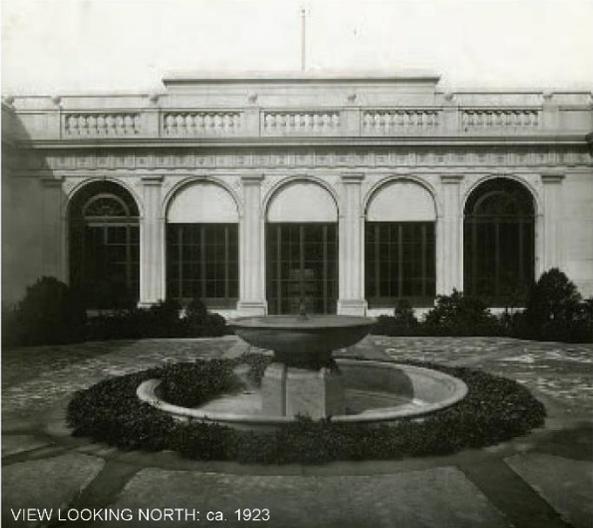
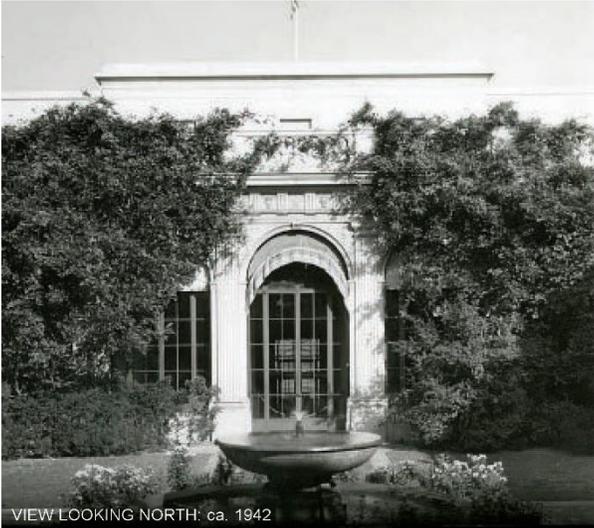
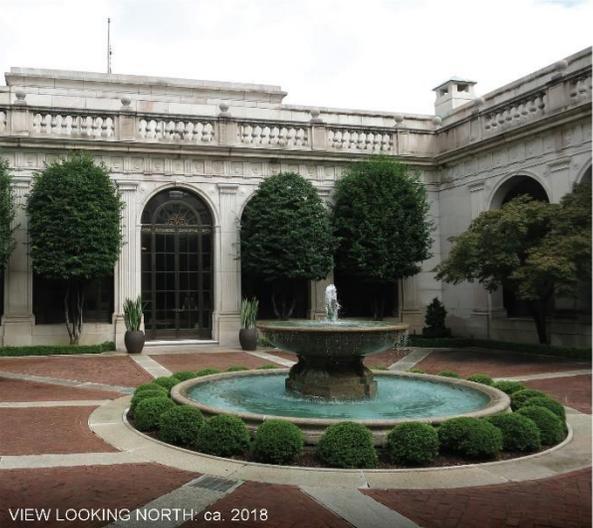
Evolution of Courtyard Planting

The character of the courtyard planting has evolved over time since the museum's opening in May 1923. In the absence of any original planting plan or plant lists prepared at that time, there are many historic photographs taken over the 20th century and at various times of the year that suggests the character of the landscape took in terms of shape and texture. The earliest photo, dated 1923 when the plantings were new, suggests a rather subdued planting character with perhaps a mix of evergreen species. Wisteria appears in the 1925 photo on the south facing wall.

In 1928, shortly after the museum opened, (8) brick panels within the paving where removed and replaced with turf to help reduce the solar heat gain during the summer. The turf grass areas were returned to brick paving around 1990 when the courtyard and plantings were removed and reinstalled as part of the museum's subgrade renovations. The plantings were most likely changed throughout the 20th century as shrubs and plantings became overgrown and season perennials were added and maintained. After 1990, more trees were introduced along with a variety of plantings within the borders resulting in the current day character described in the existing landscape conditions section.

Staff notes that the courtyard planting has evolved over time since the museum's initial opening in 1923. SI and the design team have relied on historic photos to understand the evolution of the space in the absence of any original planting plan or plant lists. The earliest images suggest a subdued planting character. In 1928, shortly after the museum opened, brick panels within the paving were removed and replaced with turf to help reduce the solar heat gain during the summer. The grass areas were returned to brick paving around 1990 when the courtyard and plantings were removed and reinstalled as part of the museum's underground renovations. Additional trees were introduced after 1990, along with a variety of plantings within the borders, resulting in the current landscape character. The landscape approach will be further refined, and several interests should be balanced in developing the design. In particular, staff suggests the **Commission recommend the applicant continue to develop the proposed landscape design while considering the original design intent, museum mission, and climatic conditions within the courtyard.**

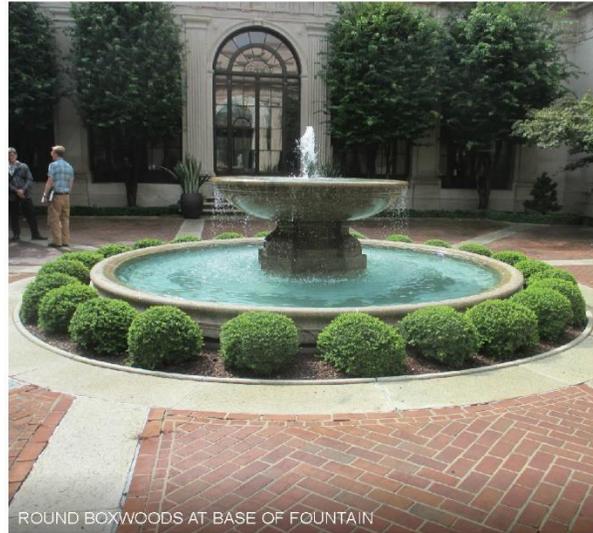
ROUND BOXWOODS AT BASE OF FOUNTAIN

The understory plantings are minimal, with small clipped boxwood, *Buxus* hedges in the planters of each quadrant and a Hinoki False cypress - *Chamaecyparis obtuse 'compacta'* holding each corner. There are small round boxwood shrubs around the base of the fountain, and a pair free standing planter pots at each set of stairs planted with seasonal plantings.

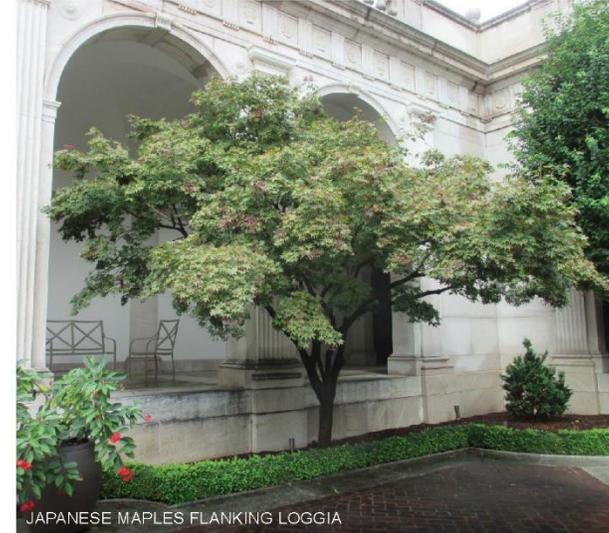
JAPANESE MAPLES FLANKING LOGGIA

There are eight Persian Ironwood, *Parrotia persica* trees on the north and south facades. The trees have been limbed up and pruned into formal oval shape to mimic the arches of the windows, and significantly block the views into the courtyard from the internal corridors. Four Japanese Maples, *Acer palmatum* trees flank the loggias, which provide some shade, but significantly obscure views into the courtyard from the loggias.

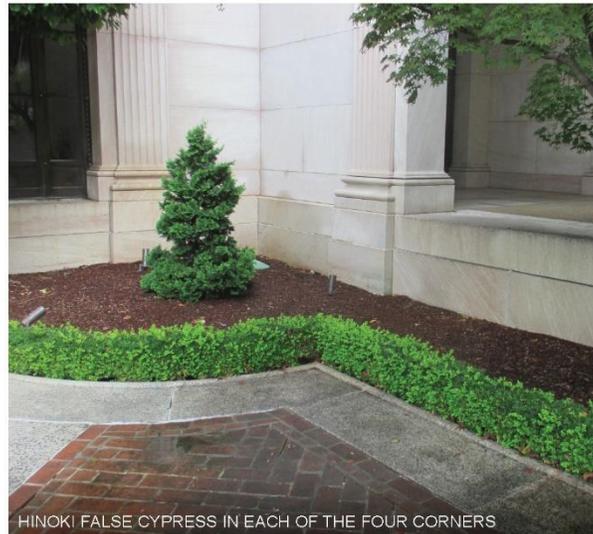
HINOKI FALSE CYPRESS IN EACH OF THE FOUR CORNERS

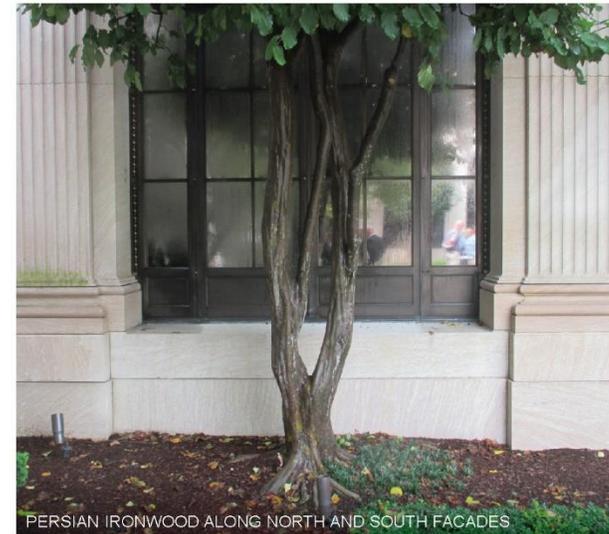
PERSIAN IRONWOOD ALONG NORTH AND SOUTH FACADES

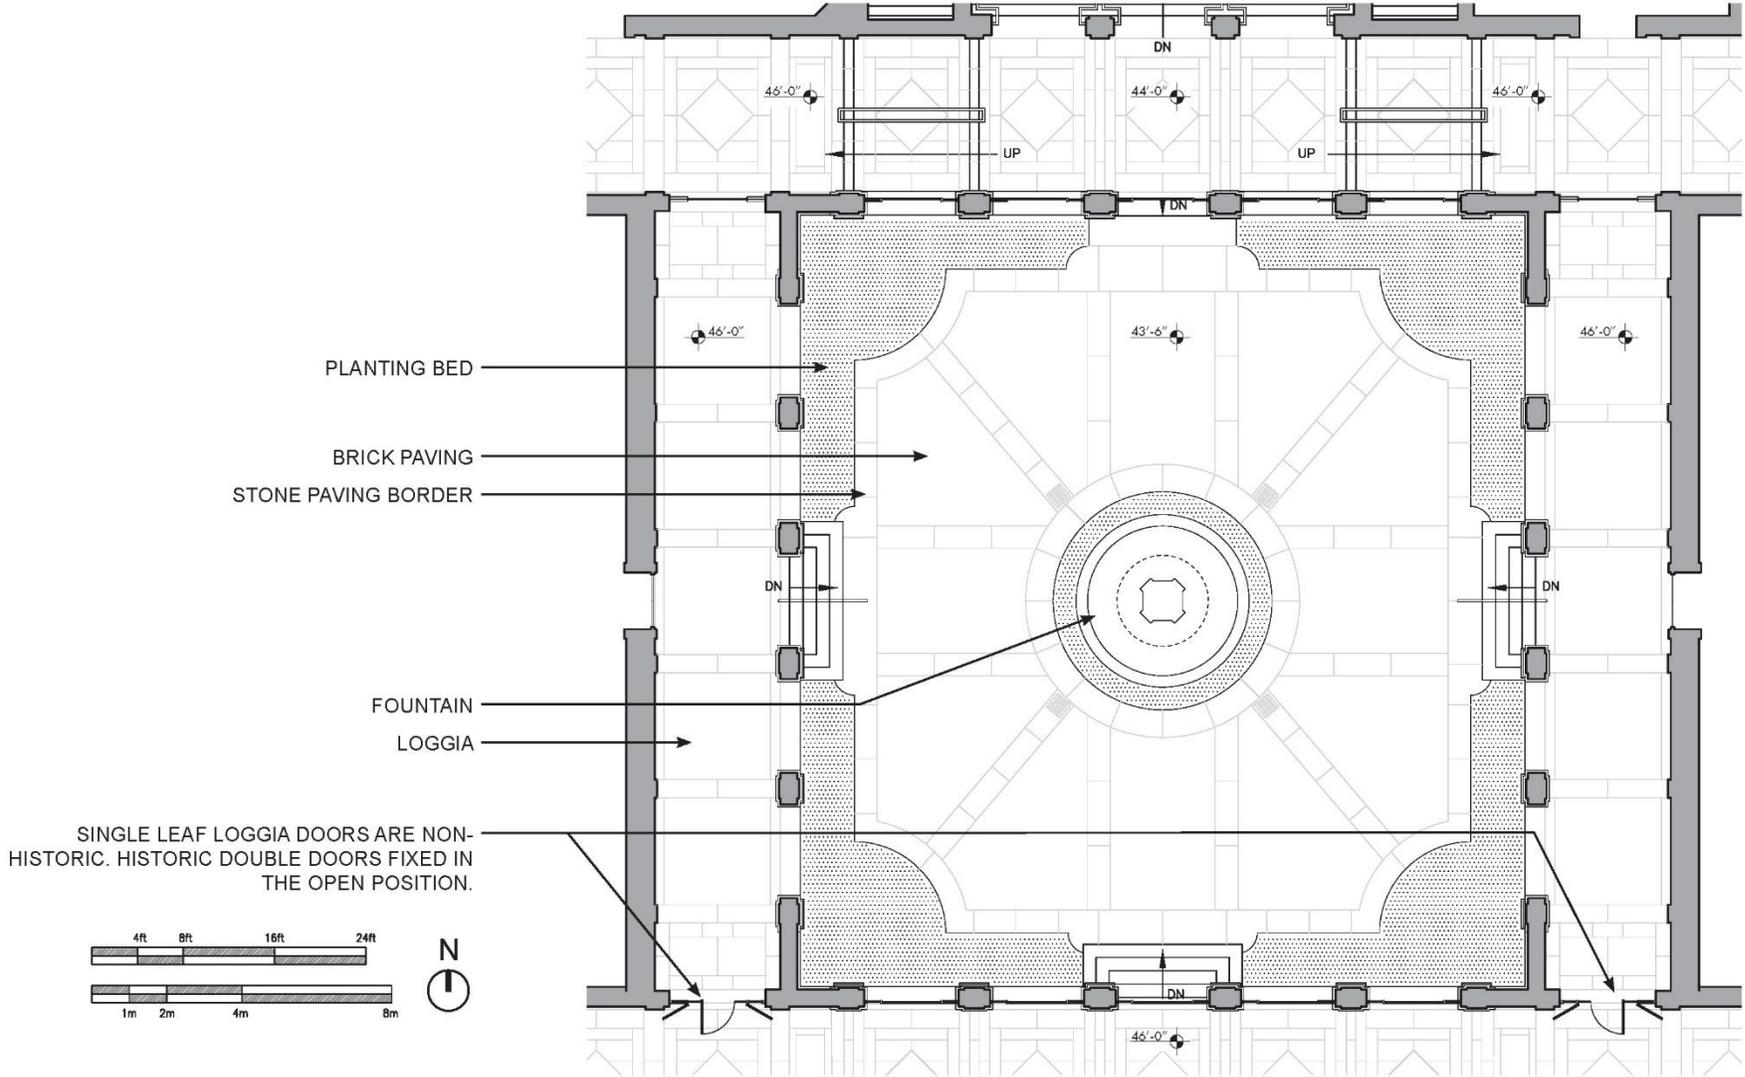
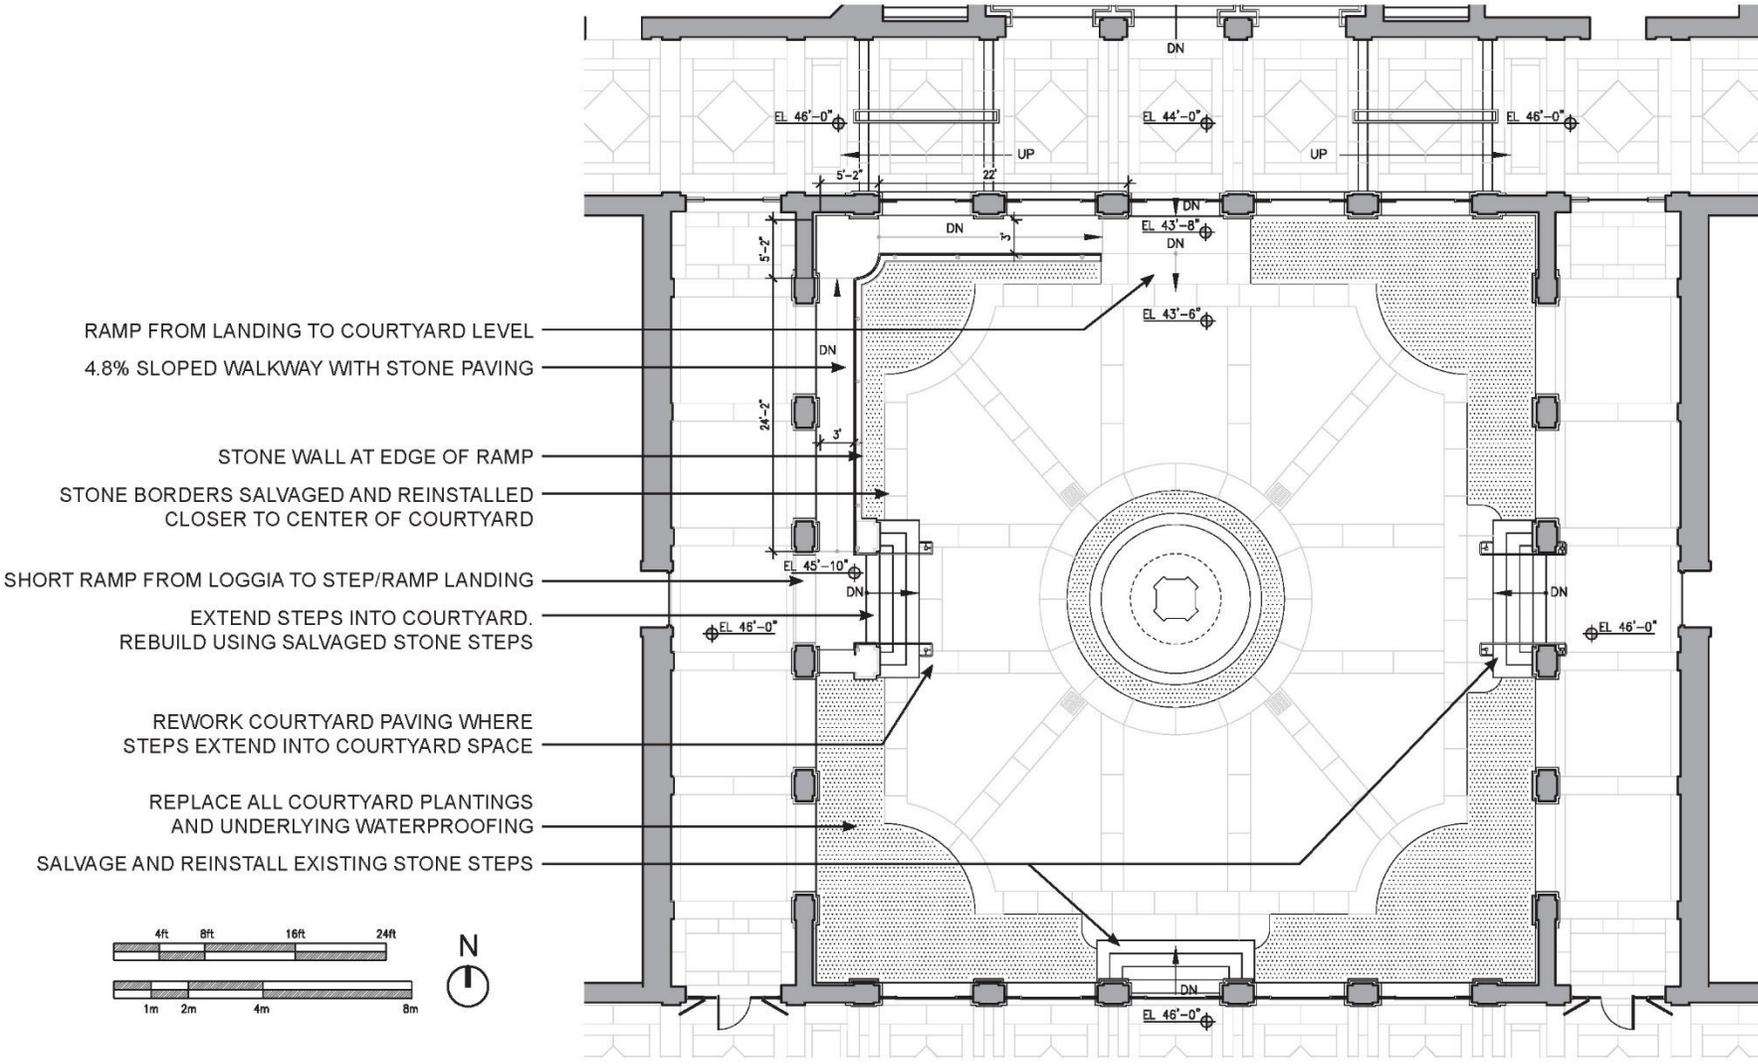
Proposed Courtyard Plan

- RAMP FROM LANDING TO COURTYARD LEVEL
- 4.8% SLOPED WALKWAY WITH STONE PAVING
- STONE WALL AT EDGE OF RAMP
- STONE BORDERS SALVAGED AND REINSTALLED CLOSER TO CENTER OF COURTYARD
- SHORT RAMP FROM LOGGIA TO STEP/RAMP LANDING
- EXTEND STEPS INTO COURTYARD. REBUILD USING SALVAGED STONE STEPS
- REWORK COURTYARD PAVING WHERE STEPS EXTEND INTO COURTYARD SPACE
- REPLACE ALL COURTYARD PLANTINGS AND UNDERLYING WATERPROOFING
- SALVAGE AND REINSTALL EXISTING STONE STEPS

The proposed project includes a new ramp from the west loggia to the north end of the courtyard with a sloped walkway with detailing reflecting the historic building. This side was selected due

to its proximity to the Main Floor's accessible entrance, and because the area north of the landing allows more space for the walkway. The proposed slope is less than five percent. A planter width is provided adjacent to the new walkway and the planted areas in the other three quadrants of the courtyard are proposed to be slightly widened to maintain alignments with pavement edges. Integration of the proposed walkway into the planted area maintains the overall symmetry of the space. The new paving and ramp materials reflect the original courtyard materials, including Tennessee Pink marble for the wall panels, cap stones and plinths, along with Milford Pink granite for the paving at the new walkway. Existing stonework will be salvaged and reinstalled where possible. New handrails will be dark bronze to match the vocabulary of the building's original architectural metalwork.

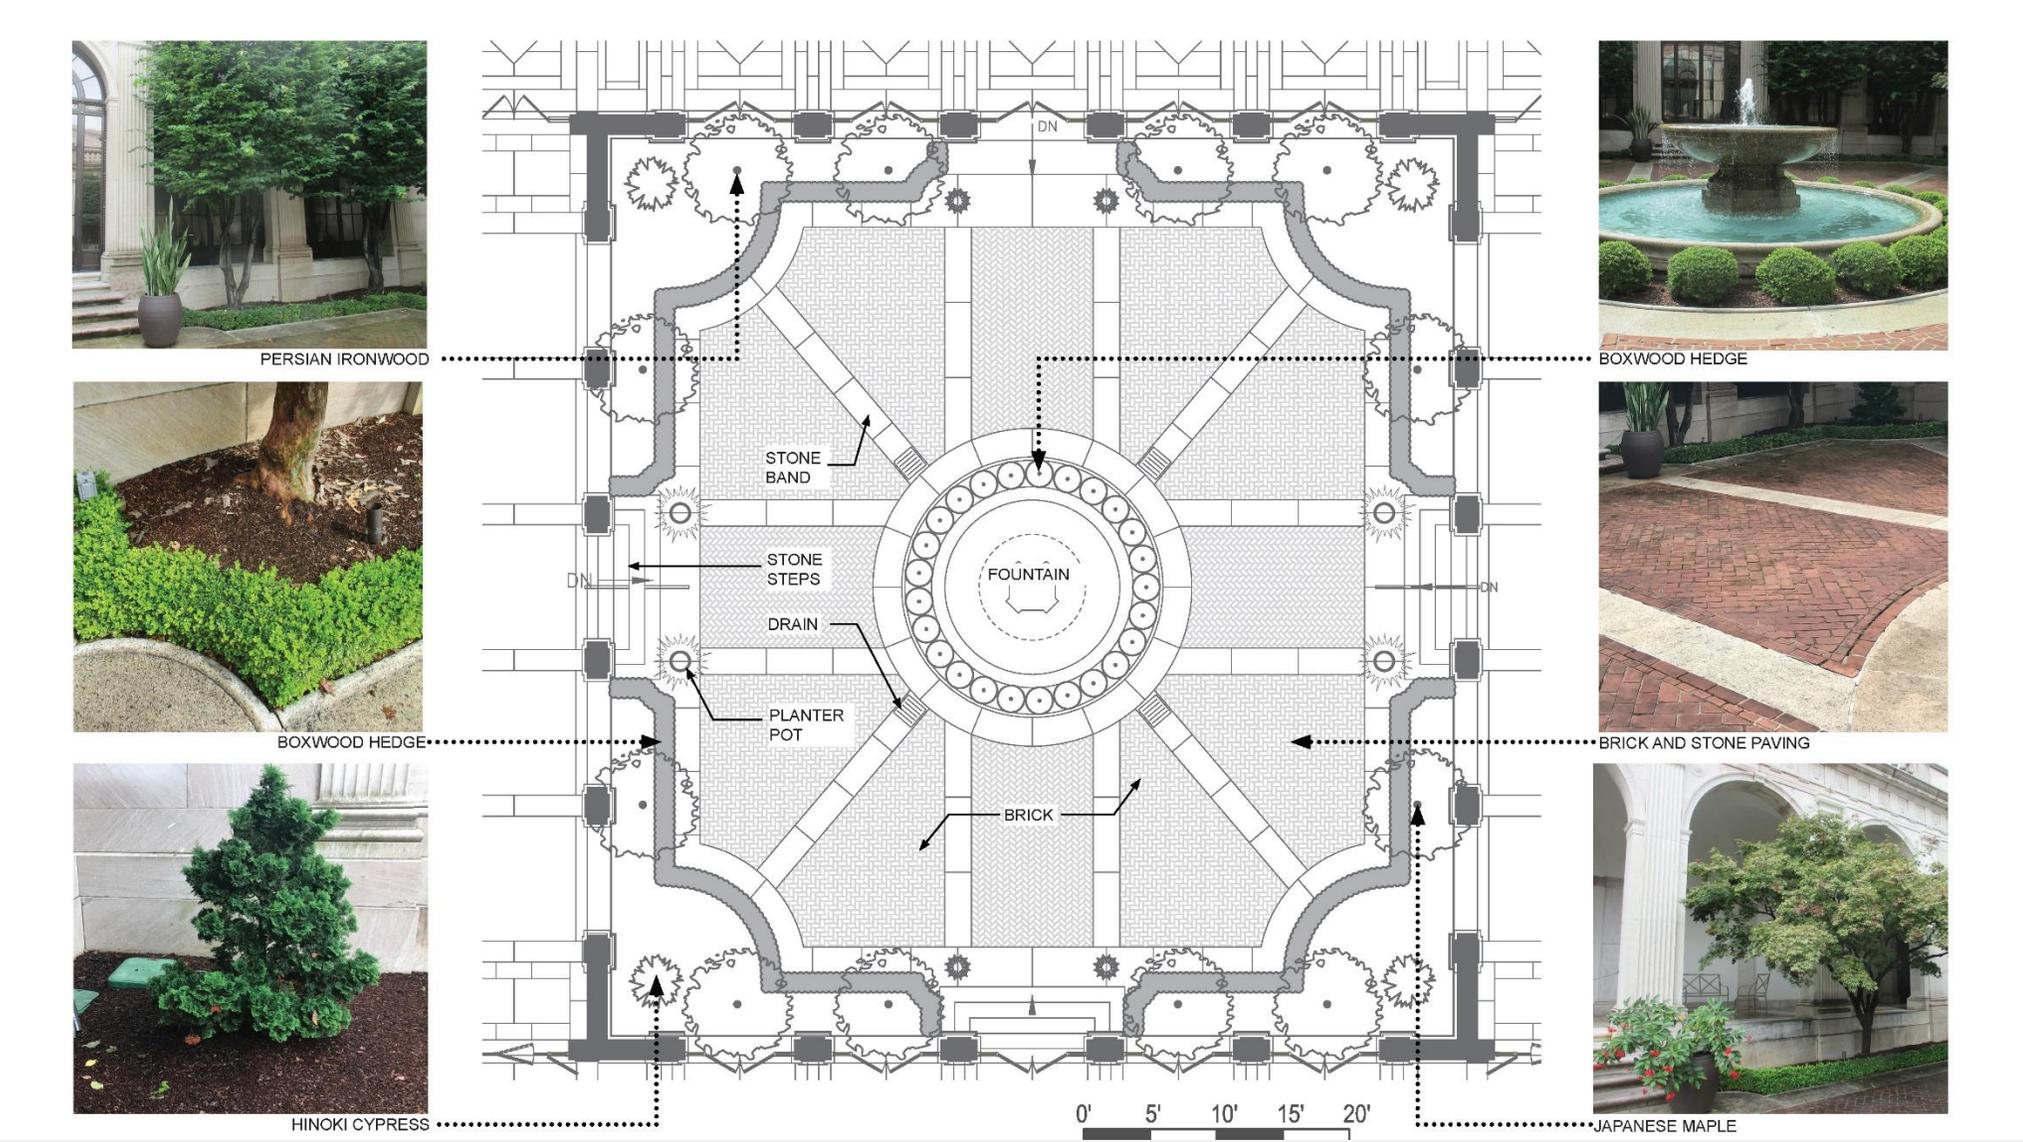
Existing Courtyard Landcapse

Currently the planting character of the courtyard is defined by predominantly tree planting and minimal understory planting that were installed as part of the major rehabilitation in the early 1990's when the courtyard was reconstructed. Based on review of historical photographs, the courtyard planting treatments have been replaced throughout the museum's history and the current plantings are not original nor historical. The tree plantings have outgrown the space, and despite significant maintenance effort, they obscure the architectural facades and block views into the courtyard from the loggias. Even if there were no need to replace the waterproofing under the courtyard, the existing landscaping is arguably overdue for substantial revitalization.

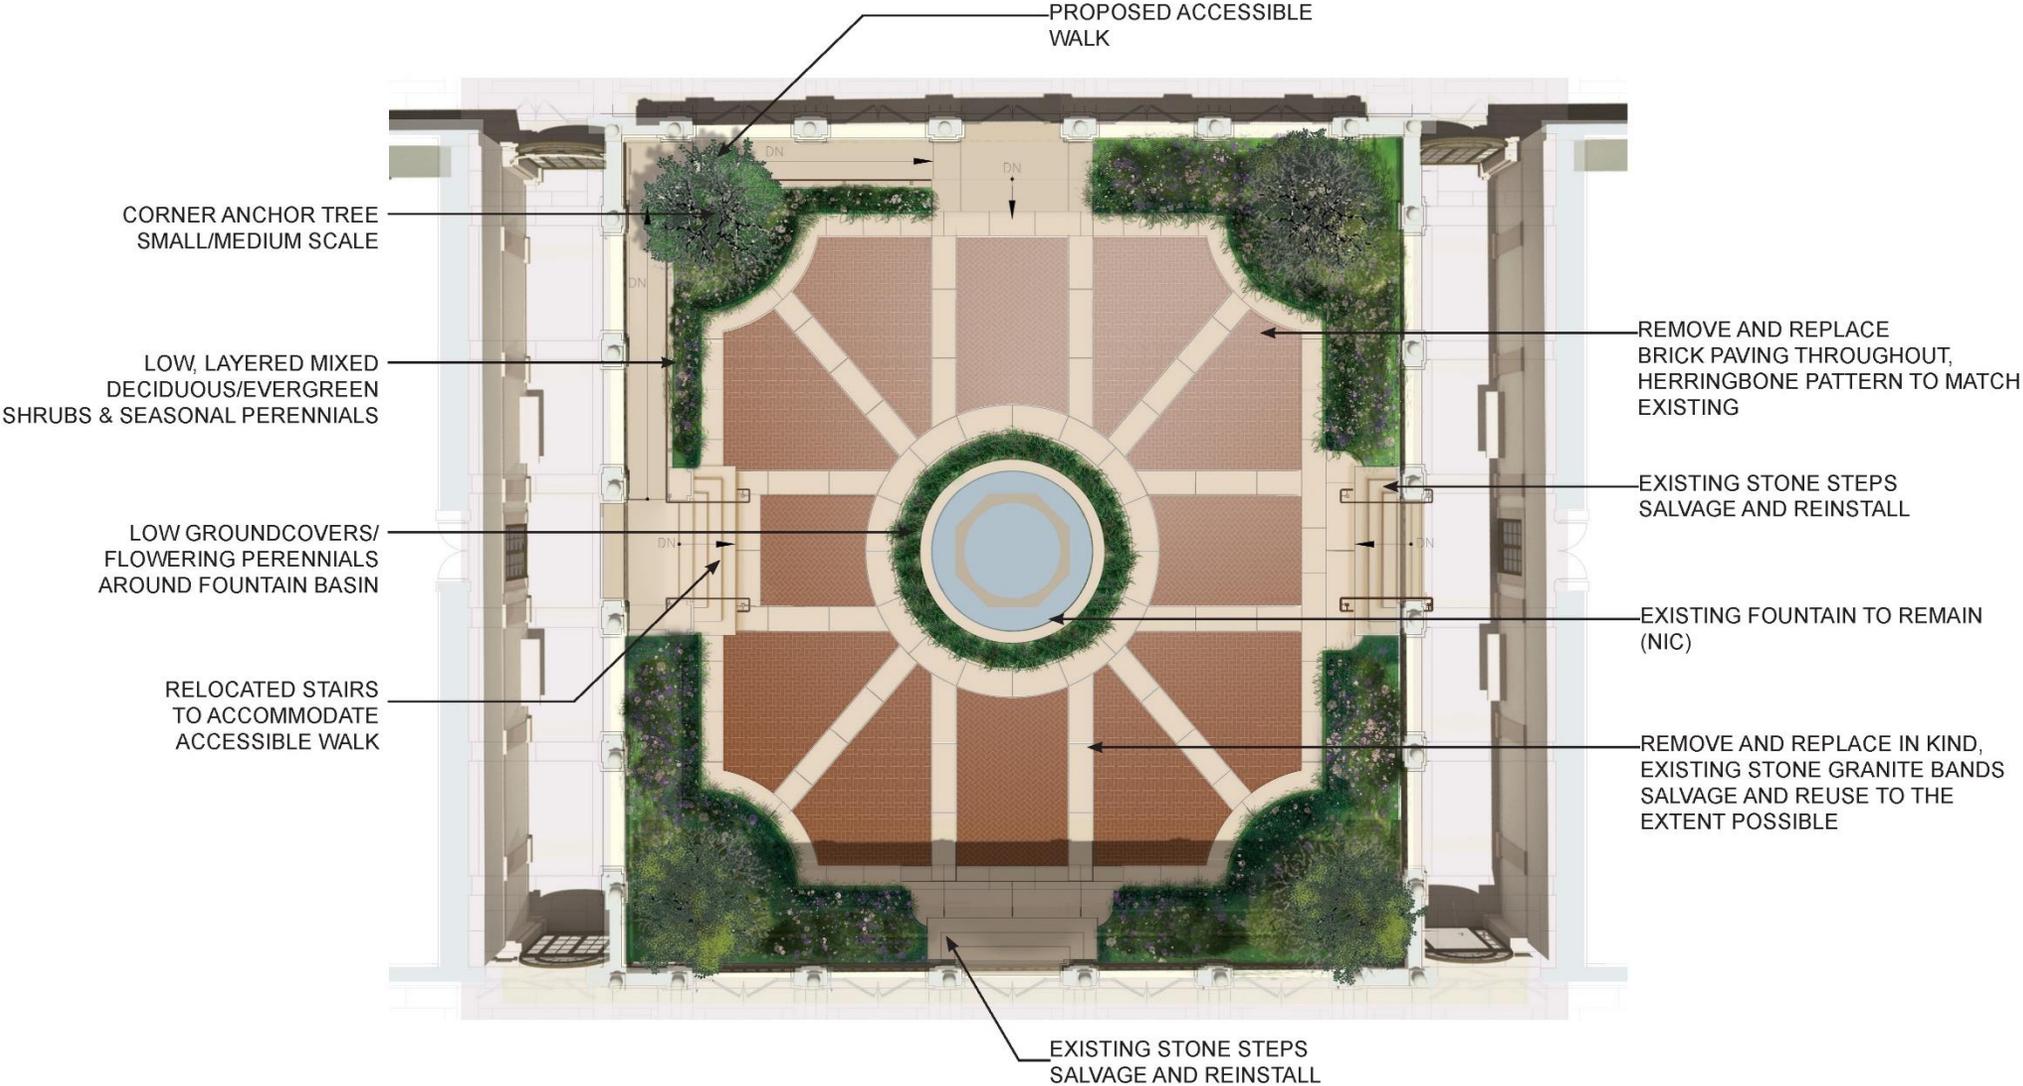
Proposed Landscape Plan

The proposed landscape concept seeks to balance the original design while also establishing an interpretive connection with the museum's collection. As such, Asian plants have been selected for the design. Specimen trees are proposed to anchor the corners of the courtyard and a mix of low evergreen and deciduous shrubs and groundcovers interwoven will be placed around the perimeter of the courtyard and water fountain. Seasonal color will be integrated in the planting scheme. The initial plant list has been developed in coordination with Smithsonian Gardens.

For the design of the landscape, they requested further development of the concept, supporting the intended approach to draw inspiration from the museum's artworks, but which should also be informed by the work of Platt, who began his career as a designer of landscapes; they suggested that his legacy of executed landscapes and publications on Italian gardens should be considered more carefully as part of the design process. They commented that the current proposal lacks the lush character and prevalence of evergreen plants seen in the courtyard's historic landscape designs; they recommended that the landscape be adapted in the spirit of Platt's work rather than specifically restored, using substitutions of the plant palette to address thematic and microclimatic change. They acknowledged the constraint of the shallow planting depth resulting from the building area inserted beneath it in the 1980s; they observed that this condition will necessarily guide plant selections, noting that pots could be used to augment the range of plantings, and that trees may not be appropriate in the new design.

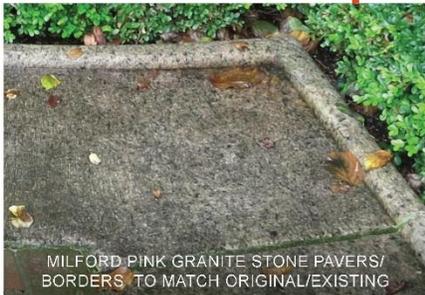
MILFORD PINK GRANITE STONE PAVERS/
BORDERS TO MATCH ORIGINAL/EXISTING

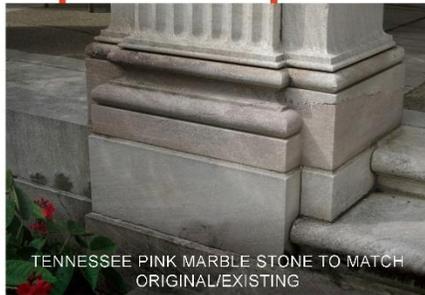
TENNESSEE PINK MARBLE STONE TO MATCH
ORIGINAL/EXISTING

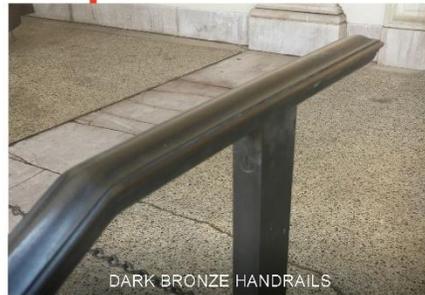
DARK BRONZE HANDRAILS

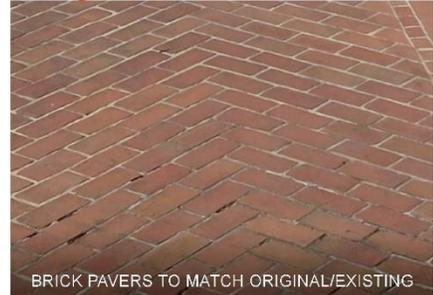
BRICK PAVERS TO MATCH ORIGINAL/EXISTING
