re: Eisenhower Executive Office Building Exterior BEAUTIFICATION Project (NCPC File #8777)

To the Chairman and Members of the National Capital Planning Commission:

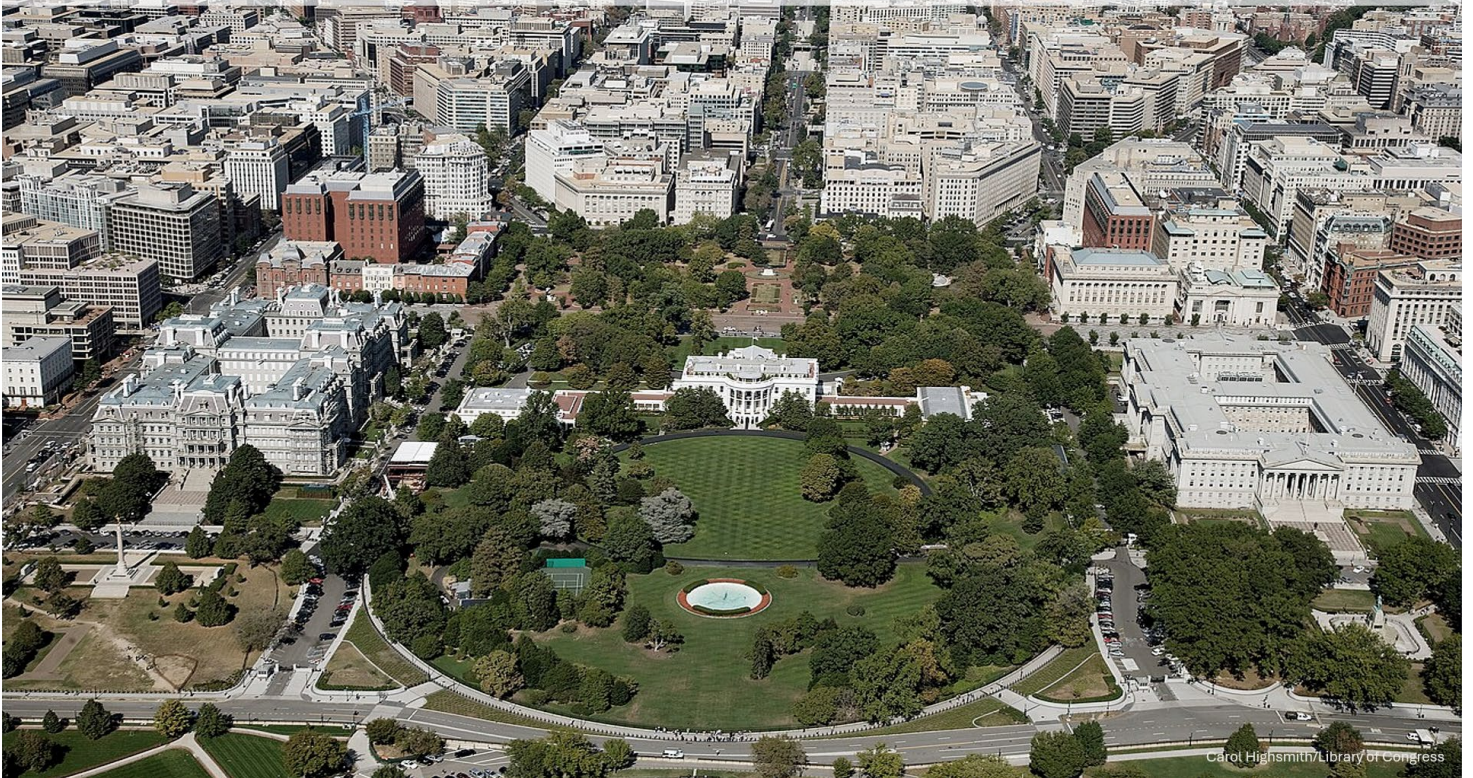
The EEOB occupies a small city block and forms part of the urban fabric of Washington

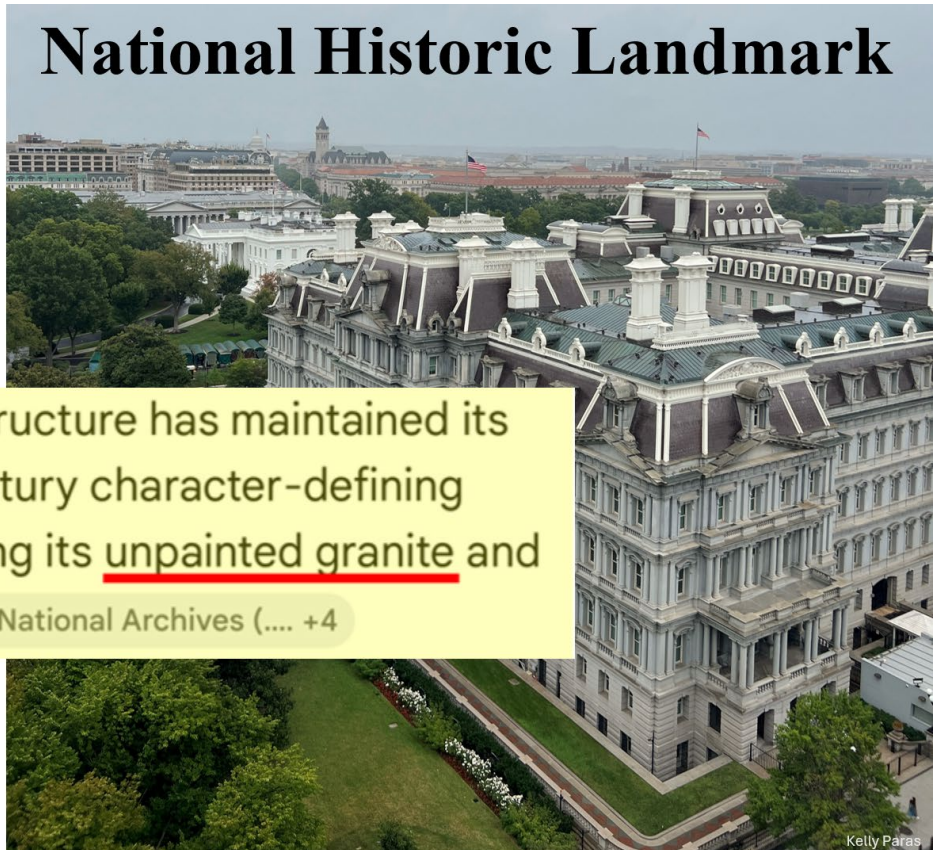
Basis for EEOB being listed as a NATIONAL HISTORIC LANDMARK:

- **Architectural Significance (Criterion 4):** As an outstanding example of the French Second Empire style, it features a distinctive mansard roof, central pavilions, and an ornate, detailed granite facade.
- **Historic Significance (Criterion 1 & 2):** The building is directly associated with crucial events and national figures in U.S. history, originally serving as the State, War, and Navy Department Building.
- **Integrity:** The original 19th-century features, including its unpainted granite and slate exterior.

1. **VIOLATE THE DESIGN INTEGRITY OF THE NATIONAL HISTORIC LANDMARK:** The polychromatic granite is an integral part of this Landmark structure's design with its complementary slate roof. One of the best examples of French Second Empire Architecture in America, the building has stood for over 150 years unpainted, and the unpainted granite was SPECIFICALLY cited as a major reason for it being listed as a rarified National Historic Landmark.

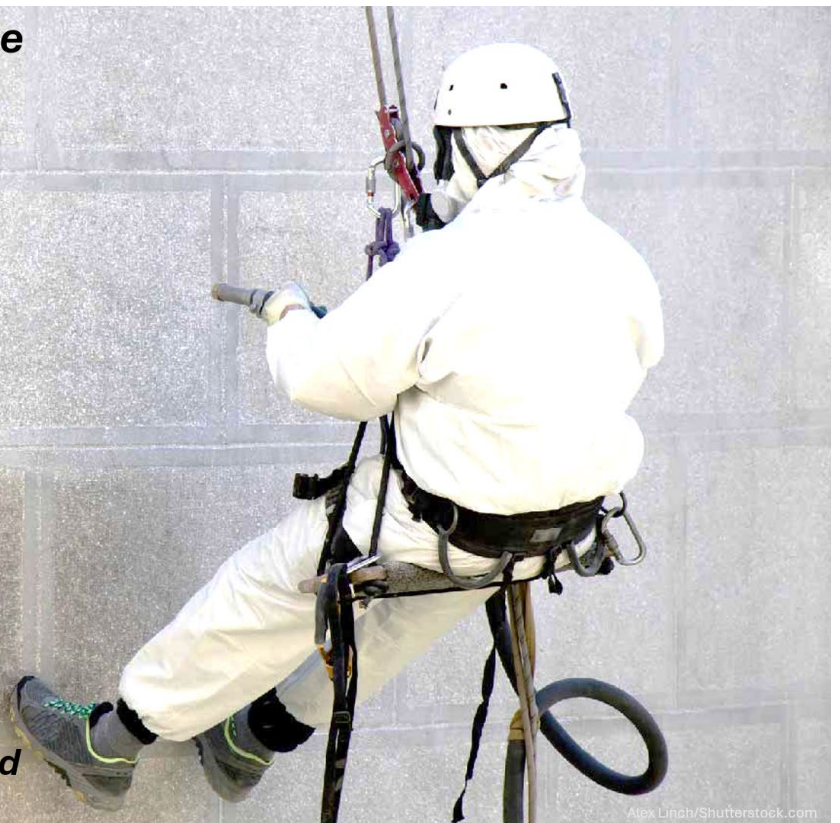
PAINING OVER STONE can be problematic due to:

- ***Moisture intrusion***
- ***Hydrostatic pressure***
- ***Freeze-thaw cycles***
- ***Internal spalling***
- ***Mineral crystallization***
- ***Efflorescence***

Potentially leading to biological growth and ongoing, previously unnecessary, EXPENSIVE MAINTENANCE

...Subsequent paint removal would require harsh SANDBLASTING

2. **TRAP MOISTURE IN THE STONE AND ITS MORTAR JOINTS.** Painting stone, especially stone with a cleft/thermal face, can cause innumerable problems. Granite is a NATURAL MATERIAL and needs to BREATHE. Hermetically sealing stone negates its ability to adapt to changing moisture conditions, trapping salts and particulates while causing ferrous metal iron ties to rust, expand and potentially crack the stone. Granite is an excellent exterior material *UNLESS* painted. Even paints that claim to be "breathable" still hinder moisture and are even more difficult to remove from the stone pores.

4. **PERMANENTLY DISFIGURE THE CHARACTER OF THE BUILDING.** It would be virtually impossible to remove the paint once this building has been coated--requiring sandblasting and other deleterious techniques, causing irreparable harm to the stone as well as damage to its 1,572 wood windows.

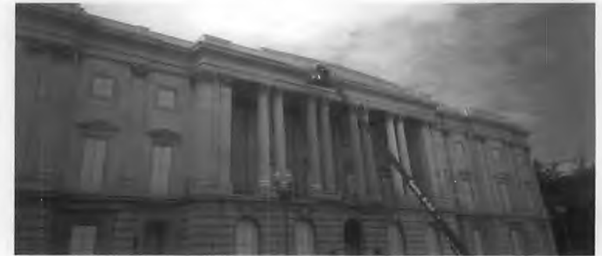
Figure 1. Low-to-medium-pressure steam (hot-pressurized water washing), is being used to clean the exterior of the U.S. Tariff Commission Building, the first marble building constructed in Washington, D.C., in 1859. This method was selected by an architectural conservator as the "gentlest means possible" to clean the marble. Steam can soften heavy soiling deposits such as those on the cornice and column capitals, and facilitate easy removal. Note how these deposits have been removed from the right side of the cornice which has already been cleaned.

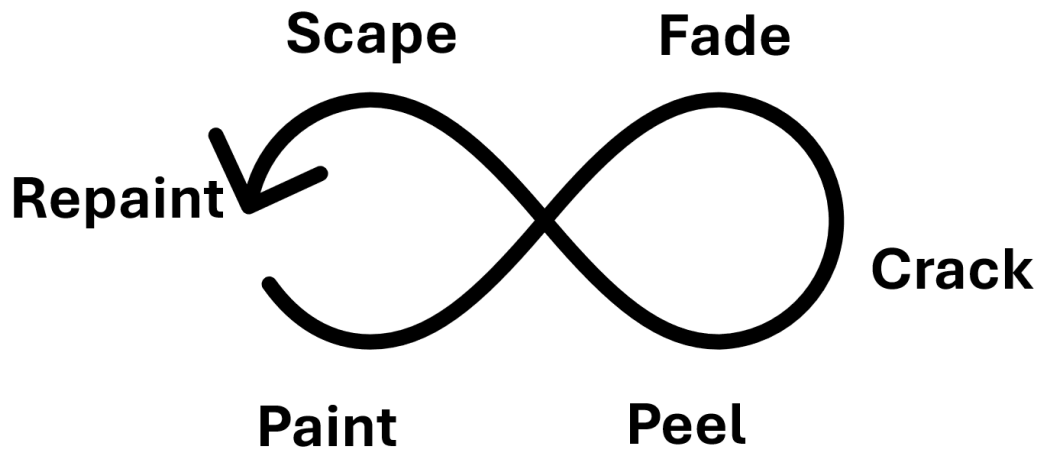
CLEANING AND REPAINTING may be necessary every 5 to 7 YEARS *

A Permanent, Vicious and Extraordinary Costly Cycle

3. **NECESSITATE SUBSTANTIAL ONGOING MAINTENACE COSTS.** Once a stone building has been painted, it must be repainted frequently, potentially every 5-7 years. Given its intricate façade elements—the immense building has over 900 stone columns and pilasters plus intricately carved cornices—repainting the 135' high structure will be exorbitantly expensive requiring cleaning, scraping and enormous scaffolding that will be up for months or years each time. Painting EEOB will add substantially to the ongoing taxpayer expense to maintain the building.

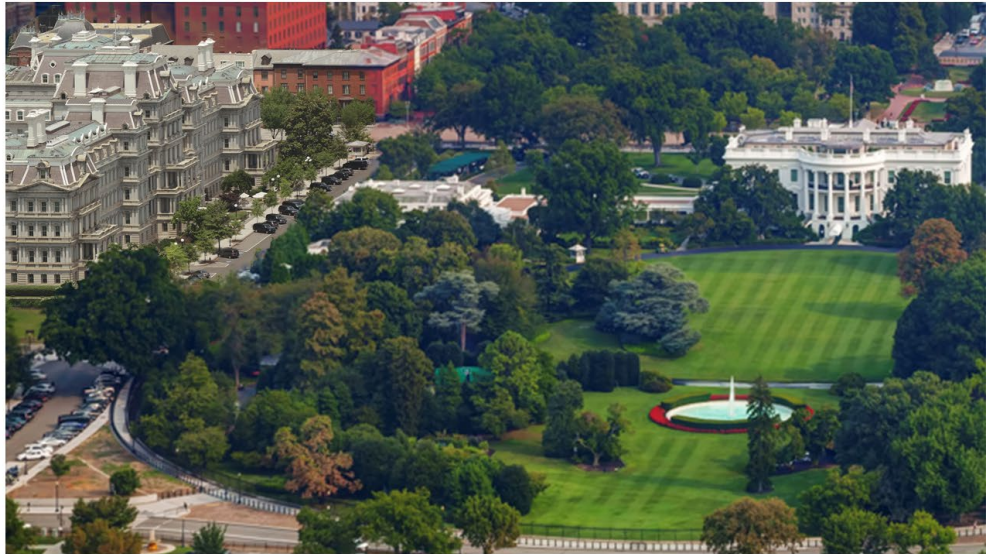
EXISTING RELATIONSHIP

This is a composite photo with the “existing” granite-faced EEOB superimposed on the aerial view to show its current relationship to the White House. The two buildings are architecturally **INDEPENDENT**-and always have been.

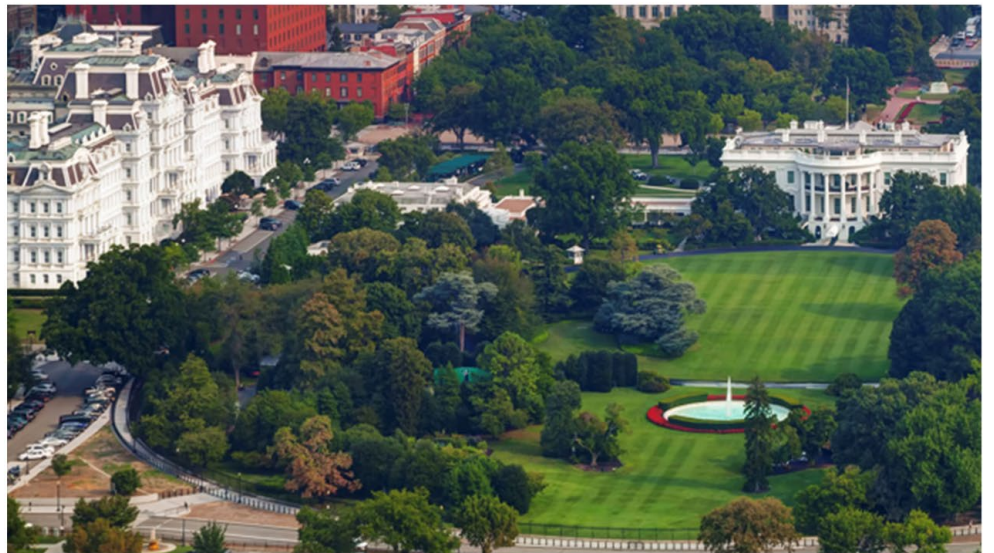
PROPOSED RELATIONSHIP

COMPARE with this **PROPOSED** view provided by the applicant as part of the current submission to NCPC. Note how the white paint makes the EEOB more dominant and pronounced-- **OVERWHELMING** the historic White House.
