T-Mobile Project Summary – GSA OPM Building (7WDC154B)

1900 E Street NW, Washington, DC 20024

Project Summary

T-Mobile Project Description – GSA OPM Building (7WDC154B)

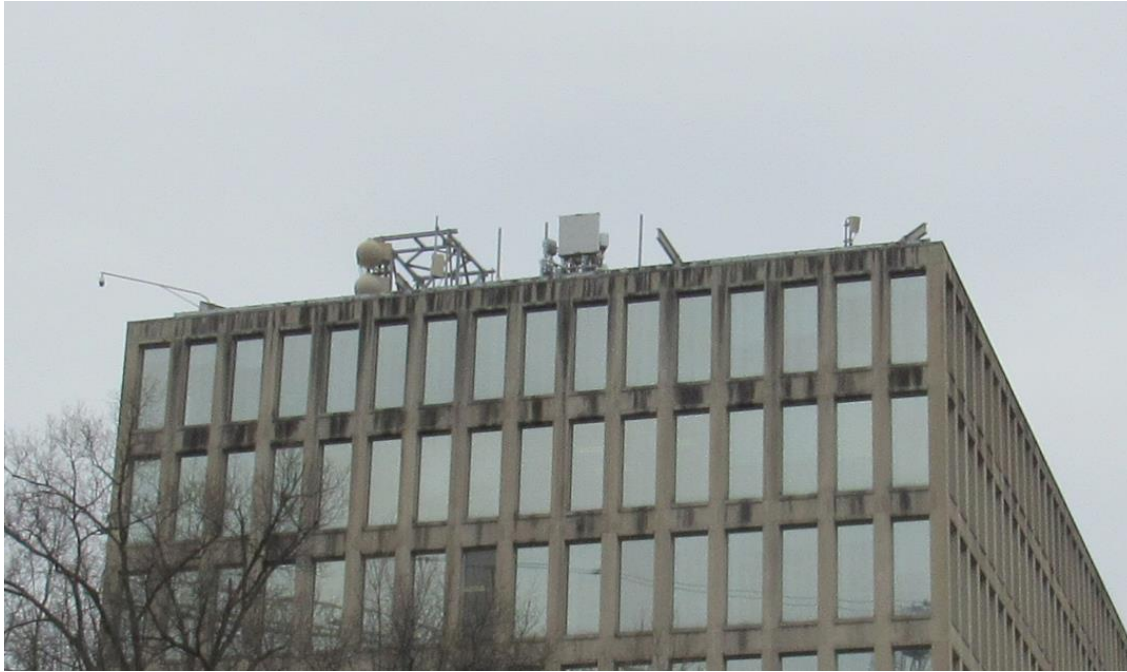
T-Mobile Existing vs. Proposed (Close-Up)

Existing Verizon and T-Mobile Antennas

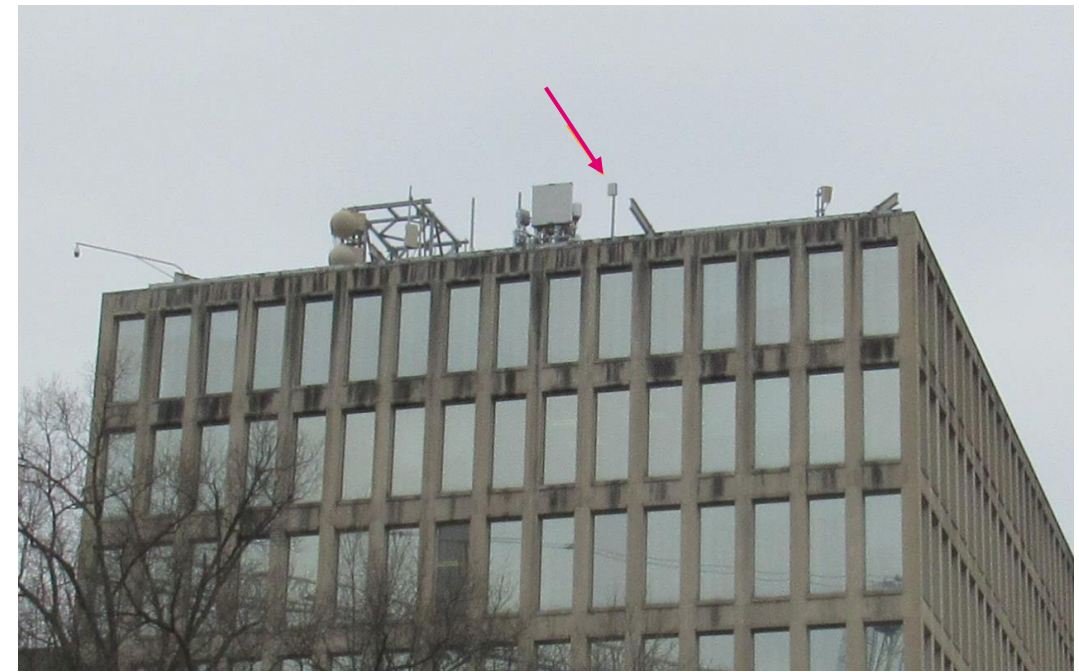
Proposed T-Mobile mmWave Antenna
