National Zoological Park Elephant Yards Stormwater Mitigation Repair

3001 Connecticut Avenue, NW, Washington DC

Approval of Preliminary and Final Site Development Plans

Smithsonian Institution

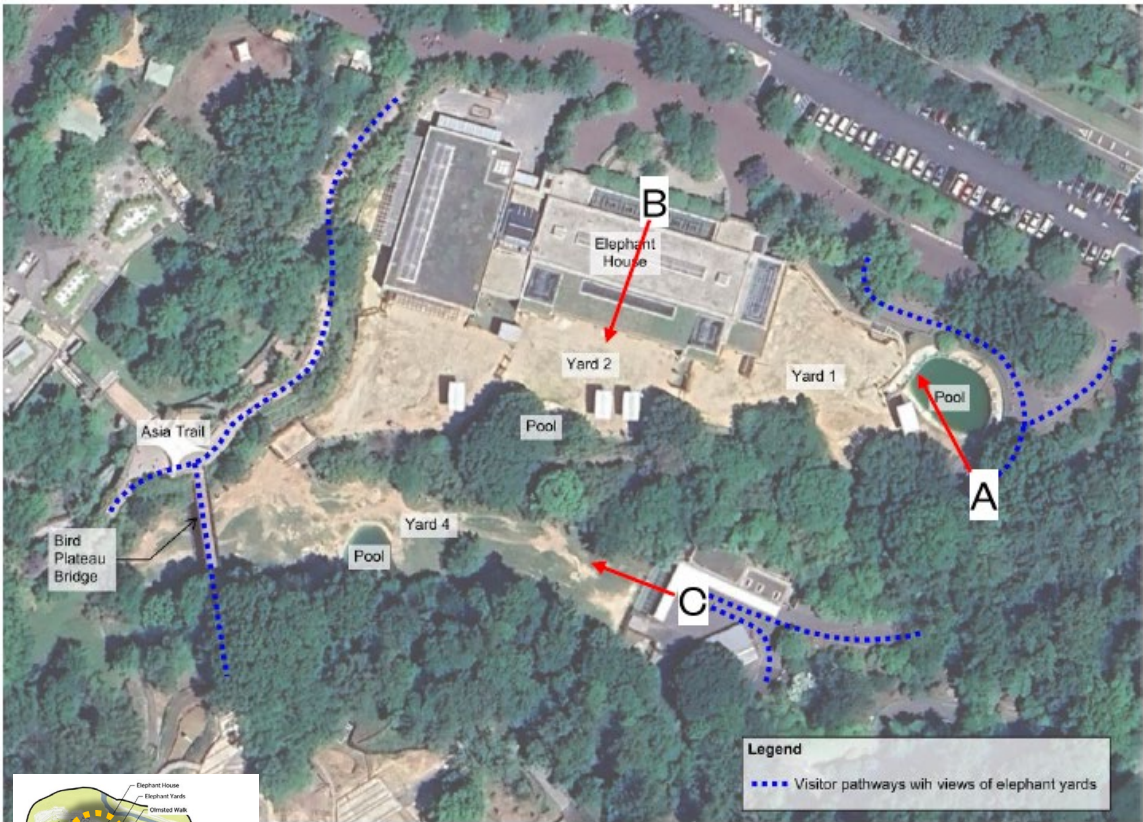
Site Context

Site and Yards
Exhibit spaces are enclosed with a steel bollard and high tensile wire barrier system and with artificial rock concrete wall systems topped with angled steel bollards and high tensile wire barrier systems. Most visitor viewing locations for exhibit spaces consist of asphalt paving, decorative low plantings and guardrail systems to prevent visitors from accessing the elephant barrier systems.

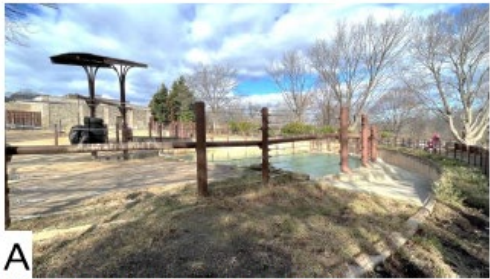
A
Photo of Yard 1 visitor viewing location and exhibit pool and barrier system.

- Steeply sloped at approximately 10%
- Fully enclosed
- Concrete exhibit pool with curbed edge at the bottom of sloped space
- Stormwater runoff carries sandy substrate downslope and into the pool

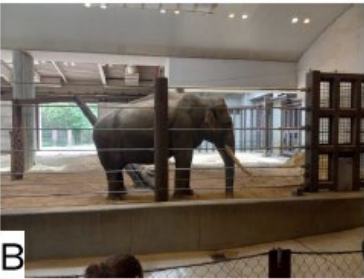
B
Photo of visitor viewing location of Yard 2 from Elephant House interior.

- Gently sloped at approximately 7%
- Fully enclosed
- Concrete exhibit pool located on southern edge of the exhibit

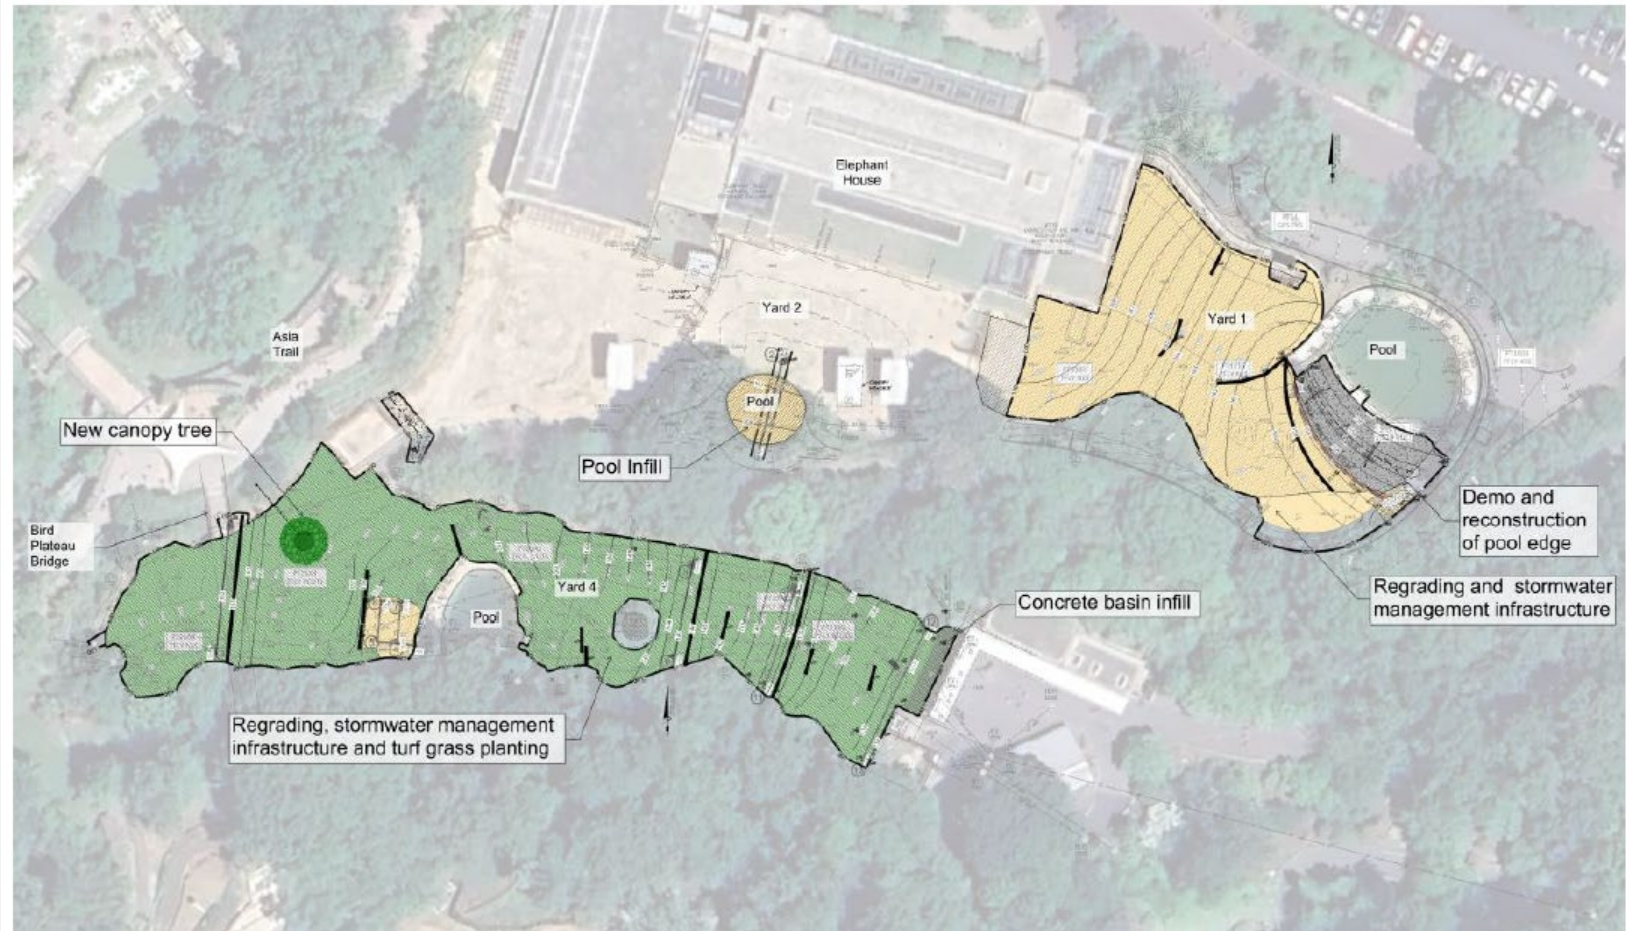
Site Plan

- Re-grading of Yard 1 and Yard 4, to reduce observed runoff and erosion issues and direct water more efficiently into improved stormwater management infrastructure.
- Planting of new turf grasses and a new canopy tree within Yard 4.
- Demolition and reconstruction of the Pool 1 perimeter within Yard 1, to reduce stormwater runoff into the pool and to make the pool more accessible for both animals and staff.
- Infill of Pool 2 in Yard 2 to create a clay bath for the elephants, including associated drainage and stormwater improvements to prevent ponding of water.
- Infill of an existing and unused concrete basin at the bottom of Yard 4, including associated drainage modifications and landscaping to improve maintenance access and visitor viewing experience.

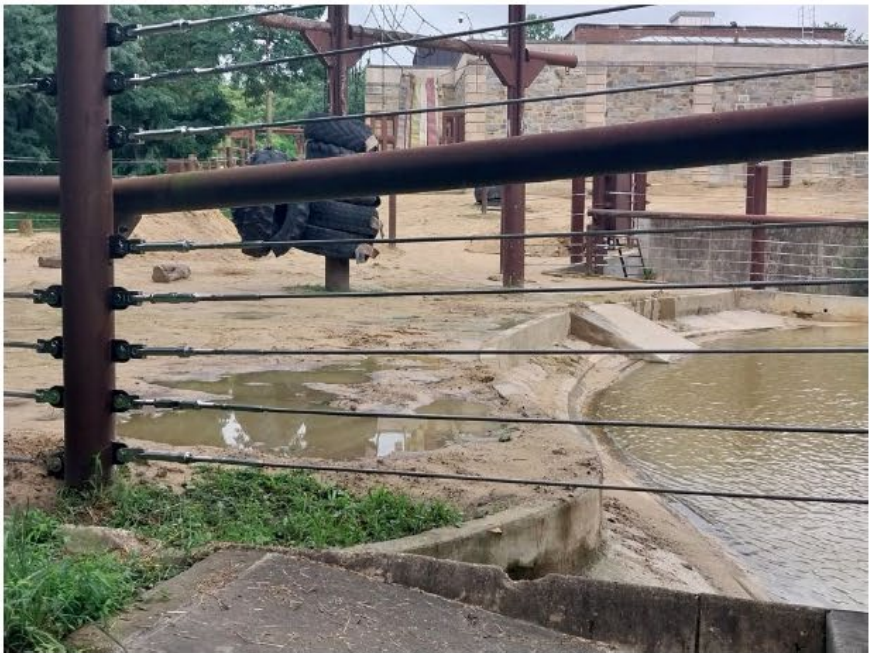
Photo of Yard 1 displaying ponding and runoff after a rain event.

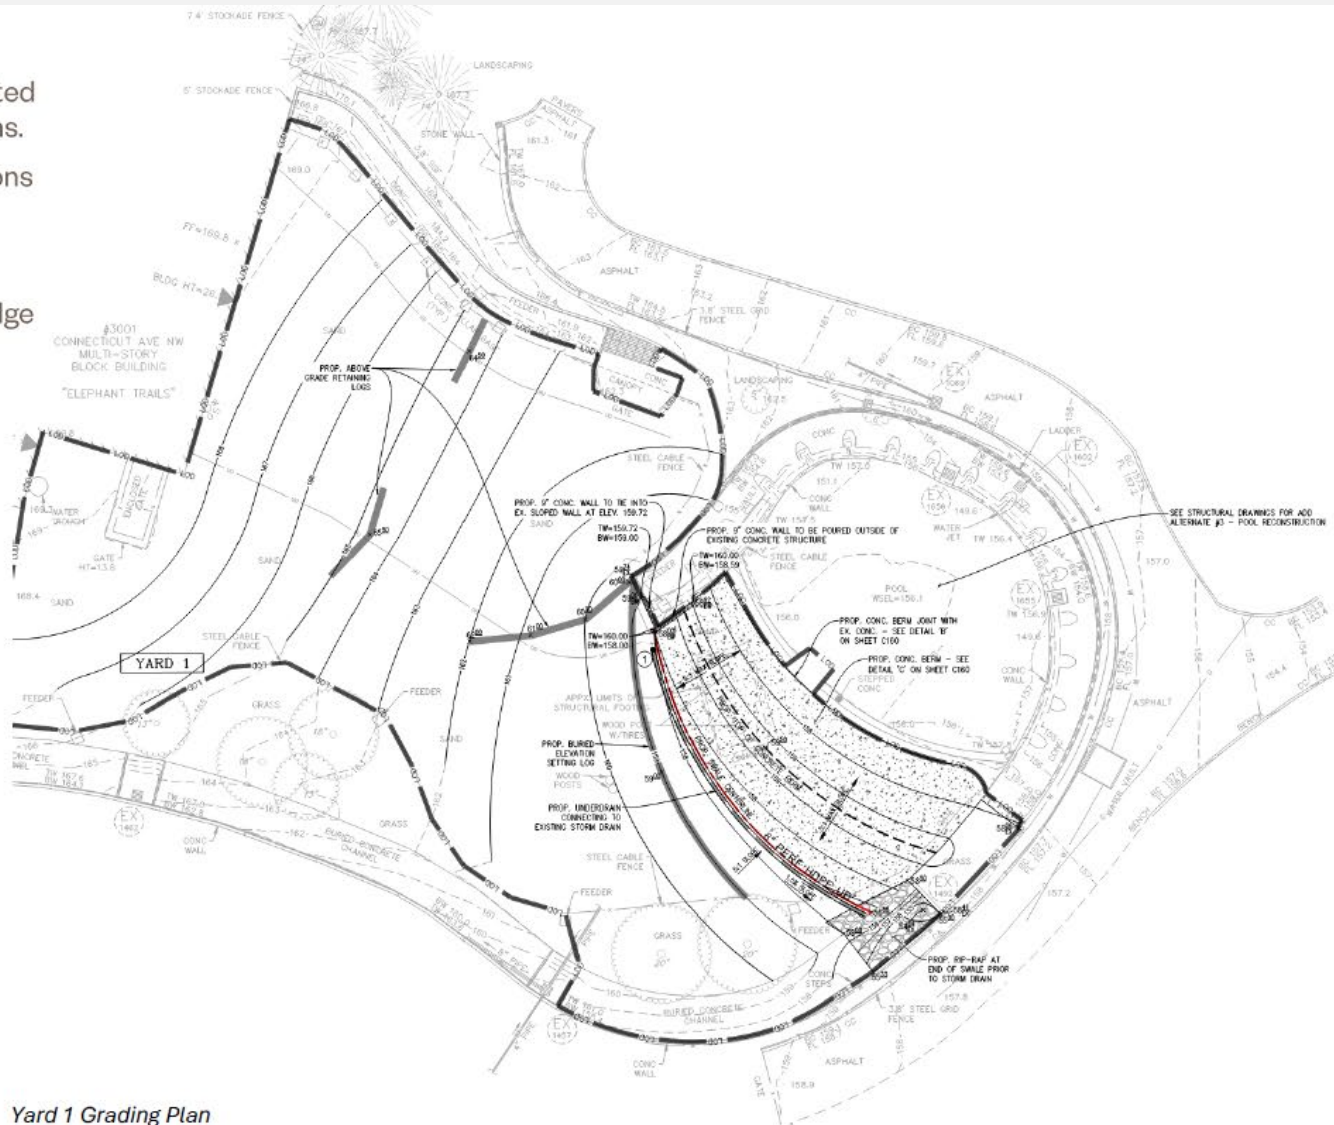
Yard 1 Grading Plan

Yards 1 and 4 each undergo grading adjustments to correct existing channels created by erosion and animal movement, and re-direct stormwater flow to new underdrains.

Yard 1: Topographic setlines in Yard 1 are drawn to start and end in the same locations as the existing grade but in between are smoothed and adjusted to help properly direct water flow down the yard. Semi-buried retaining logs are placed in key locations where sediment runoff has been observed, particularly around sandier areas to prevent sand transfer into Pool 1. Where the slope of the yard meets the edge of Pool 1, a swale has been created with an underdrain below, capturing any runoff and directing it to a nearby existing drain.

Yard 1: Yard improvements include the grading and retaining strategies previously mentioned and improvements to the exhibit pool edge. Pool edge improvement includes the removal of the curb edge and replacement with a gently sloping cast in place concrete pool edge to improve elephant pool access and to reduce sand migration into the pool. The proposed pool edge will increase concrete coverage in the exhibit space and will aesthetically blend the pool edge with the sandy substrate.

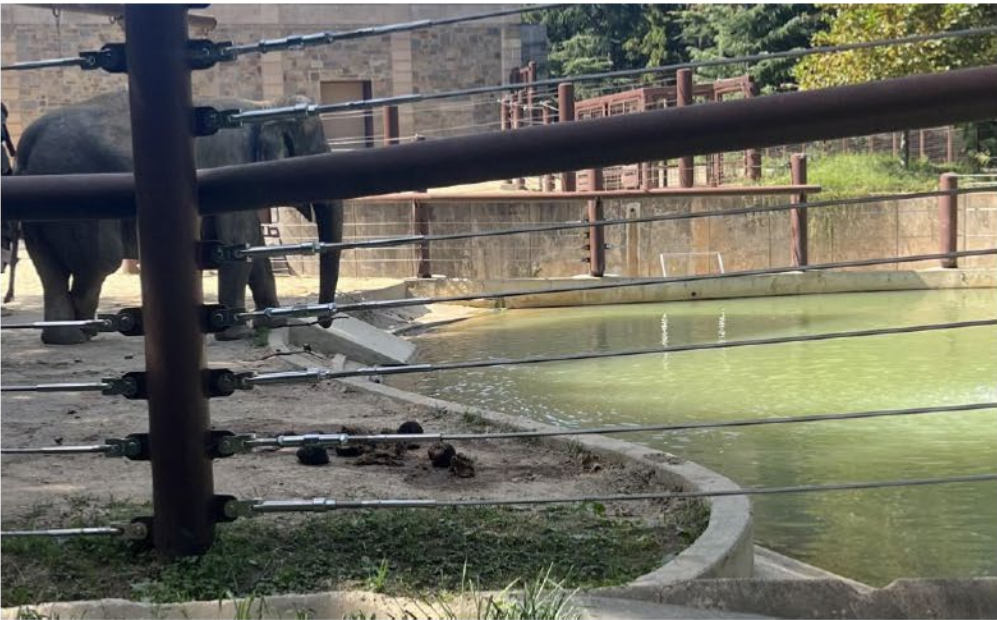
Photo of existing Pool 1 edge.

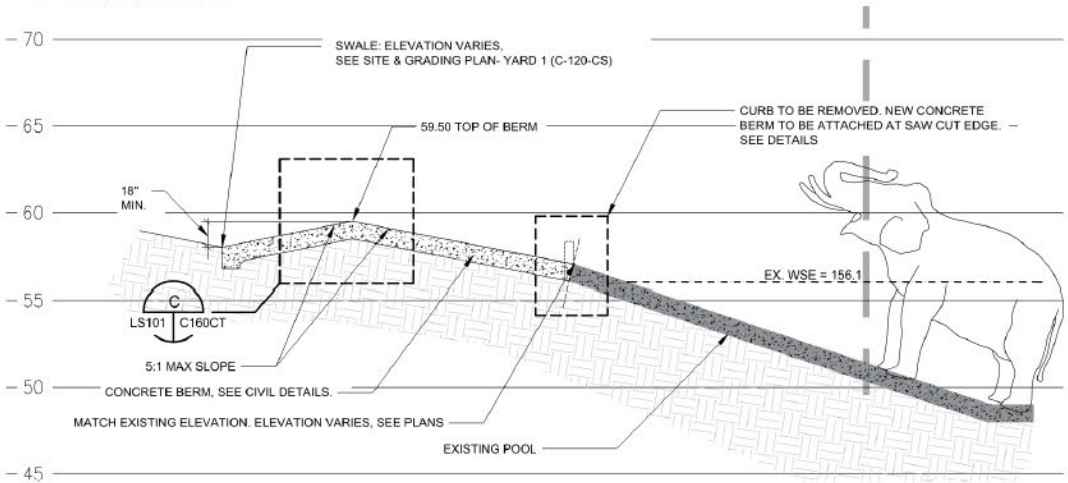
Yard 1: The Pool 1 perimeter will be partially demolished, removing a concrete curb and a steep skid-steer ramp. The perimeter is then reconstructed as a rolled-edge apron, terminating at the bottom of the new swale. This modification makes the pool more accessible for both animals and staff by creating a more gradual slope into the water, and helps the proposed swale divert stormwater runoff away from the pool.

Pool 1 proposed section.

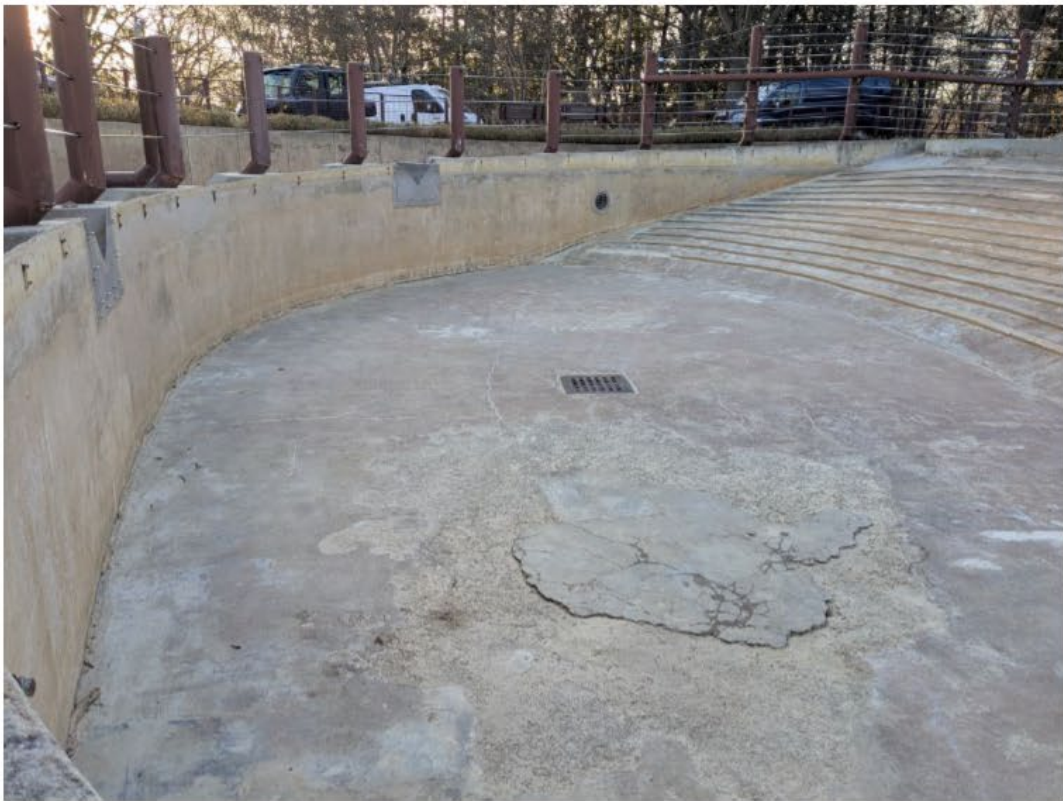
Photo of existing Pool 1 exhibiting concrete spalling.

- Correction of Pool 1 leaks by demolition and replacement of failed concrete, drain line, and waterproofing materials.

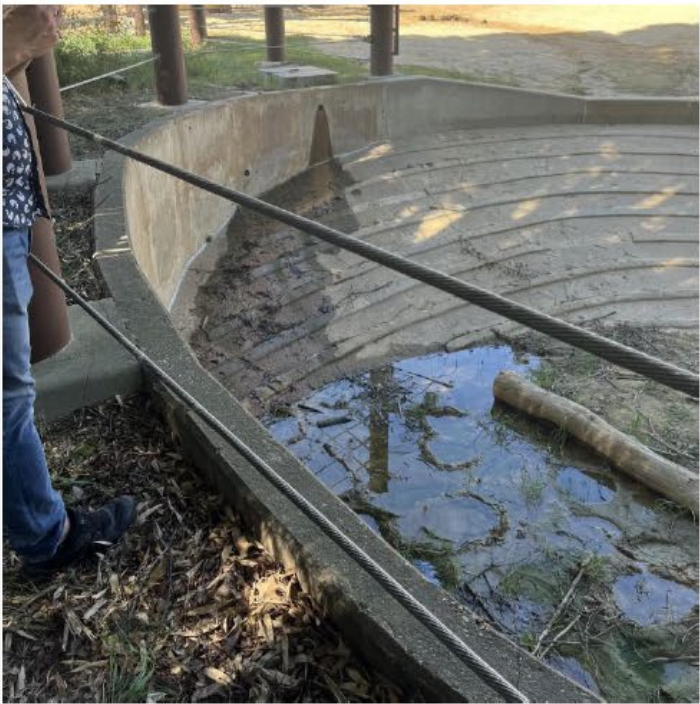
Photo of existing Pool 2.

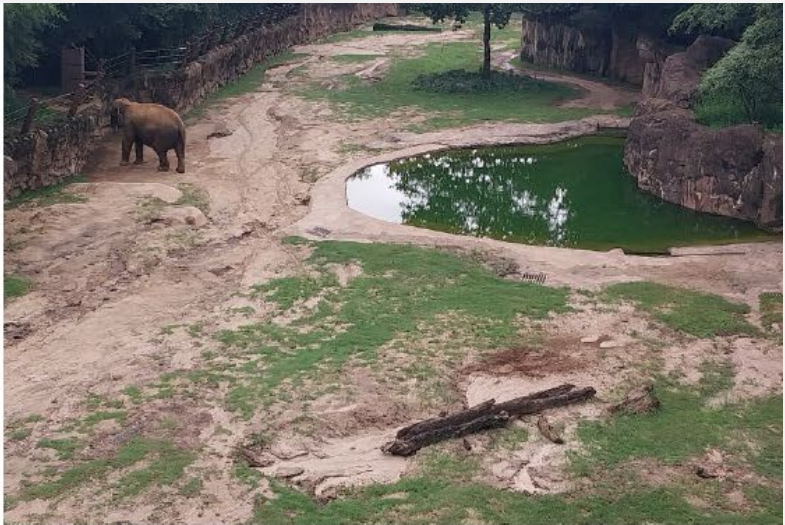
Photo of Yard 4 displaying erosion after a rain event.
