National Zoo & Conservation Biology Institute

# **Repair Stormwater Mitigation at Elephant Yards**

SF Project #2233104

## **NCPC Preliminary and Final Review Submission**

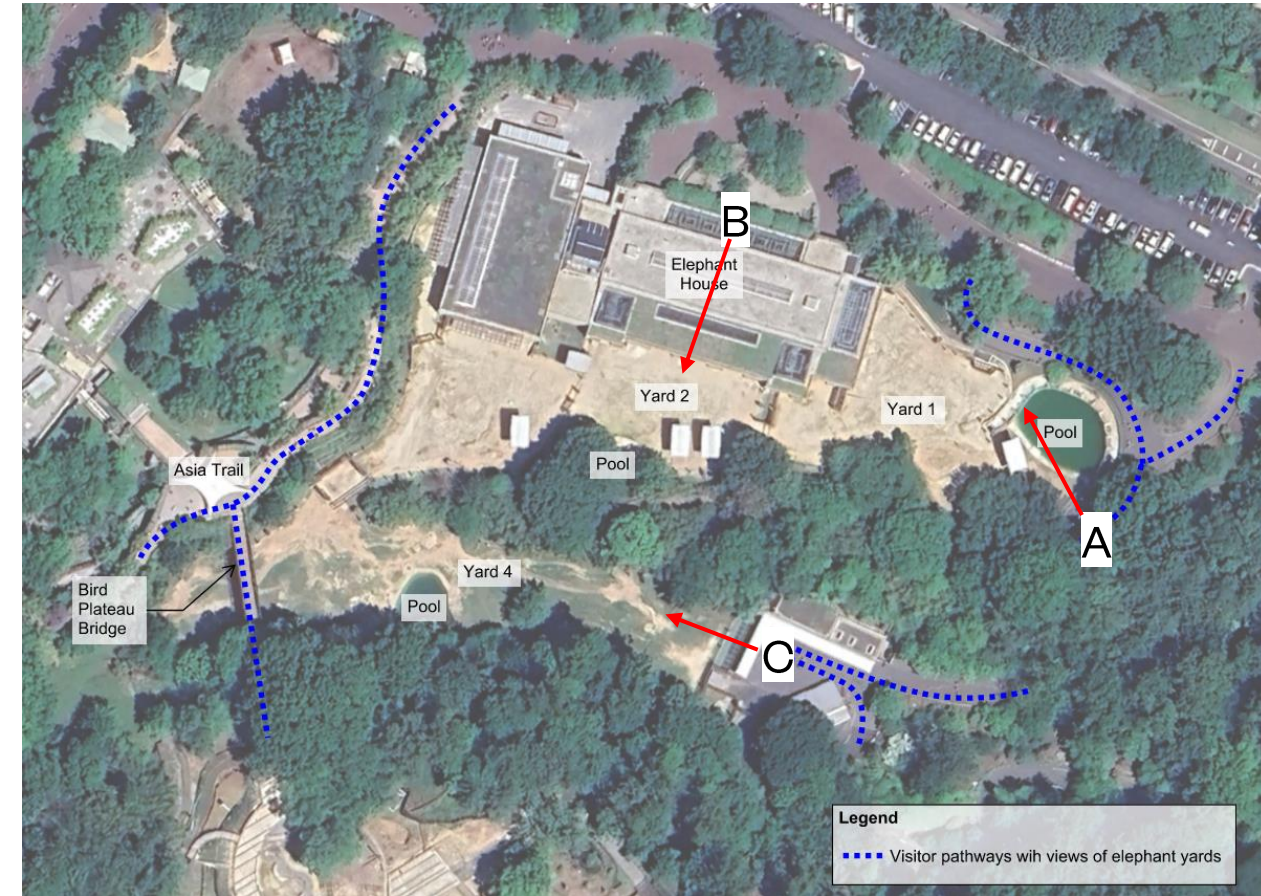
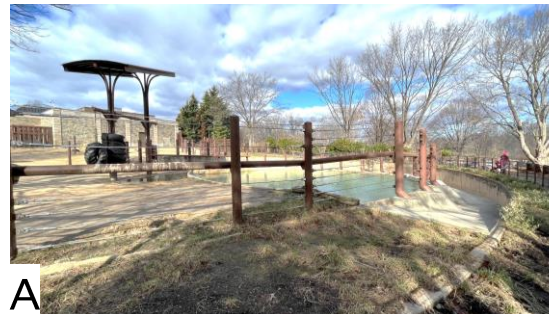
**A**  
Photo of Yard 1 visitor viewing location and exhibit pool and barrier system.

Yard 1: Yard 1 is steeply sloped at around 10% grade and is fully enclosed by a bollard and wire barrier system. A concrete exhibit pool with a curbed edge is located at the bottom of the sloped exhibit space. Rain events result in migration of the sandy substrate downslope and into the pool. Multiple shade trees line the southern edge of the exhibit space. Visitor viewing areas wrap around the exhibit space on the north and east edges of the exhibit space.

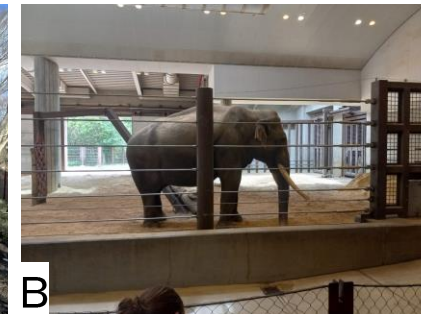
**B**  
Photo of visitor viewing location of Yard 2 from Elephant House interior.

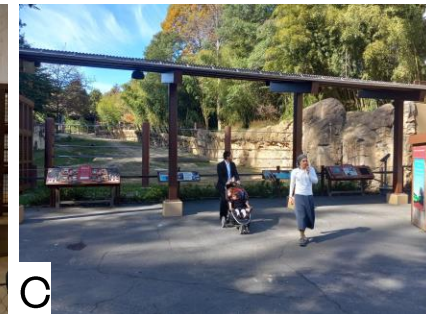
**C**  
Photo of visitor viewing location on the east side of Yard 4.

Yard 4: Yard 4 is steeply sloped at around 10% to 15% grade. Barrier systems include a bollard and wire system, and a shotcrete system. Rain events cause sand migration and creates erosion gullies, primarily along the northern edge of the exhibit space. Yard 4 is viewed by visitors from the eastern edge from an asphalt and view rail system. The exhibit is also viewed from the Bird Plateau Bridge spanning over the habitat near the west side of the habitat, and distantly from a viewing area on Asia Trail, an adjacent visitor pathway that is out of the project area.

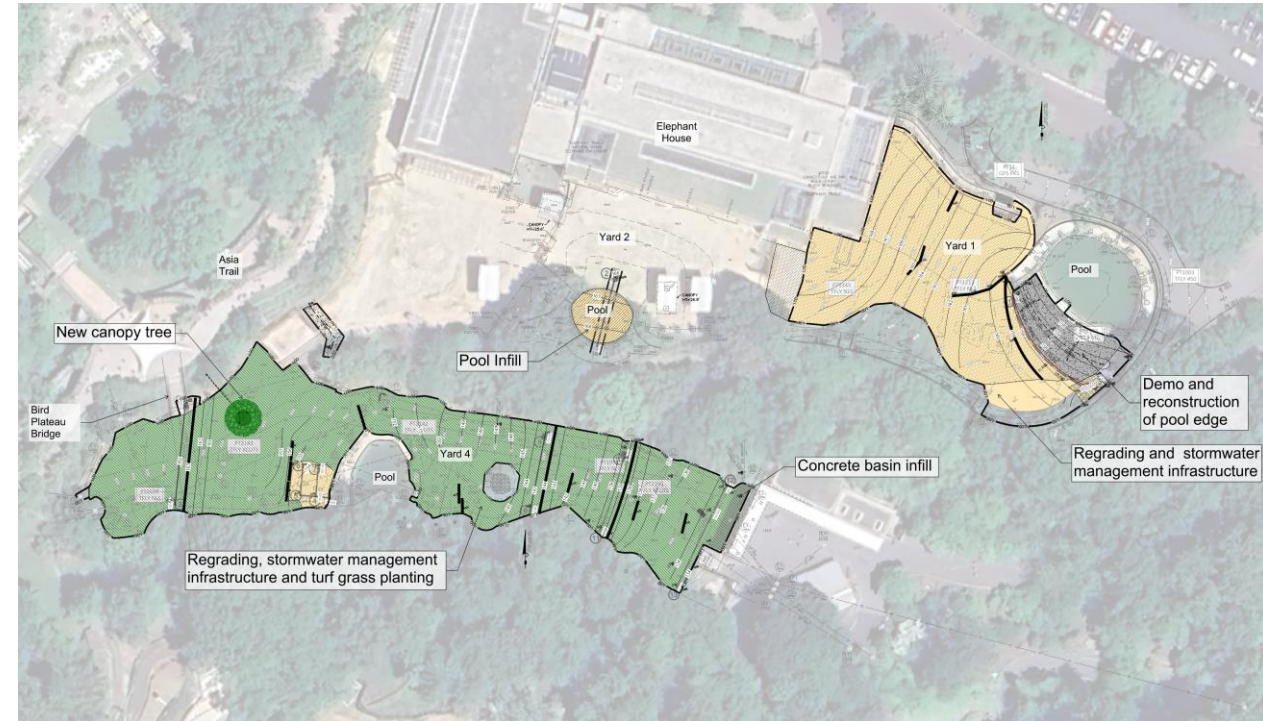
Site Plan

- Re-grading of Yard 1 and Yard 4, to reduce observed runoff and erosion issues and direct water more efficiently into improved stormwater management infrastructure.
- Planting of new turf grasses and a new canopy tree within Yard 4.
- Demolition and reconstruction of the Pool 1 perimeter within Yard 1, to reduce stormwater runoff into the pool and to make the pool more accessible for both animals and staff.
- Infill of Pool 2 in Yard 2 to create a clay bath for the elephants, including associated drainage and stormwater improvements to prevent ponding of water.
- Infill of an existing and unused concrete basin at the bottom of Yard 4, including associated drainage modifications and landscaping to improve maintenance access and visitor viewing experience.

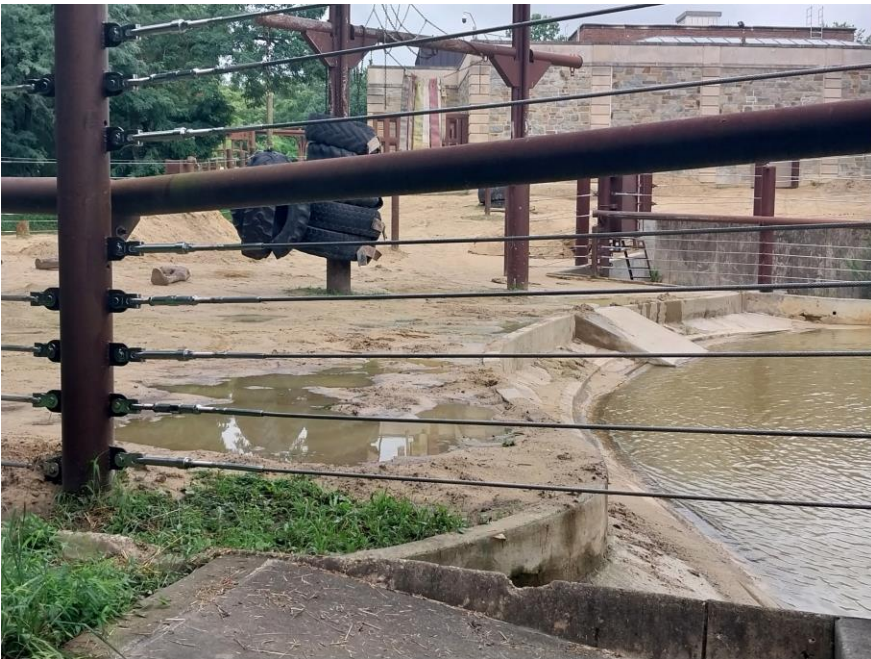
Photo of Yard 1 displaying ponding and runoff after a rain event.

Yard 1: Topographic setlines in Yard 1 are drawn to start and end in the same locations as the existing grade but in between are smoothed and adjusted to help properly direct water flow down the yard. Semi-buried retaining logs are placed in key locations where sediment runoff has been observed, particularly around sandier areas to prevent sand transfer into Pool 1. Where the slope of the yard meets the edge of Pool 1, a swale has been created with an underdrain below, capturing any runoff and directing it to a nearby existing drain.

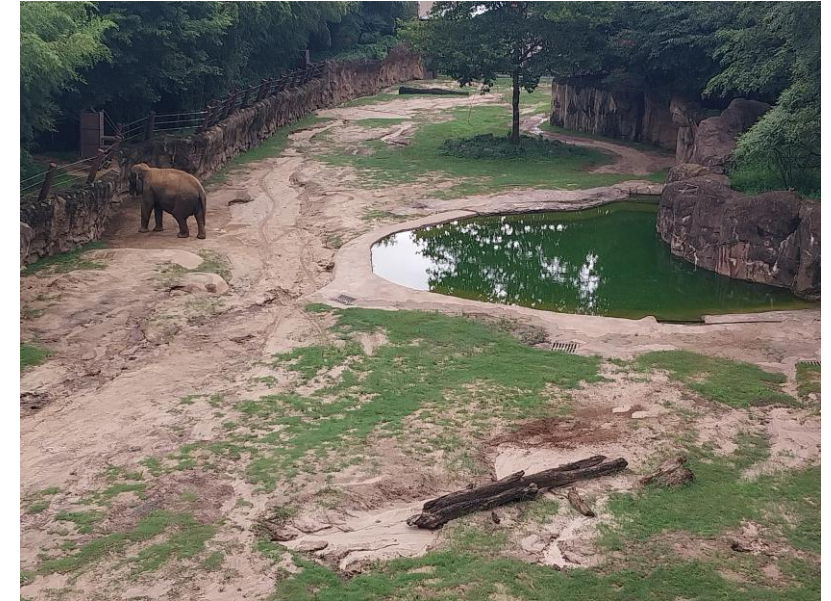
Photo of Yard 4 displaying erosion after a rain event.

Yard 4: Re-grading in Yard 4 is limited to areas where animal movement and erosion has created channels in the substrate, and where new swales and berms are created to direct water flow. These new swales, paired with underdrains and elevation-setting logs, occur at intervals along the downward slope of the yard, capturing overland flow of water and directing it toward nearby existing drainage structures. Additional above-grade retaining logs and underdrains are distributed throughout the yard, helping hold back areas prone to erosion, reduce ponding of water, and re-direct elephants from over-trodden paths.

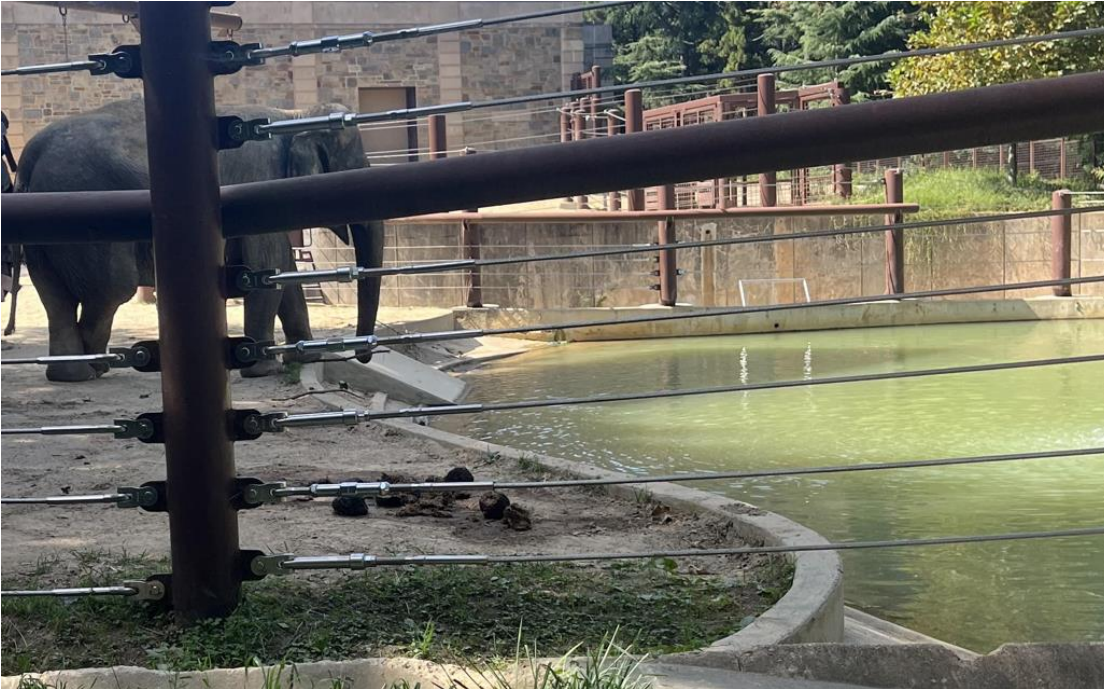
Photo of existing Pool 1 edge.

Yard 1: The Pool 1 perimeter will be partially demolished, removing a concrete curb and a steep skid-steer ramp. The perimeter is then reconstructed as a rolled-edge apron, terminating at the bottom of the new swale. This modification makes the pool more accessible for both animals and staff by creating a more gradual slope into the water, and helps the proposed swale divert stormwater runoff away from the pool.

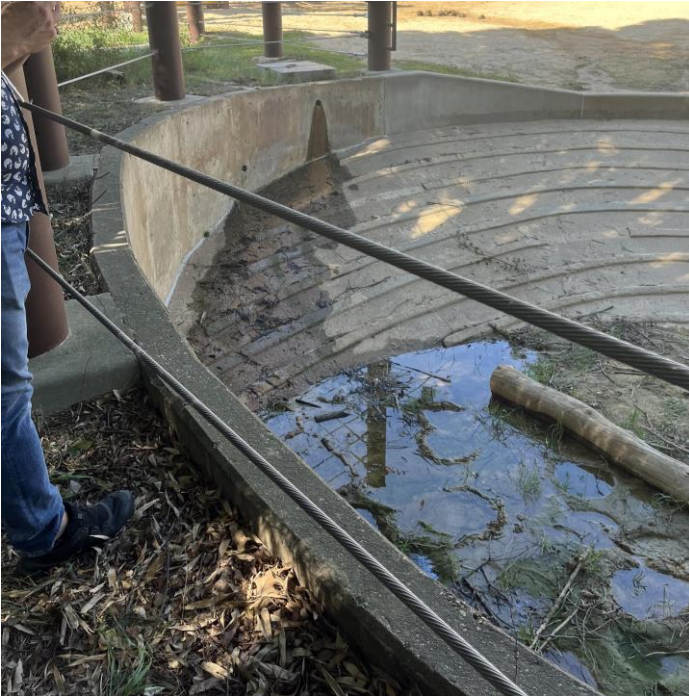
Photo of existing Pool 2.

Yard 2: Pool 2 will be decommissioned and filled with gravel, filter fabric, and substrate to allow more walkable space for the elephants. A new grate inlet and drainage line connecting into a nearby existing storm structure prevents future ponding of water around the infilled pool.

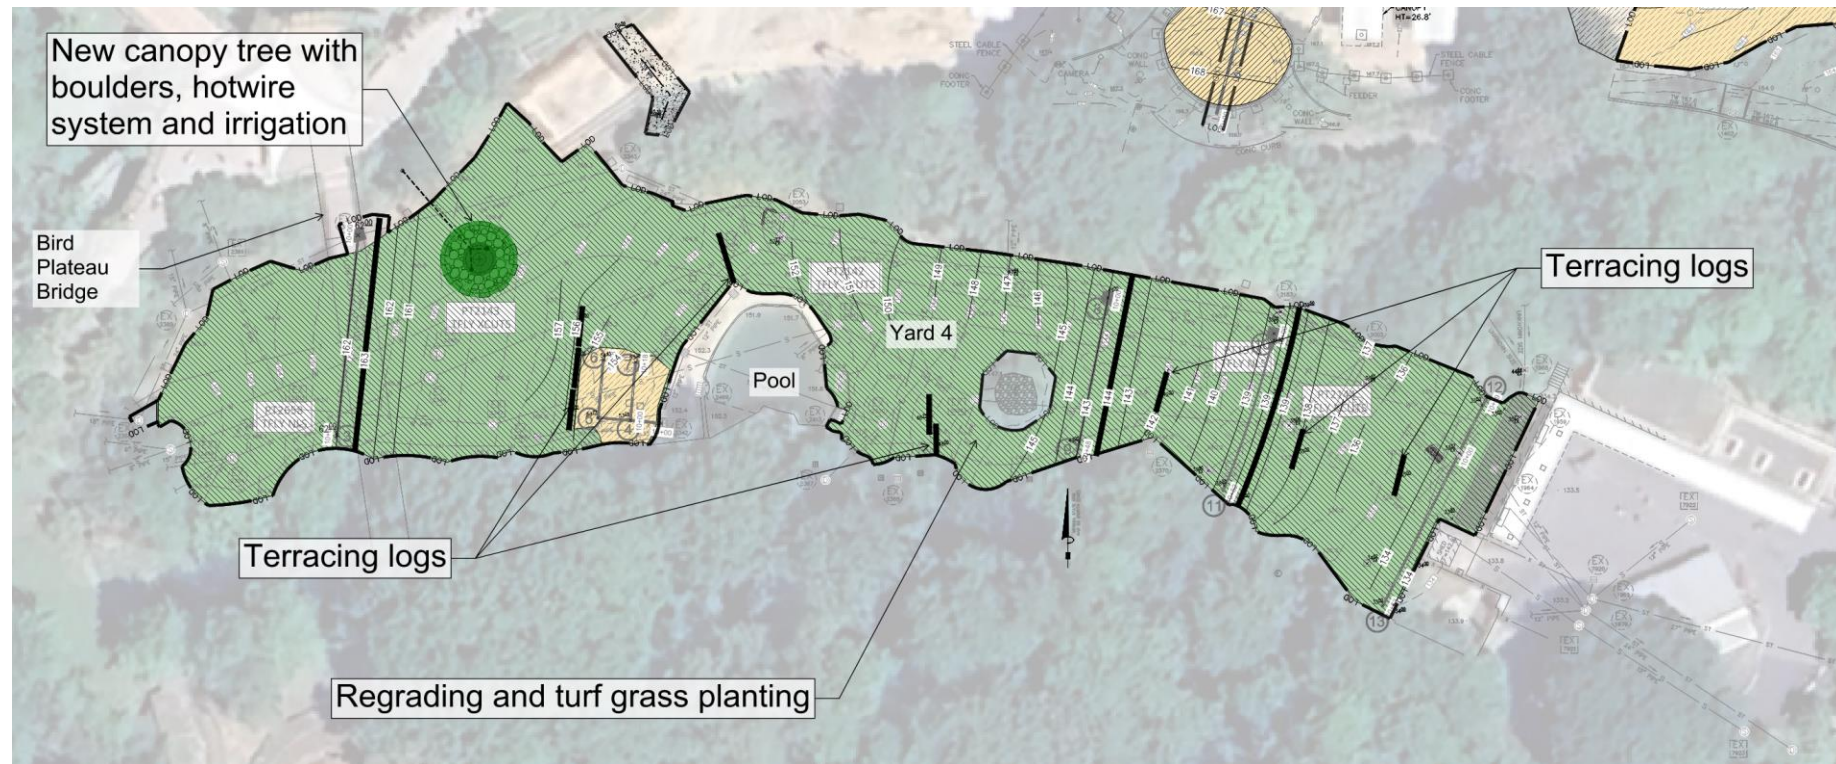
Yard 4 Landscape Plan

Yard 4: Worn-down areas of Yard 4 will be re-seeded with a turf grass seed mix. A new canopy tree will be planted within Yard 4, creating a new shade element for the elephants. At the lower end of the yard, outside of the containment fence, an existing unused concrete basin is infilled with permeable fill and substrate materials, bringing the surface to grade and allowing stormwater to drain through to an existing storm structure below.

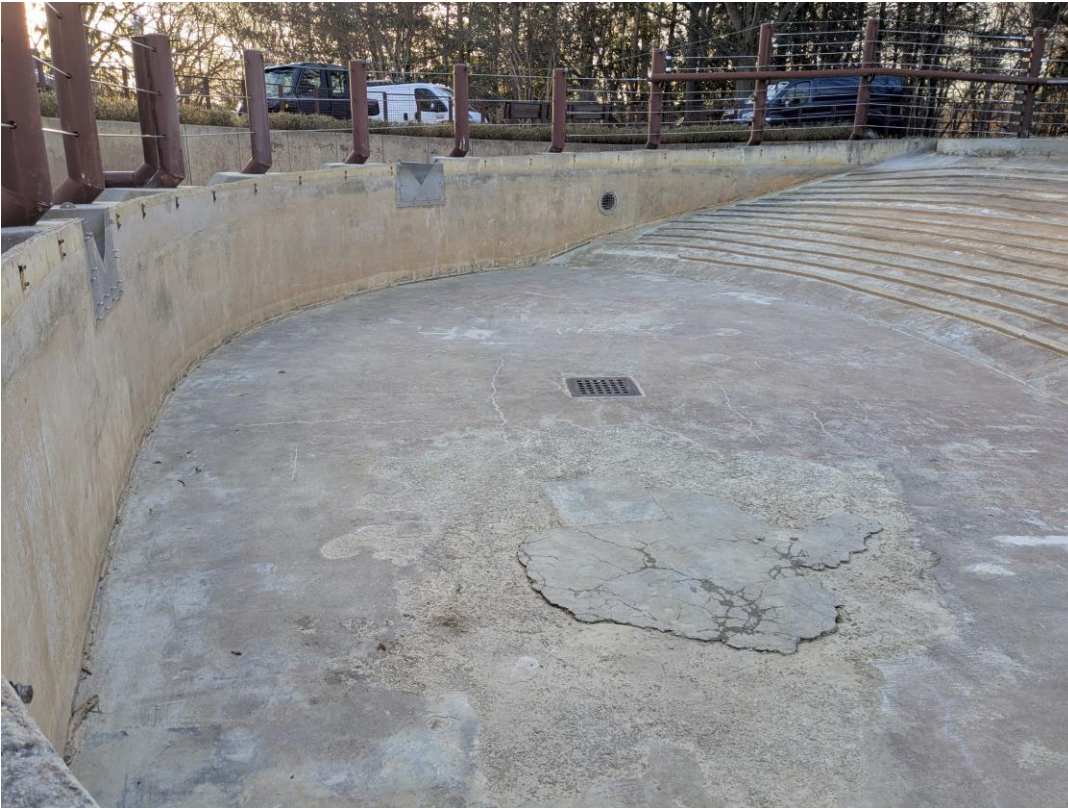
Photo of existing Pool 1 exhibiting concrete spalling.

Pool 1 in Yard 1 will be partially demolished, including the removal of the concrete ramp and floor, sump pit, drain line, and waterproofing materials. A new drain line is run to the nearby vault, and the ramp, sump pit and floor will be re-poured with appropriate detailing and waterproofing to prevent future water loss.

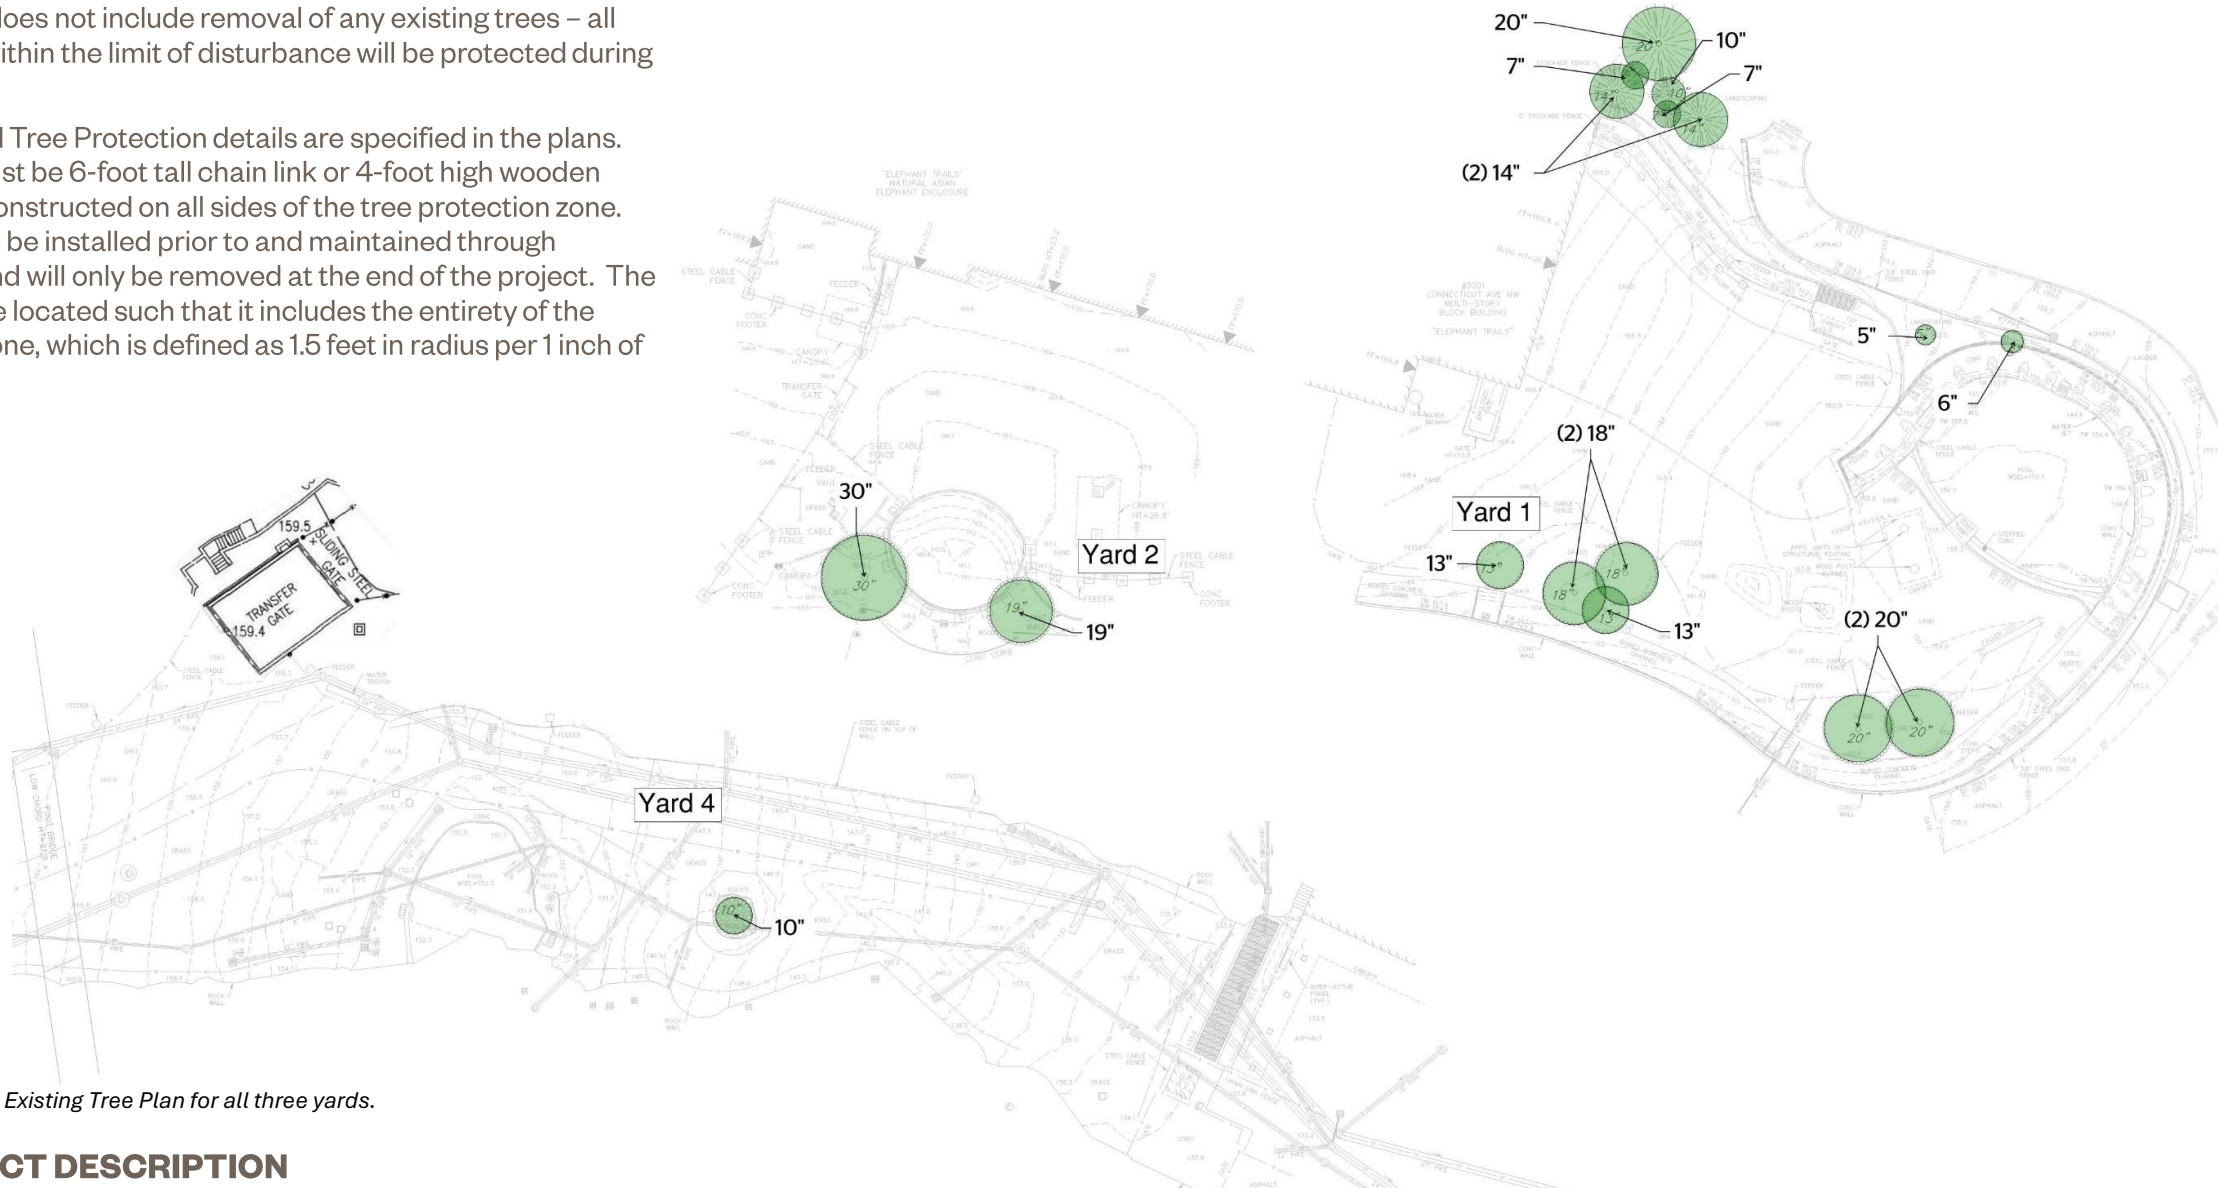
Project scope does not include removal of any existing trees – all existing trees within the limit of disturbance will be protected during construction.

DOEE standard Tree Protection details are specified in the plans. The fencing must be 6-foot tall chain link or 4-foot high wooden snow fencing constructed on all sides of the tree protection zone. The fencing will be installed prior to and maintained through construction and will only be removed at the end of the project. The fencing must be located such that it includes the entirety of the Critical Root Zone, which is defined as 1.5 feet in radius per 1 inch of tree diameter.

Existing Tree Plan for all three yards.

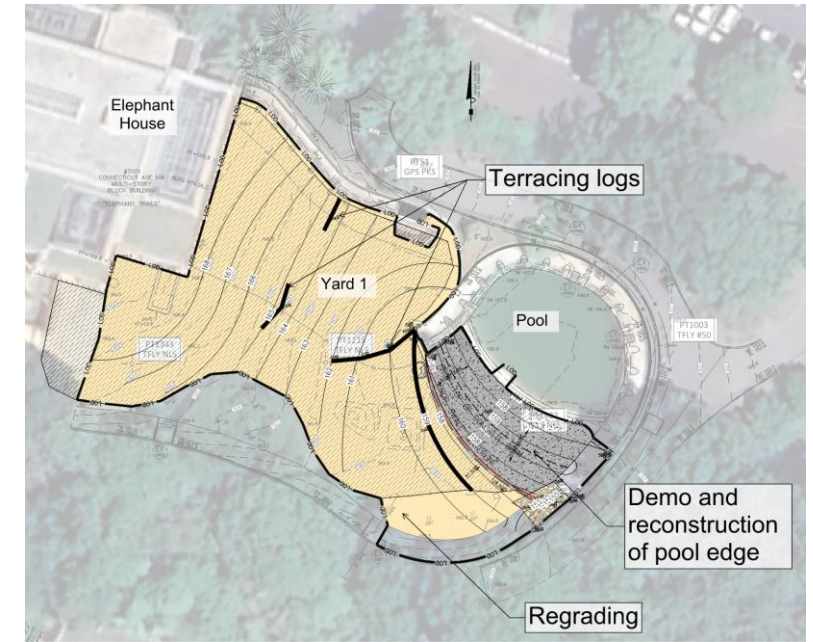
Yard 1 Landscape Plan

**Yard 1:** Yard improvements include the grading and retaining strategies previously mentioned and improvements to the exhibit pool edge. Pool edge improvement includes the removal of the curb edge and replacement with a gently sloping cast in place concrete pool edge to improve elephant pool access and to reduce sand migration into the pool. The proposed pool edge will increase concrete coverage in the exhibit space and will aesthetically blend the pool edge with the sandy substrate.

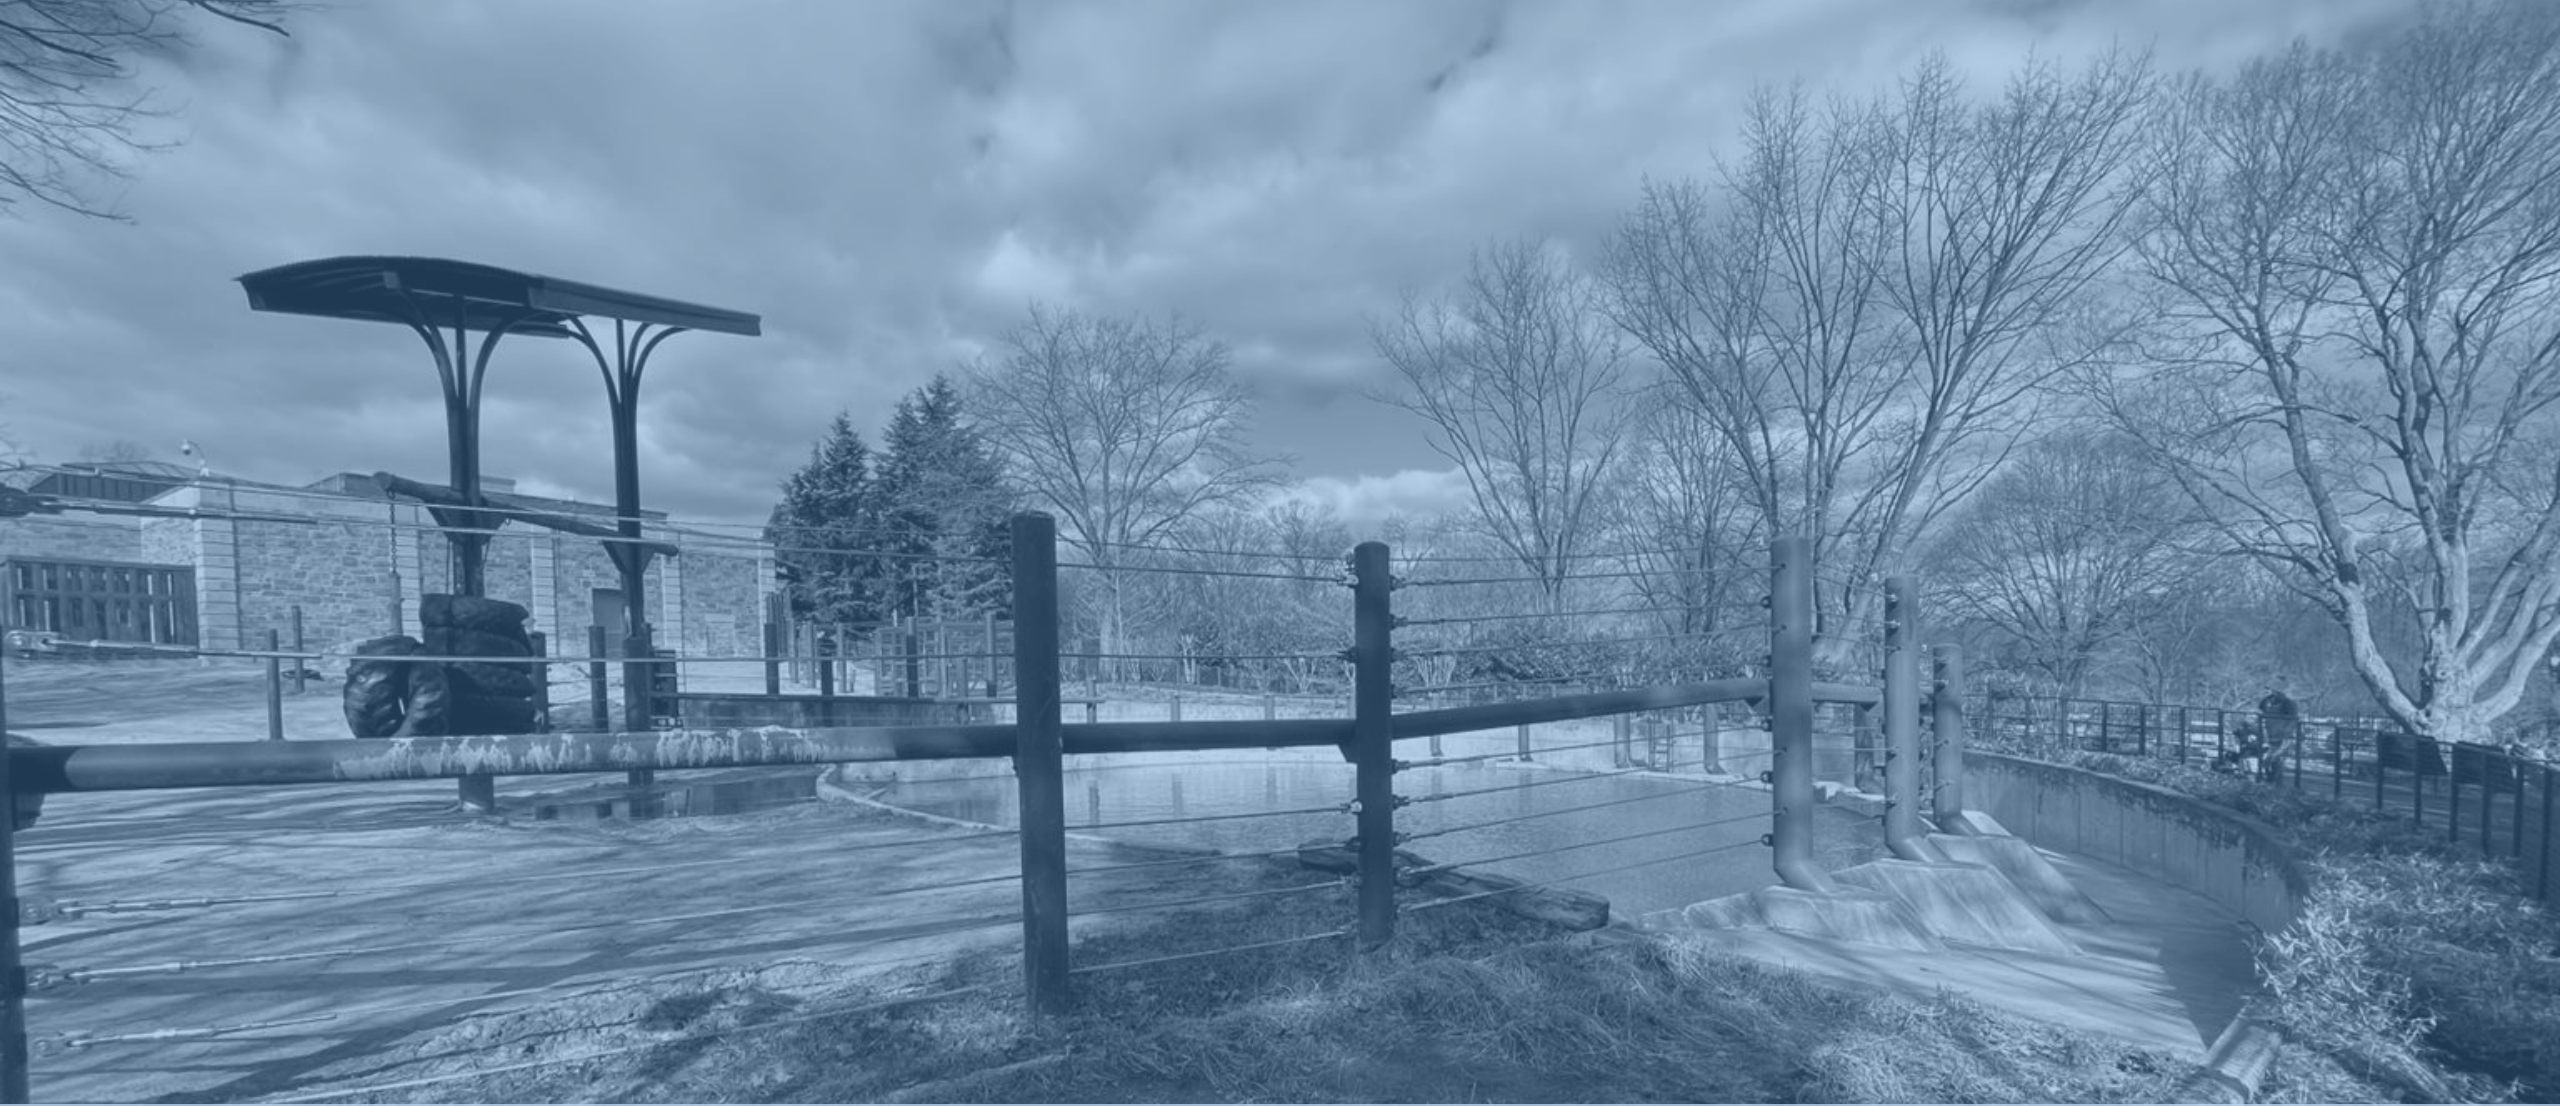
*Photo of Yard 1 and Pool 1, looking towards the Elephant House from the visitor viewing area.*
