NATIONAL GALLERY OF ART SEVENTH STREET ENTRANCE IMPROVEMENTS

NATIONAL CAPITAL PLANNING COMMISSION CONCEPT REVIEW

JUNE 05, 2026

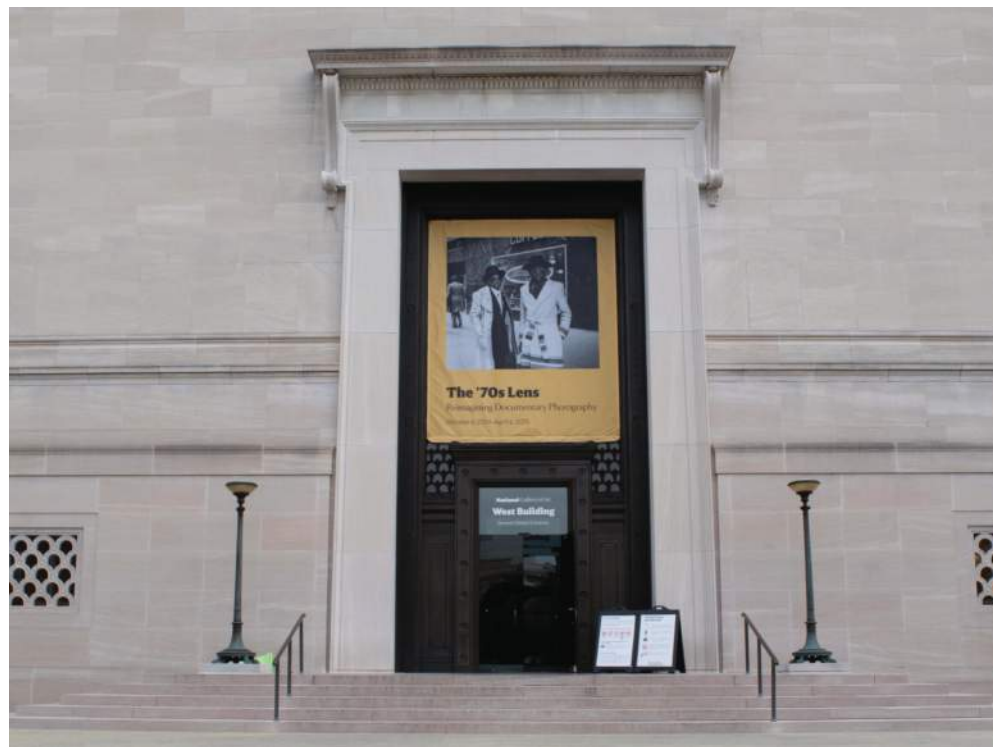
Figure 1-8. View of bronze entry doors and light standards.

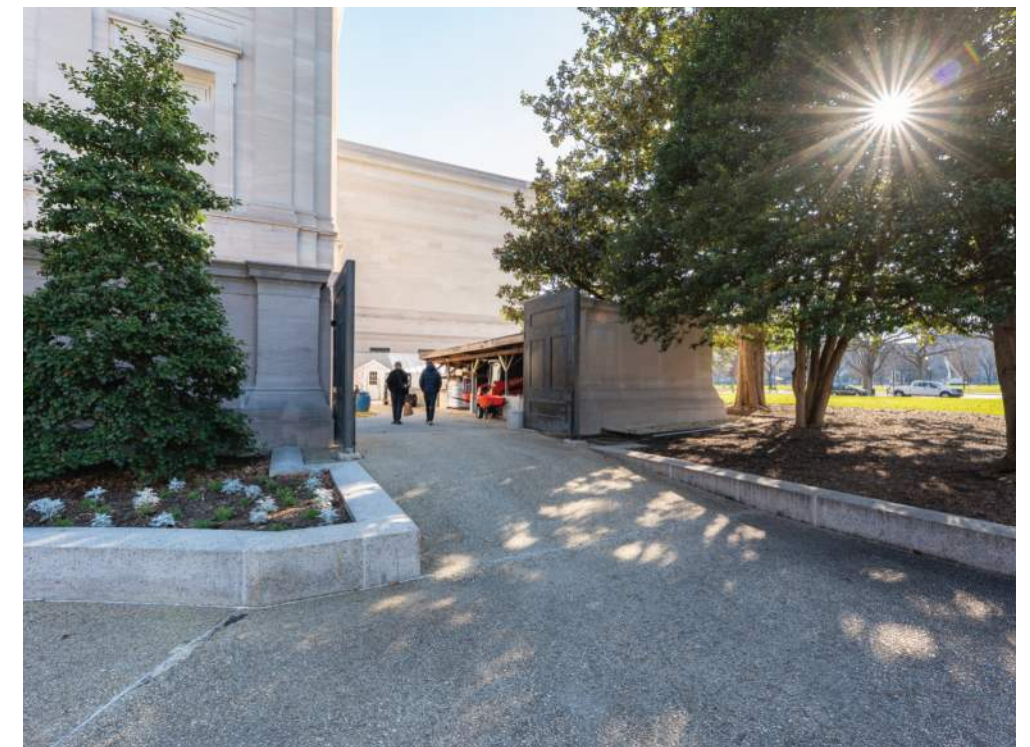
Figure 1-10. View of SW moat entrance.

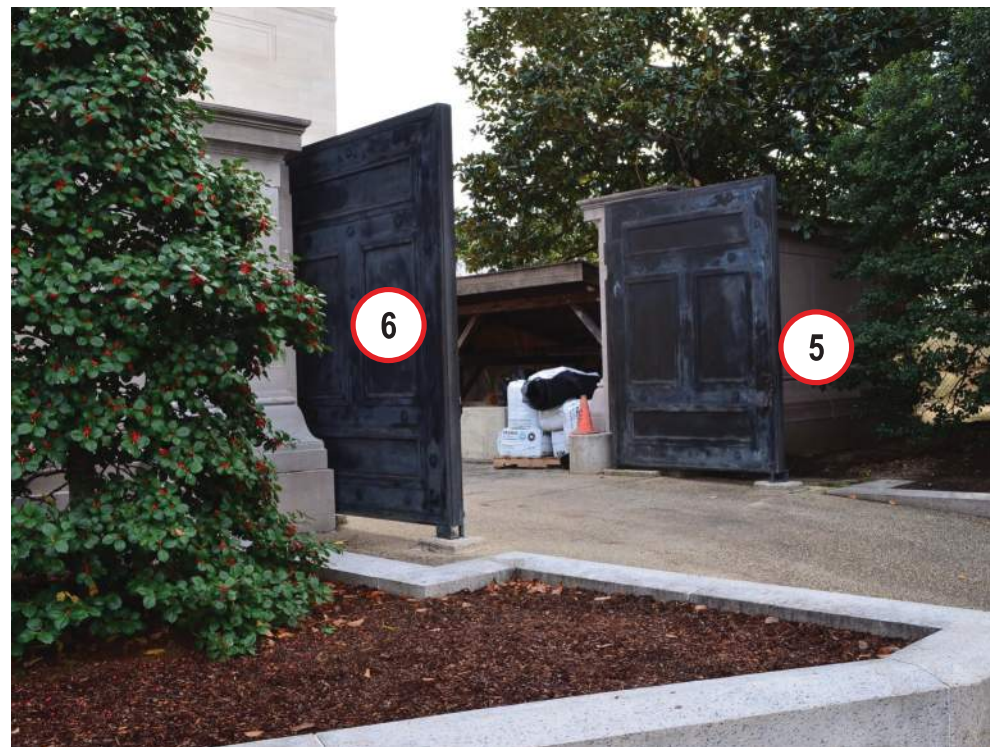
Figure 1-14. View of moat walls and open moat gates.

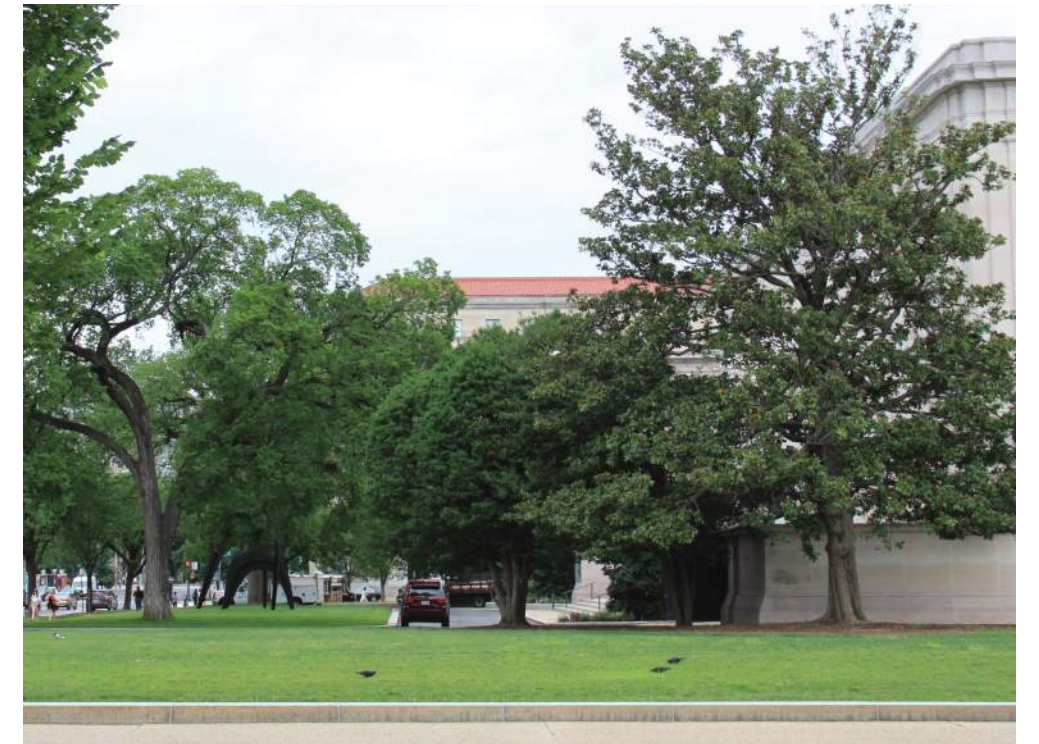
Figure 1-22. View of the southwest side of the Seventh Street Entrance showing a southern magnolia and American elm.

Against the site walls are curvilinear, mulched beds that reach to the service drives. Each contains a single southern magnolia (*Magnolia grandiflora*) and two American holly in the same arrangement. Deep in the corner of the north lawn panel a single Chinese elm (*Ulmus parvifolia*) is planted to the east of the Southern magnolia against the site wall. Along the exterior edge of the north lawn panel an American elm and two Japanese zelkova (*Zelkova serrata*) are present near the granite curb.

Today, the American elms in the central lawn and the southern magnolias and American hollies flanking either side of the U-shaped driveway remain. These still preserve the original evergreen structure of the planting as intended by landscape architect Alfred Geiffert, Jr., who designed the planting plan for the West Building in 1937-1941. The shrub and groundcover layers only partially exist and the species, arrangement, and quantities are substantially different. The lawn continues to exist as it did in 1940, but the species and locations of specimen trees in these areas are different and lack symmetry. There are no flowering understory trees, and the plant bed edges lack spatial definition. While some of the existing trees remain in their original locations, the overall planting does not convey the layered evergreen scheme that Geiffert designed.

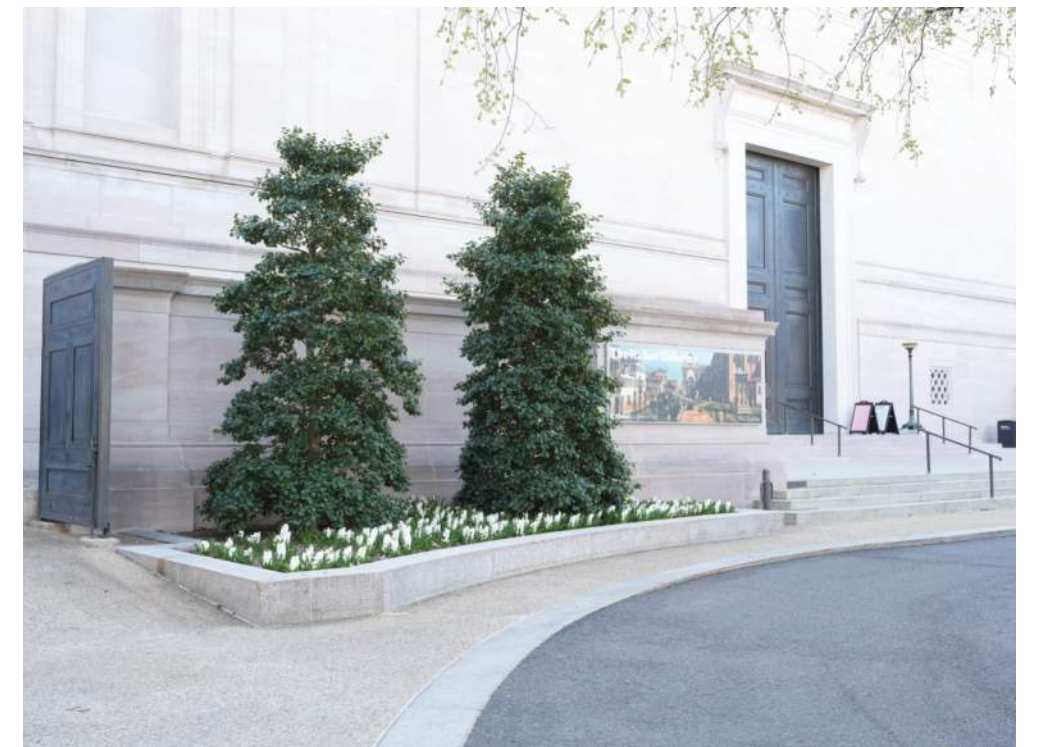
Figure 1-23. View of the plant bed on the north side of the steps at the Seventh Street Entrance.

The Seventh Street Entrance landing is framed by two plant beds that flank the base of the terrace steps and are bordered by granite curbing. Each is planted with a pair of American holly (*Ilex opaca*) against the site walls and annuals in front.

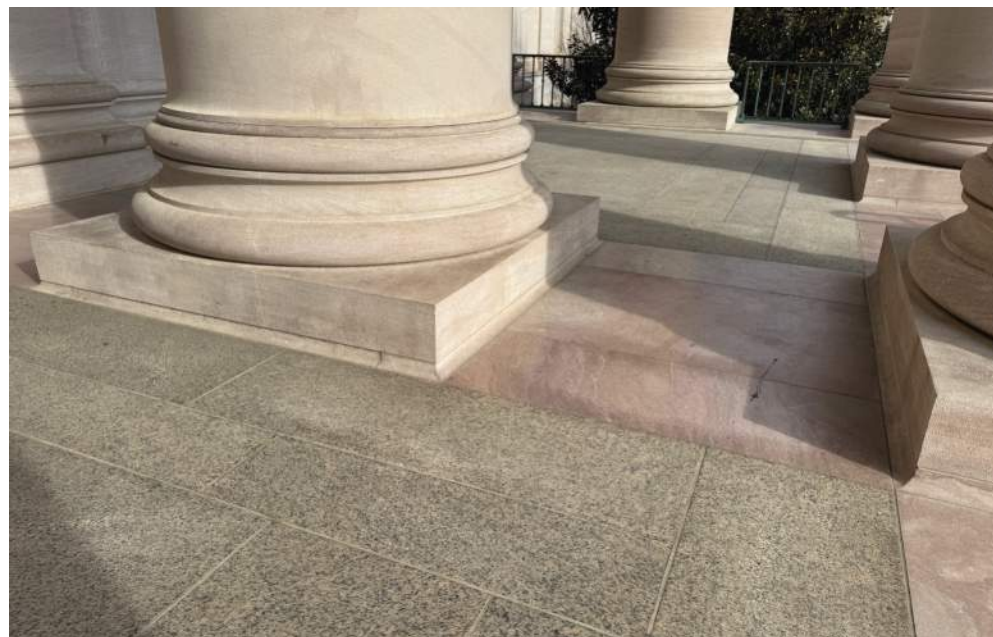
Figure 1-34. Mix of stone finishes at the Mall Entrance.

Pope deliberately designed the Mall Entrance as the formal entry to the building, reflecting the McMillan Plan's direction for "great institutions" facing the National Mall. The scale and formality of the neoclassical grand staircase mirrors other museums and monumental structures on the National Mall. The secondary walkways leading from the staircase guide visitors to the more intimate, fountain courtyards that underscore the harmony of the landscape design, the building, and its surroundings. The symmetrically arranged circulation elements harmonize with the building. The monumental stair, site walls, and plinths use a combination of Tennessee Pink marble and Milford granite as a balanced material palette.

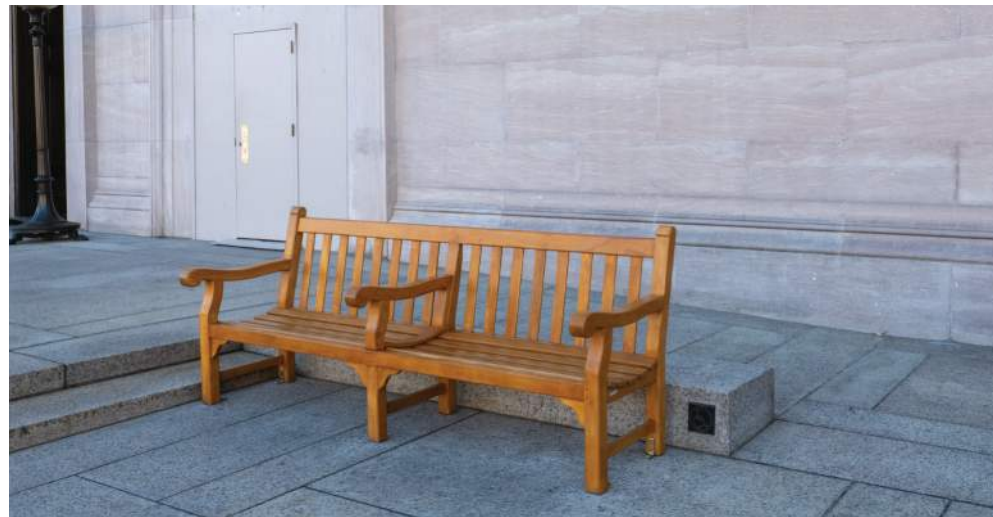
Figure 1-38. View of the Sixth Street Entrance steps and west ramp, facing southwest.

The circulation adjacent to the Sixth Street Entrance changed with the construction of the East Building and Connecting Link. A new ramp was constructed between 1974 and 1976 to provide access to the new below-grade garage and truck dock in the Connecting Link. The project required the removal and replacement of a portion of the granite curb and paving on the north entrance and slightly modified the east side of the U-shaped driveway. Pedestrian ramps were added in 1993, connecting the first and second landings for accessibility. Today, the entrance terrace retains integrity of design intent. Changes made to the circulation after 1941, particularly modifications related to the U-shaped drive and service ramp, altered the symmetry of the circulation elements designed by Pope and impacted the physical character. The entrance steps, ramps, plinth, and curbs are all crafted from Milford granite.

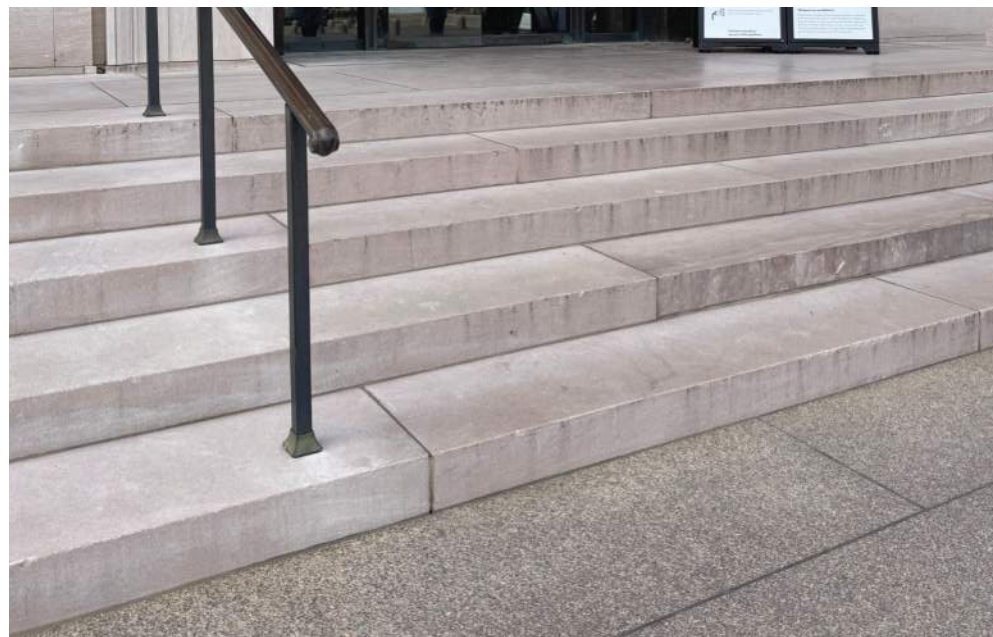
Figure 1-41. Mix of stone finishes at Fourth Street Entrance steps.

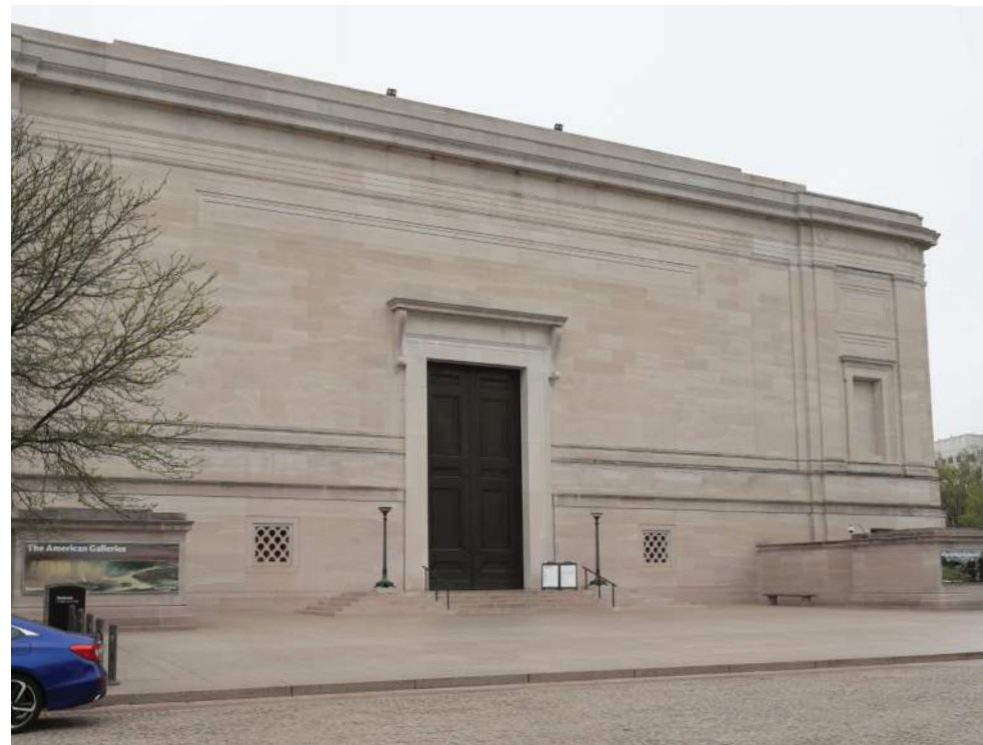
Figure 1-42. Marble landing and stairs and granite landing at the Fourth Street Entrance of the West Building.

Architect I. M. Pei collaborated with landscape architect Dan Kiley of Kiley Tyndall Walker to design the Fourth Street Plaza, which was completed in conjunction with the opening of the Connecting Link in 1976. The plaza is a T-shaped open space composed of three main elements. The stem of the “T” is a rectangular paved area oriented east–west, while the top of the “T” consists of two roughly square, formally planted green spaces located to the north and south of the plaza. The paved section physically links the Fourth Street Entrance of the neoclassical West Building with the main entrance of the modern East Building. The Fourth Street Plaza cobblestones are Autumn Rose granite, with Rockville granite used as the plaza border and landing pavers. The Fourth Street Entrance landing and stairs are Tennessee Pink marble.

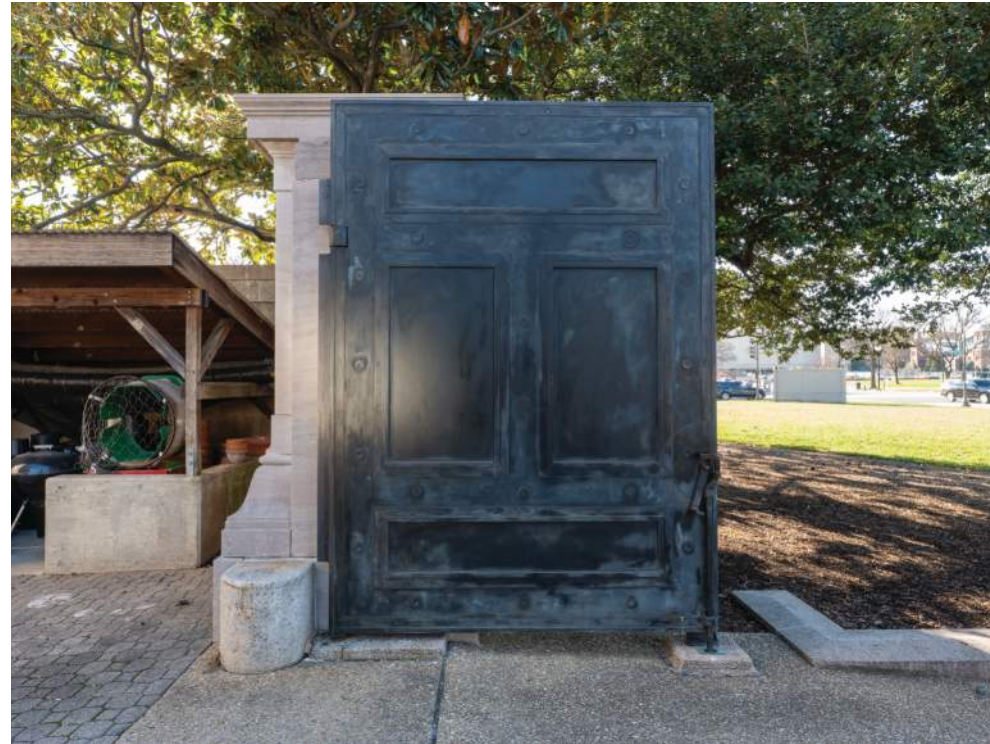
Figure 1-46. View of bronze moat gate.

The NGA West Building is located within the flood-prone area of Federal Triangle. Although flood mitigation is not a primary goal of this project, the proposed improvements will provide a modest increase in the site’s flood resiliency. The ground elevations at the gates to both the north and south Moats will be raised by approximately 0.5 feet just in front of the gates, providing a minor increase in flood protection for the Moats. In addition, the existing storm drainage system within the project limits will be completely overhauled and replaced with a new system designed to safely convey runoff from a 15-year storm event away from the site. During a major flood event, if the existing public combined sewer system is overwhelmed beyond its capacity, the proposed onsite storm drainage system will have limited ability to prevent flooding. However, once capacity is restored in the public combined sewer system, the new storm drainage system will facilitate the draining of standing stormwater within the site.

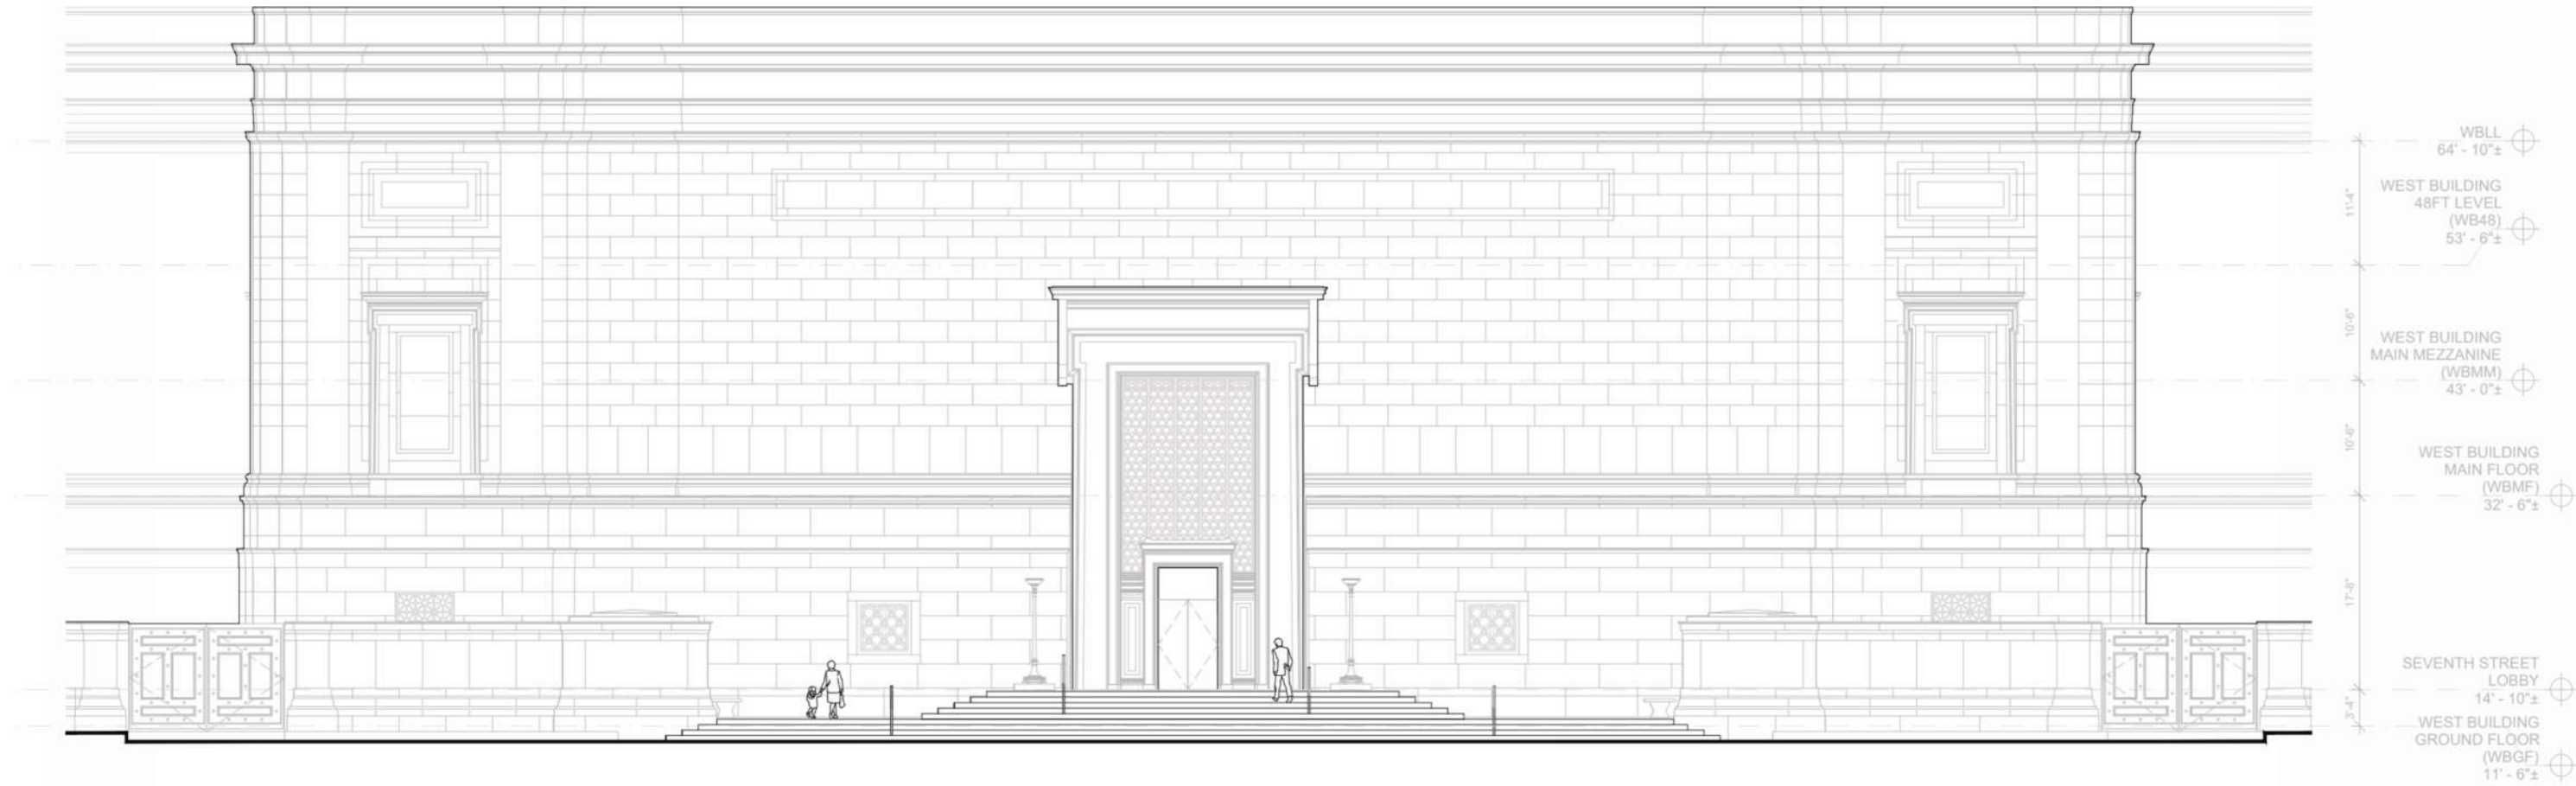
DESIGN STUDY A

Option 1 includes an enlarged plinth with central stair and curved inclined walkways and introduces large planters at the plinth.

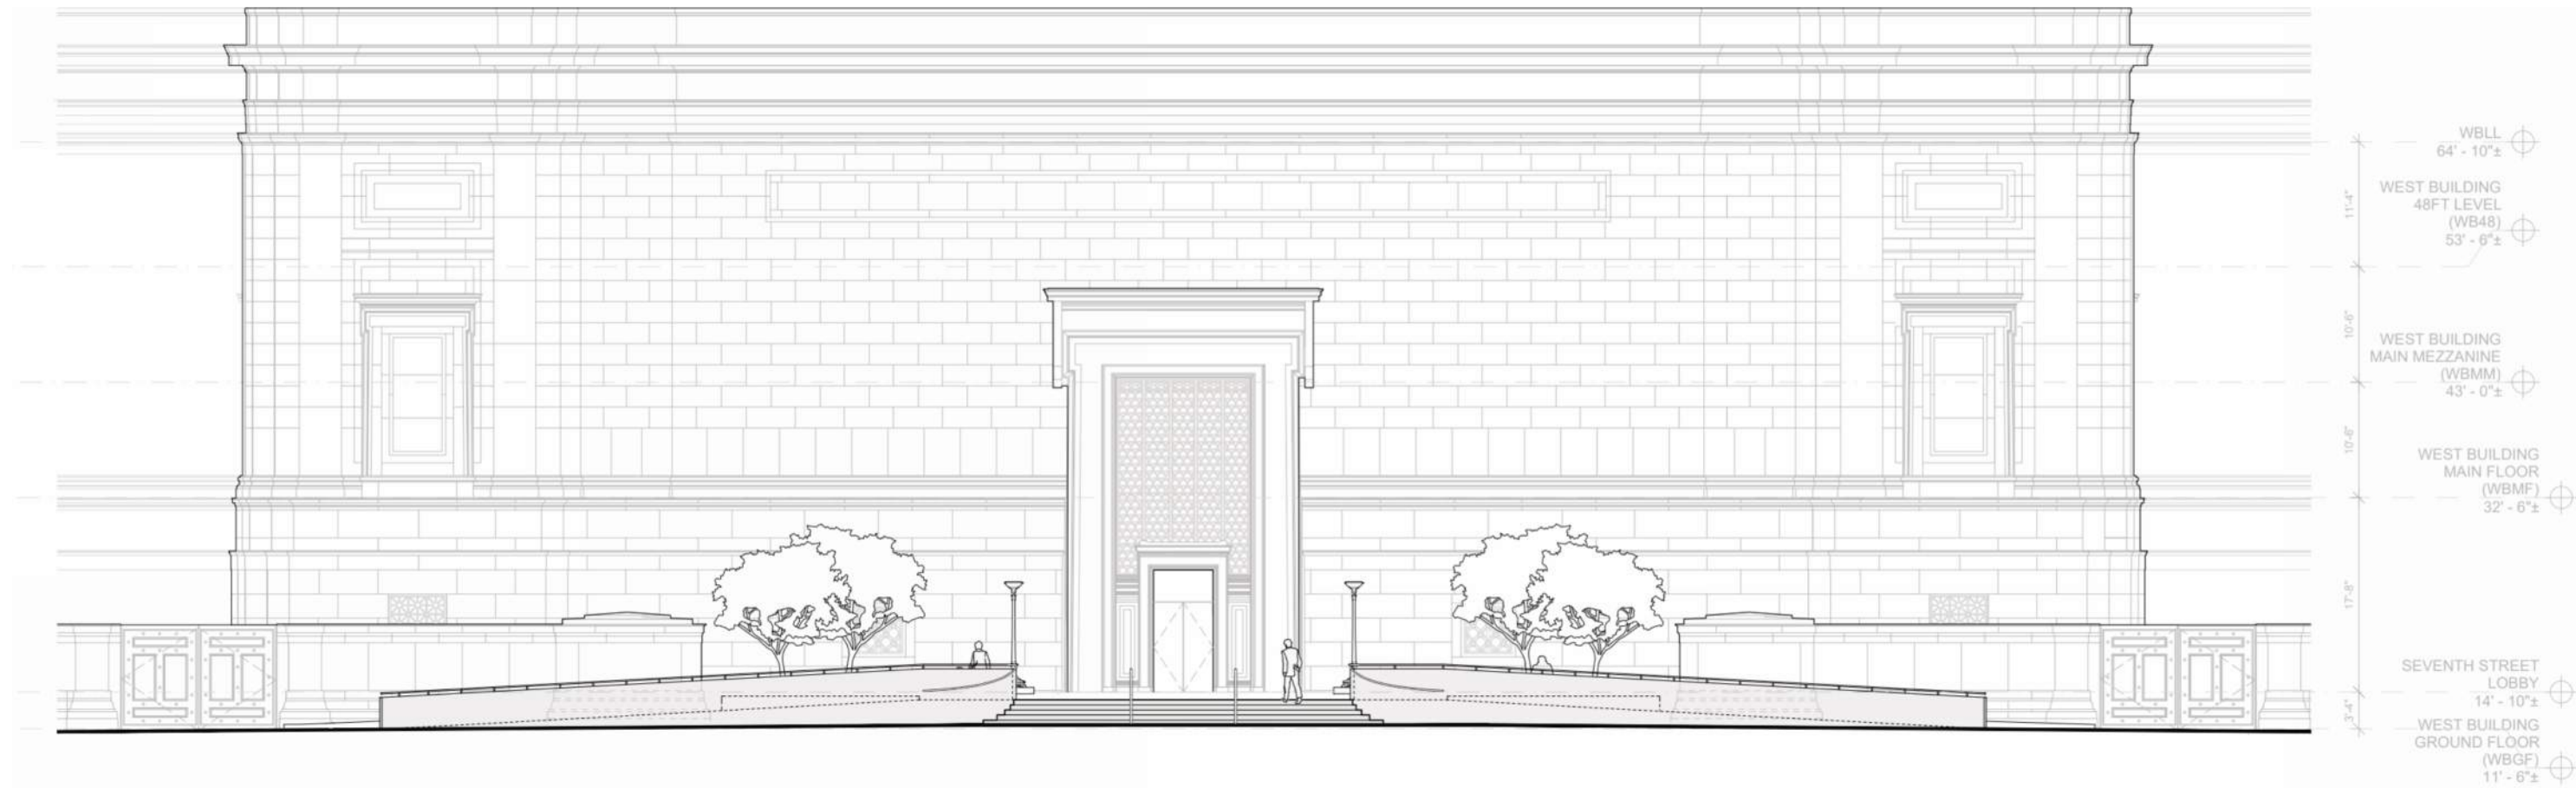
DESIGN STUDY A | WEST ELEVATION

- Dismisses the existing tiered plinth approach to the entry by creating a singular, enlarged plinth.
- Introduction of large curved walls for the inclined walkways introduces new geometries to the Seventh Street Entrance elevation.
- Height of inclined walkway walls conceals portions of the moat walls and main elevation.
- Introduction of large planters and larger scale vegetation obscures existing architectural features of the elevation.

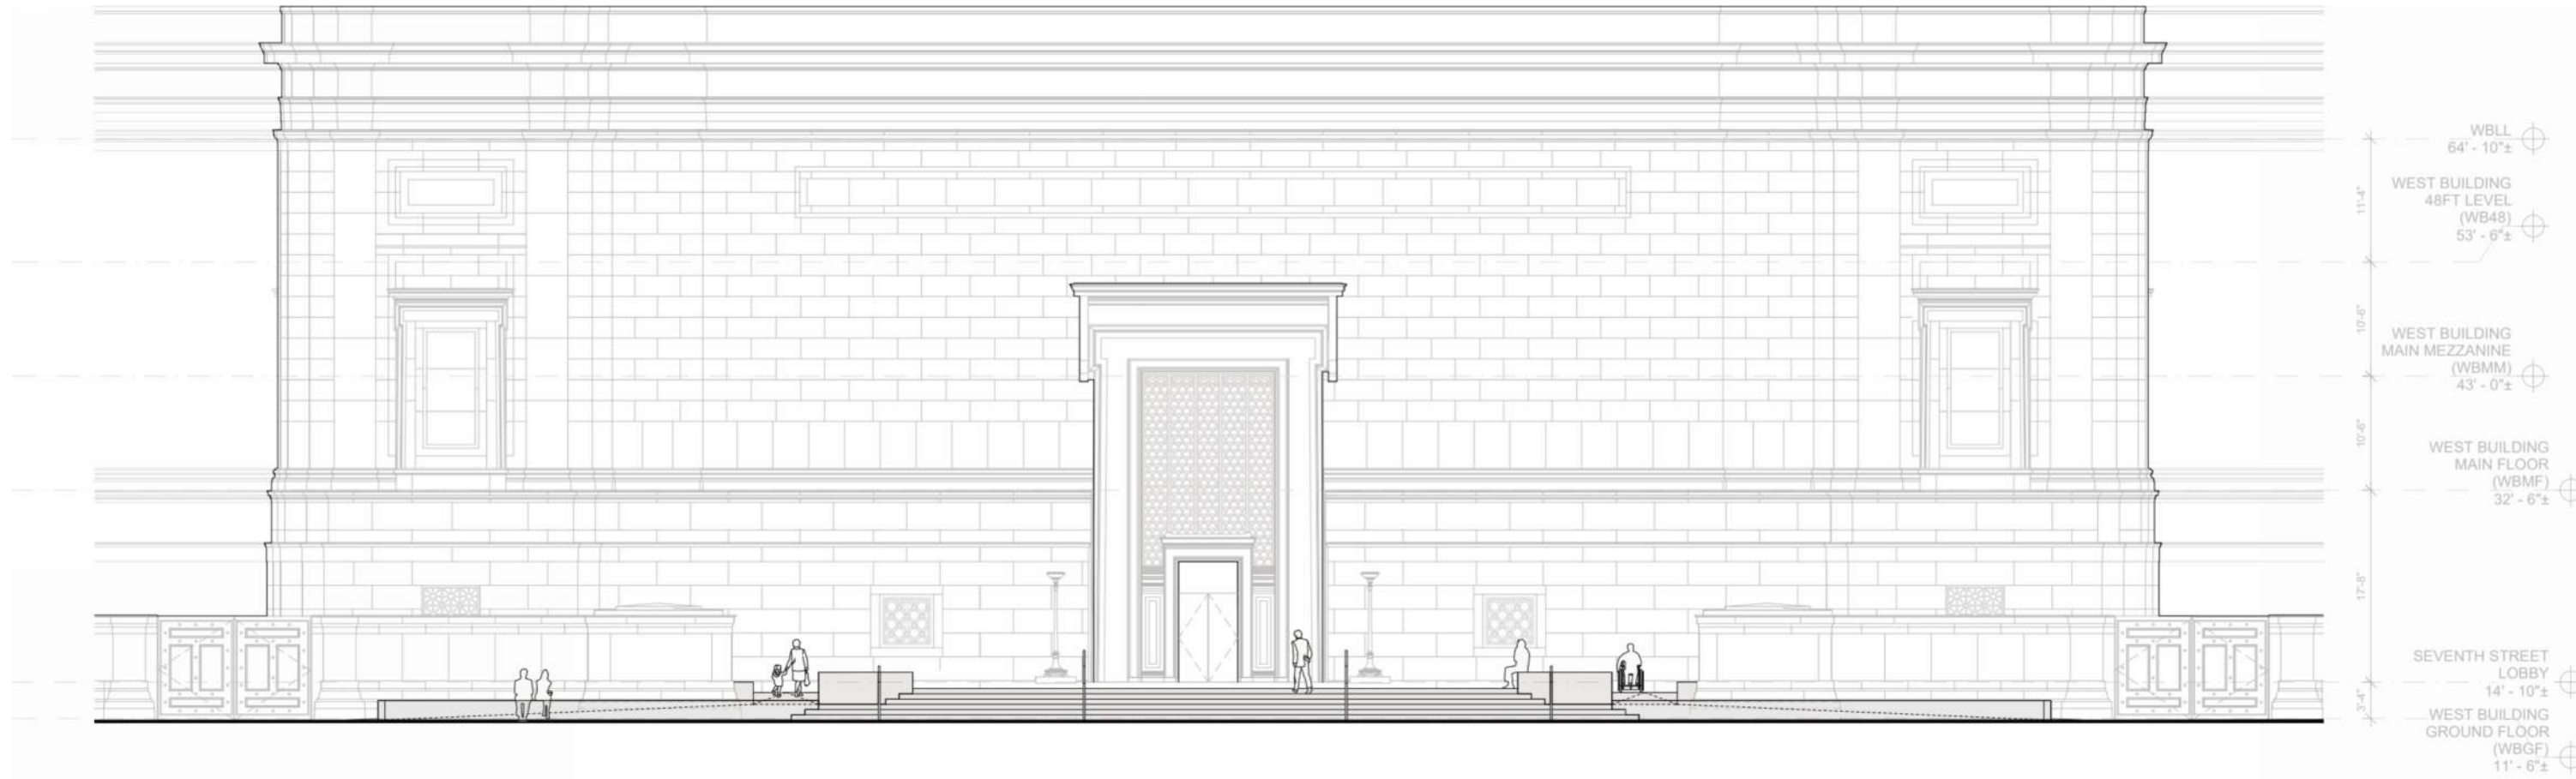
DESIGN STUDY B | WEST ELEVATION

This option explores incorporating symmetrical 1:20 inclined switchback walks. The exterior terrace is larger to accommodate congestion at the entrance.

- The switchback inclined walks within the depth of the existing plinth are lengthy. Their arrival points are far from the building vestibule, asking visitors to double back to the entrance.
- The switchbacks and landings are less resolved against the existing building elevation.
- The length required for 1:20 walkways in the east/west direction pushed the plinth westward towards the drive and creates a narrow sidewalk in front of the stair.

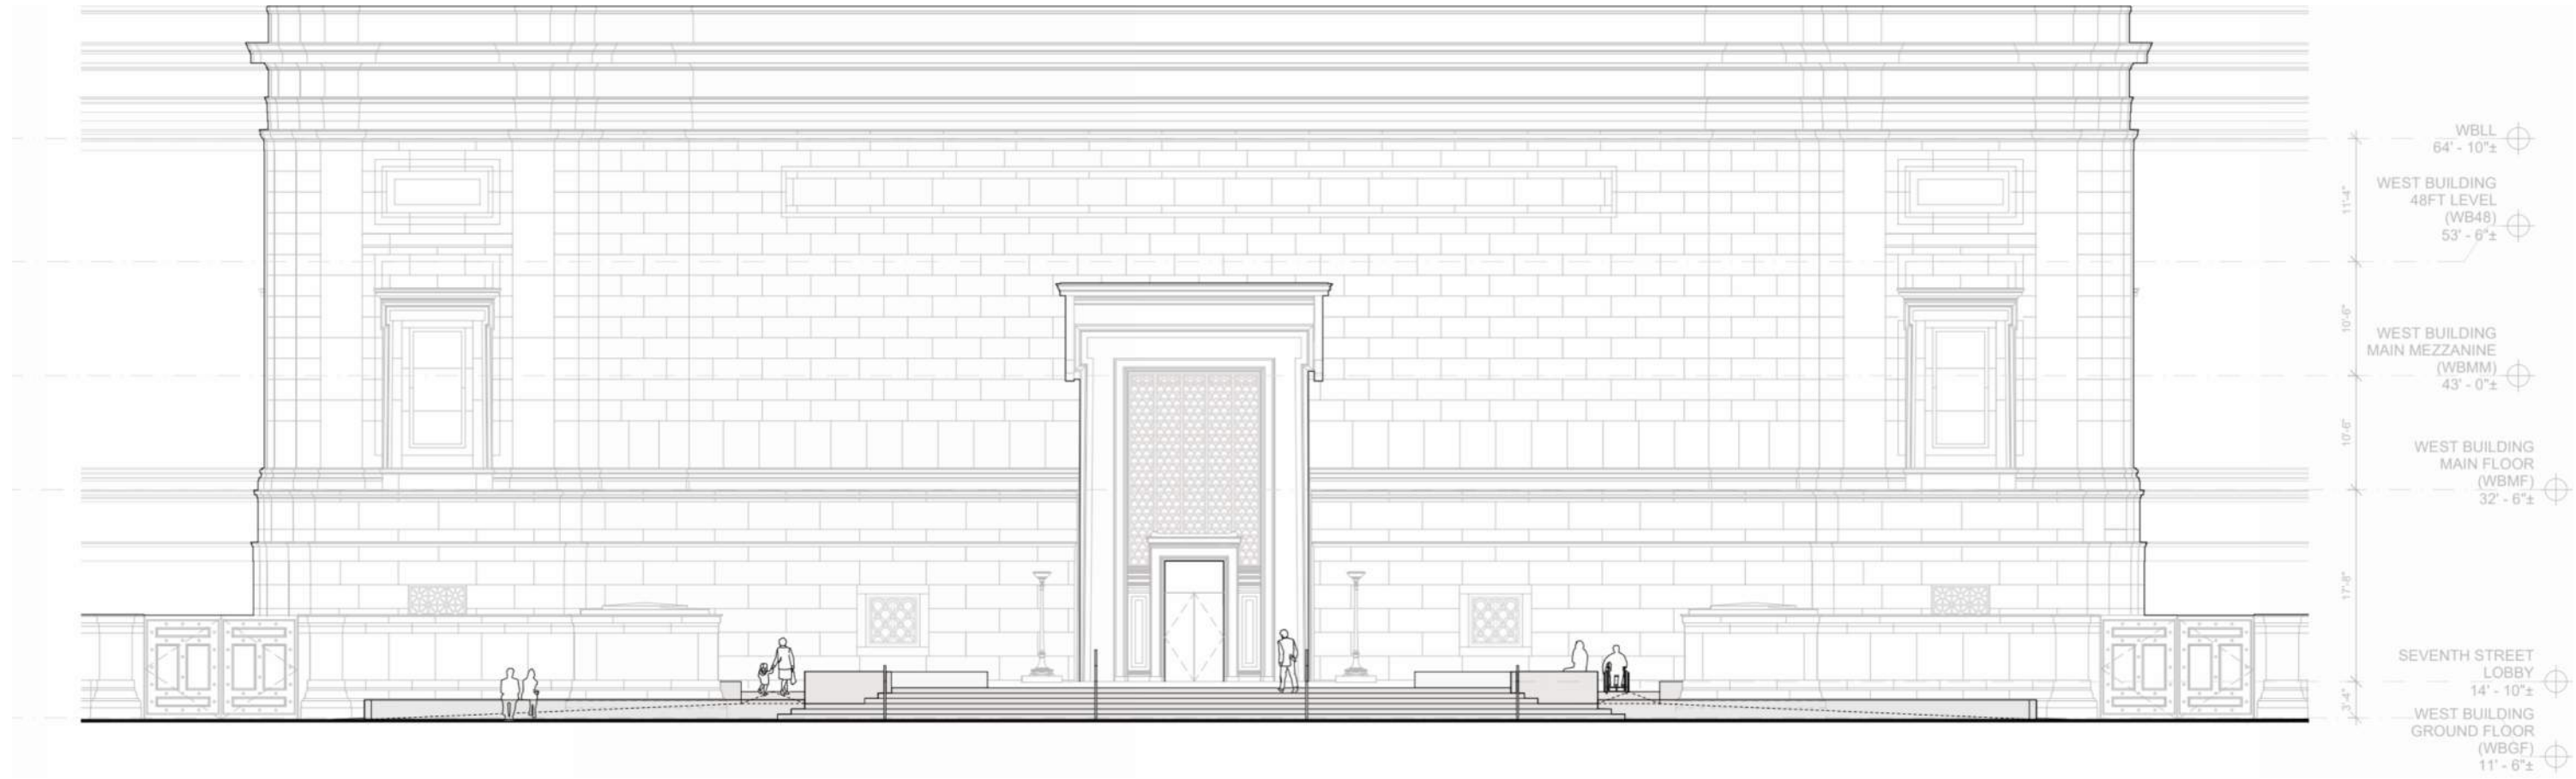
DESIGN STUDY C | WEST ELEVATION

- Intervention conflicts with horizontal banding at the existing building elevation.
- More activity against the building elevation.
- Location of the salvaged bronze luminaires is not resolved.
