CONSTRUCT ARABIAN LEOPARD HABITAT  
NCPC FINAL REPORT

SMITHSONIAN PROJECT CODE: 2533105

SEPTEMBER 3, 2026

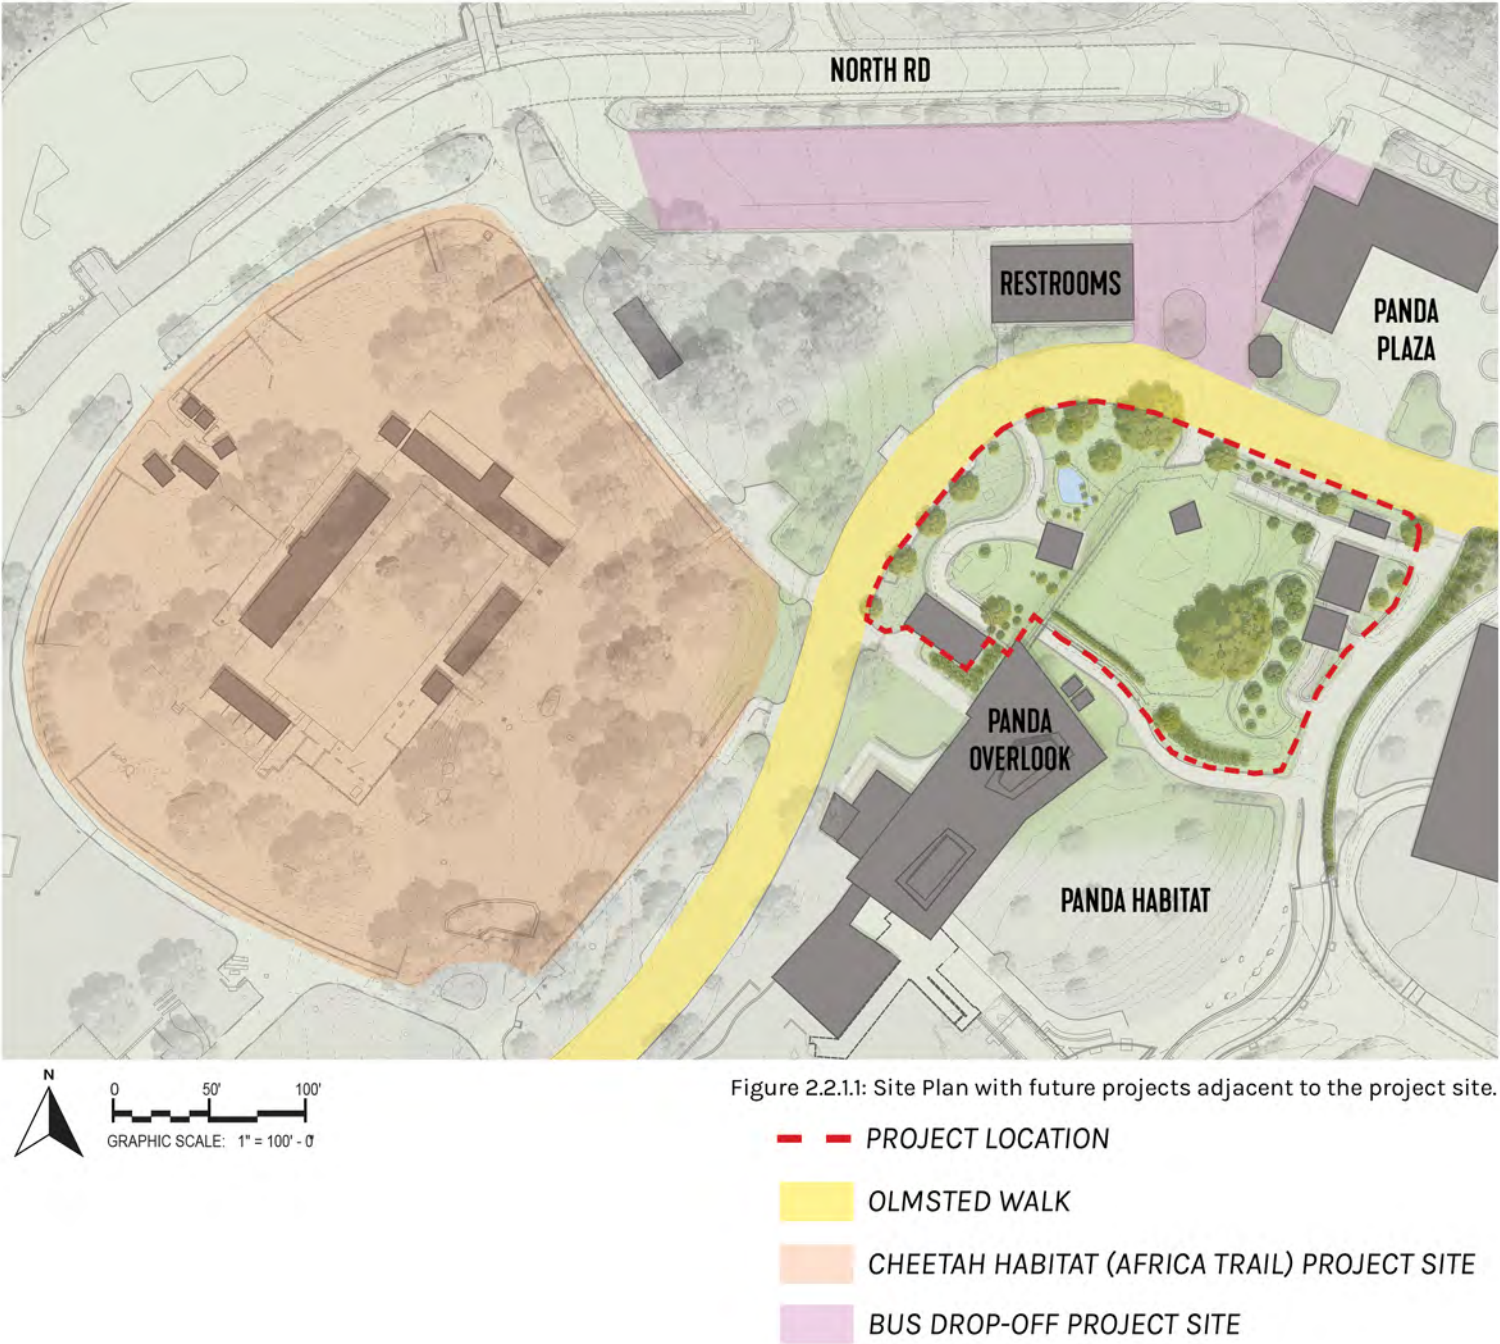
Figure 2.2.1.1: Site Plan with future projects adjacent to the project site.

The Arabian Leopard Habitat project will provide a habitat and care building for supporting an Arabian Leopard exhibit to augment the range of species that are displayed at the National Zoo. The scope of work includes:

- Habitat enclosure that is open air
- Care building structure for animal care and all-weather viewing
- Pedestrian entry/exit from Olmsted Walk
- Service drive to access the Care Building
- Perimeter landscaping

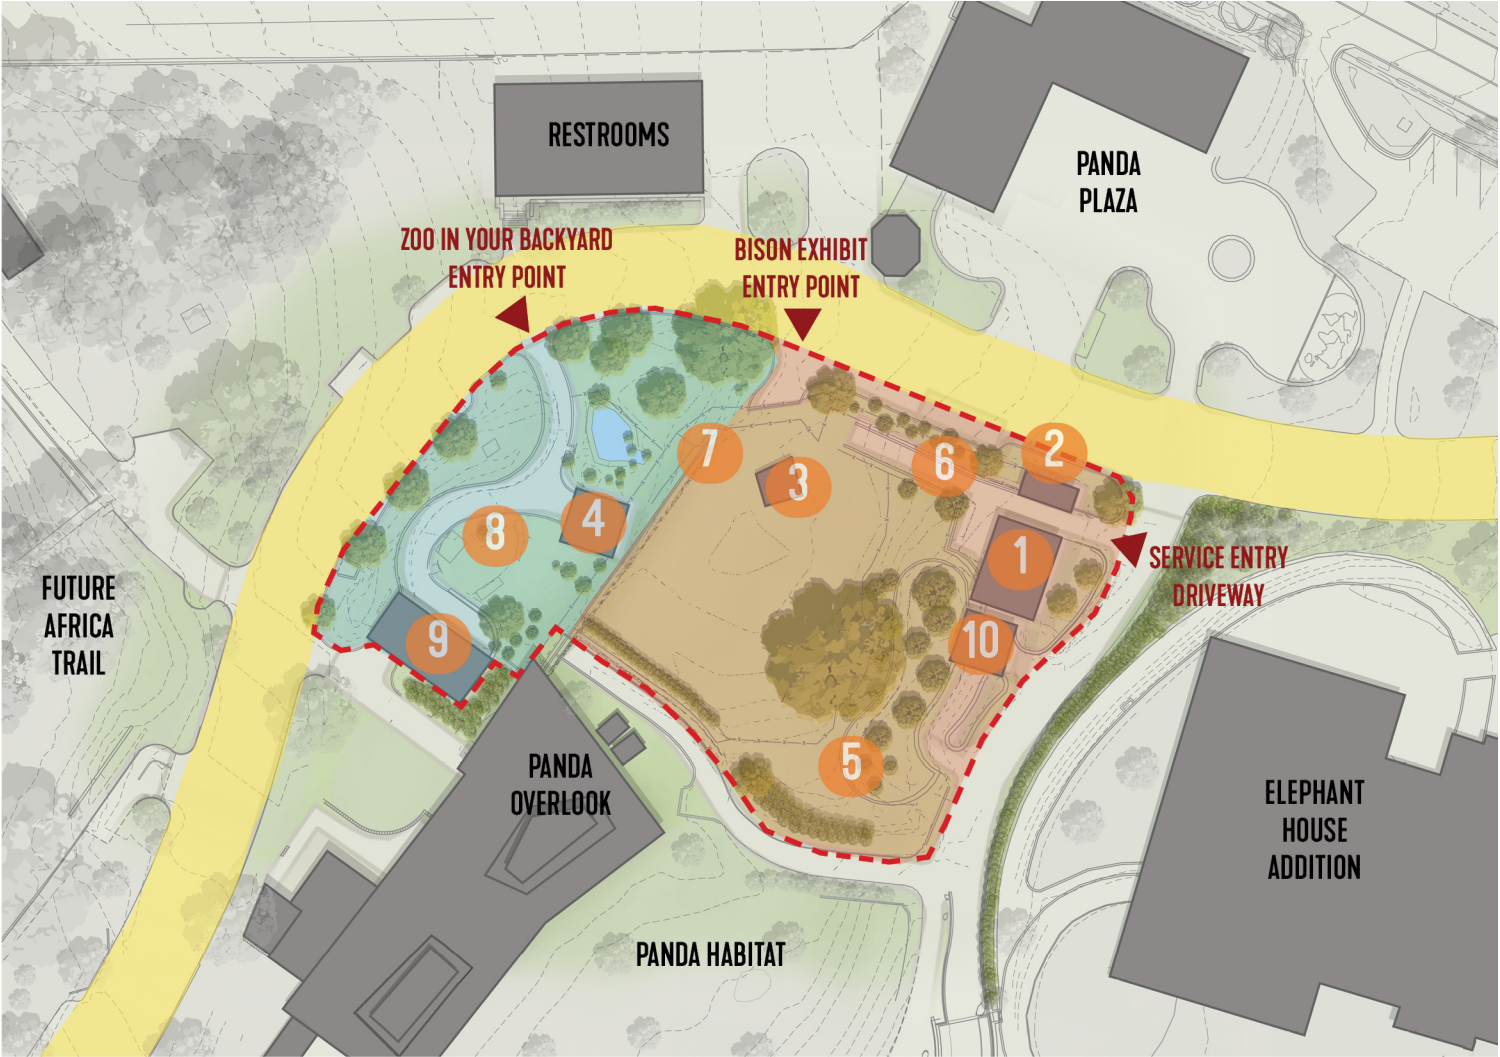
Figure 2.3.1.1: Project Site and Existing Features

- SITE BOUNDARY
- OLMSTED WALK
- ZOO IN YOUR BACKYARD EXHIBIT
- BISON EXHIBIT AND HABITAT

The previous habitat experience had a viewing location directly off of Olmsted Walk and a viewing pavilion on the west side of the site that allowed visitors to look down in the site (Item 4 in Figure 2.3.1.1). The design for the Arabian Leopard Habitat will adjust the grade to allow visitors to walk through the project site on an accessible path via Olmsted Walk.

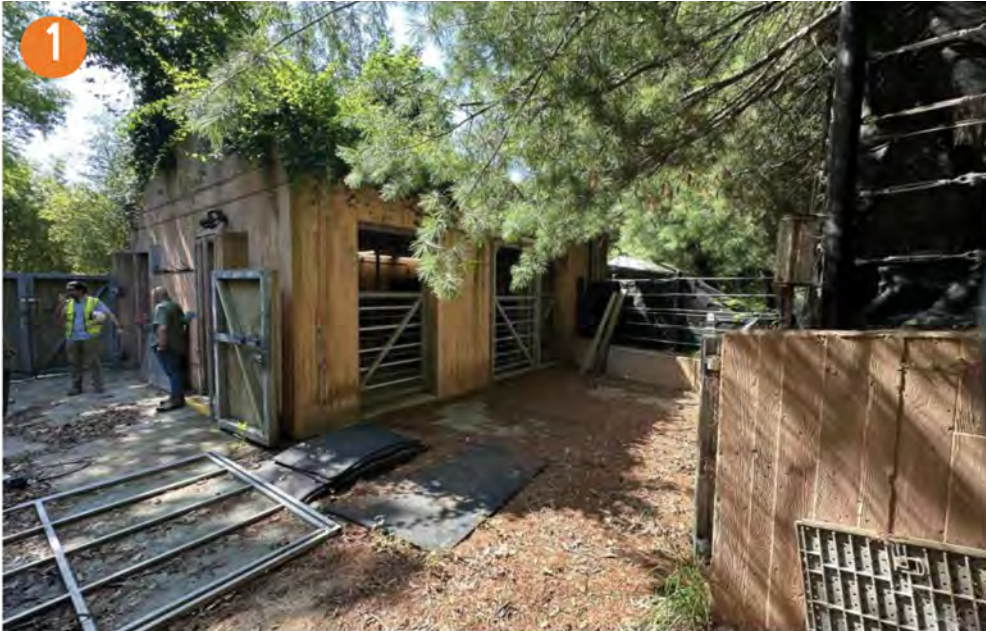
Bison Care Building

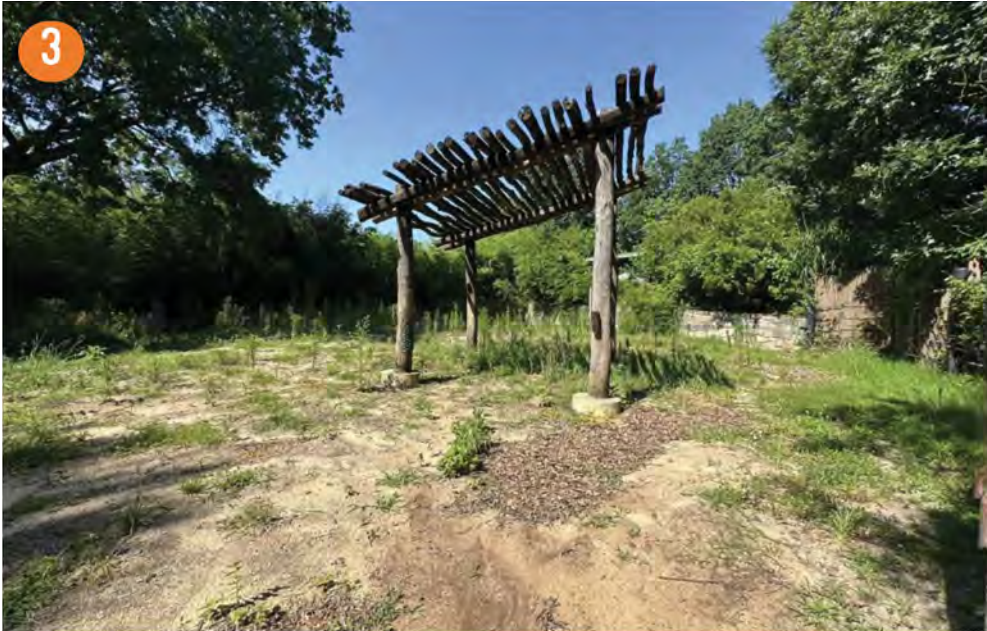
Bison Shade Structure

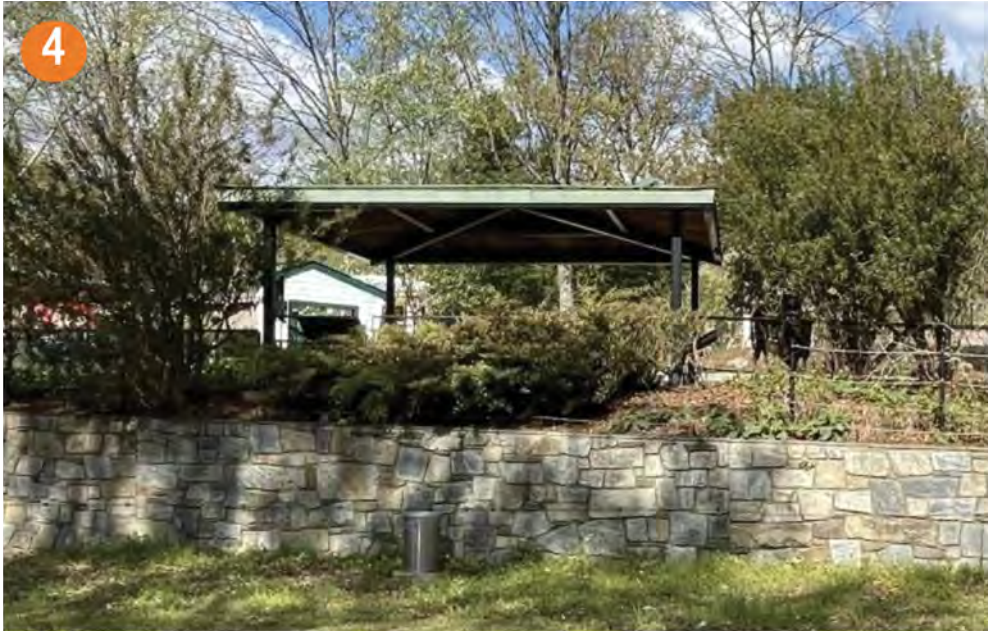
Bison Overlook Structure

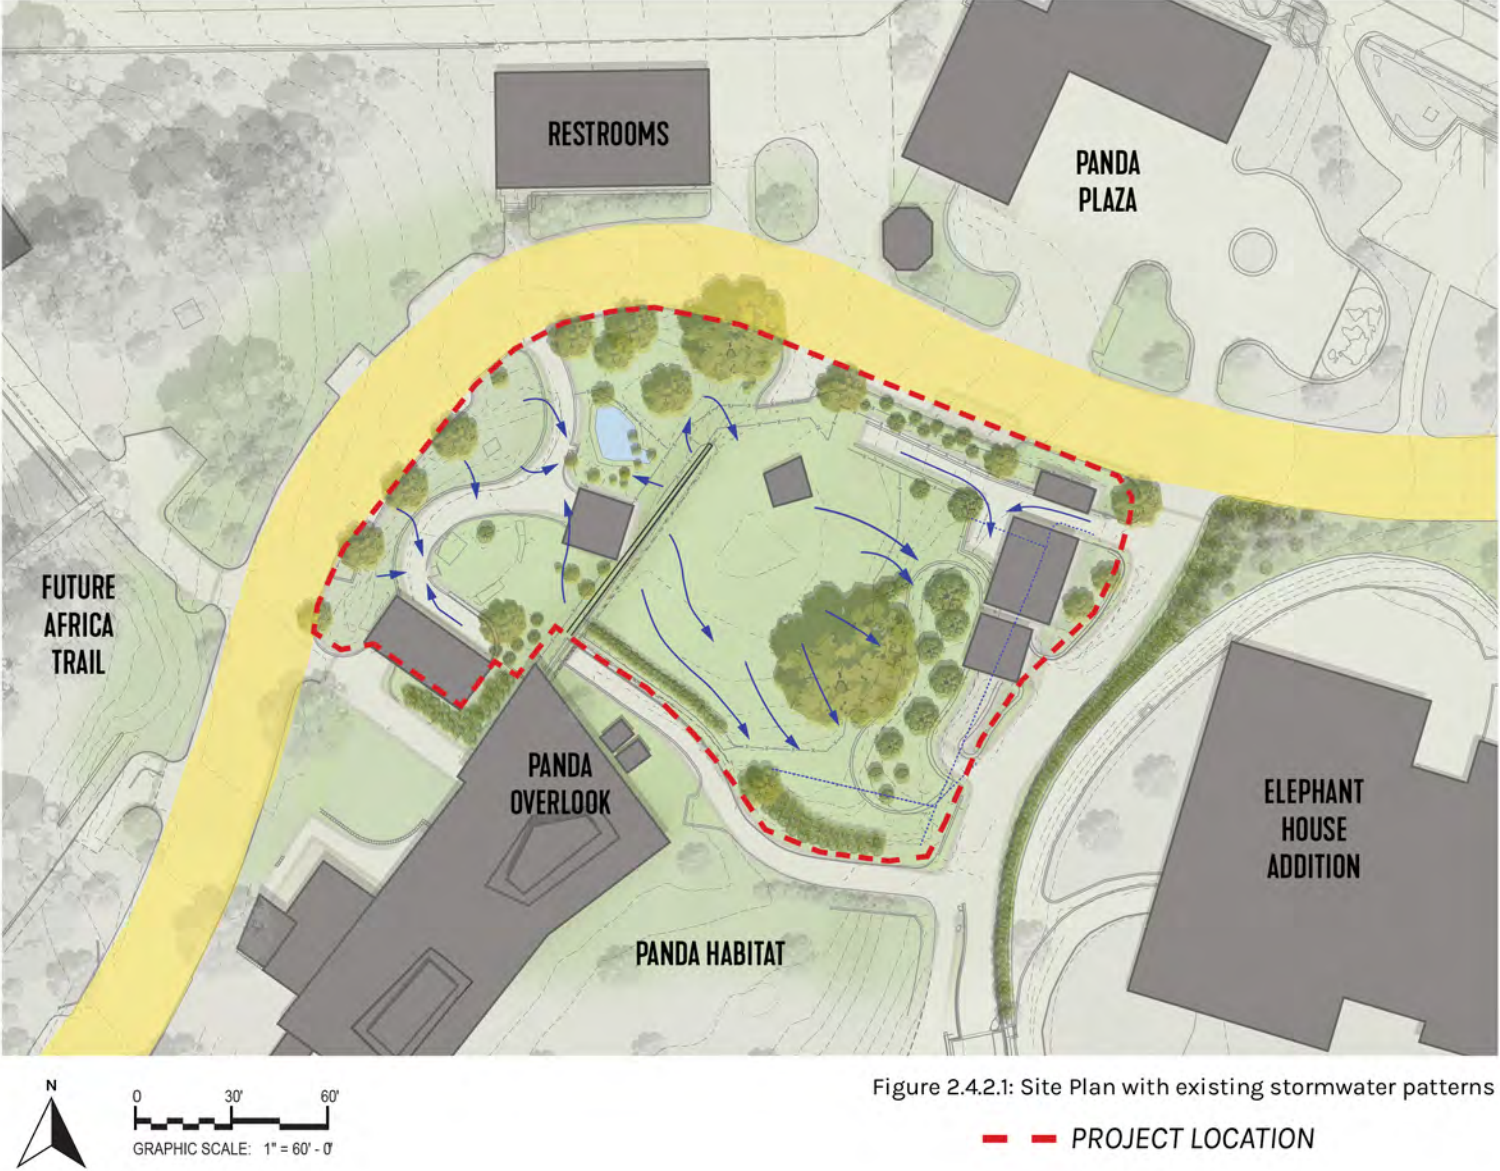
The existing site drainage system consists of multiple perforated underdrains designed to collect infiltrated groundwater. The site is graded to direct surface runoff as sheet flow from the center of the habitat area toward the south, where it is captured by an area drain. Most perforated underdrains are connected to this area drain, and the collected flow is conveyed through a 6-inch PVC pipe that discharges into the contaminated storm network.

The included site plan, Figure 2.4.2.1, shows the general direction of surface flows and the location of the various stormwater lines on the existing site. Reference 5.8 Proposed Civil.

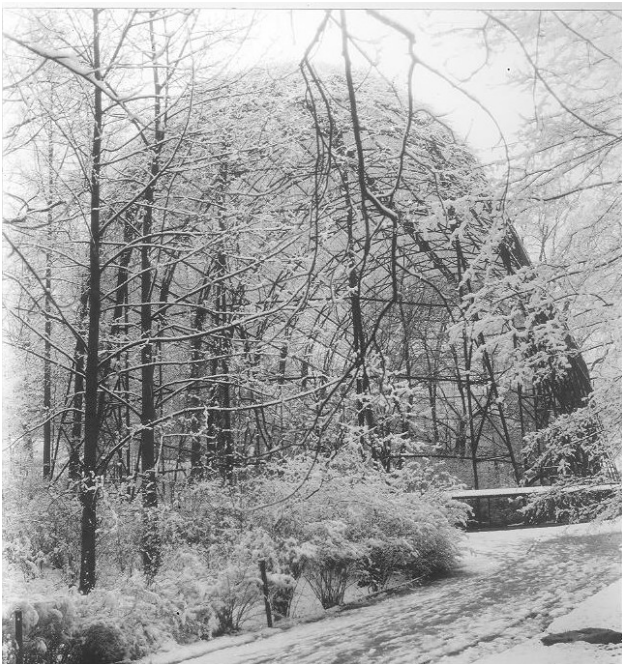
Figure 3.2.1.1: Great Flying Cage, c. 1920-22  
Note: Mesh screen with tall, arched truss superstructure, as seen through dense foliage in winter (demolished)

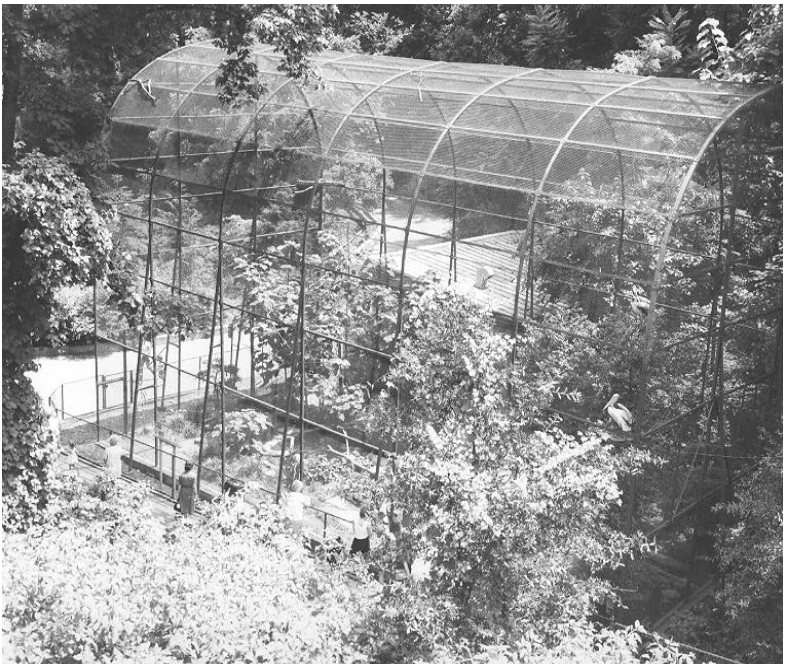
Figure 3.2.1.2: Bird Enclosure, c. 1912  
Note: Mesh screen with tall, pointed-arch superstructure to accommodate animals' natural habitat and behavior (demolished)

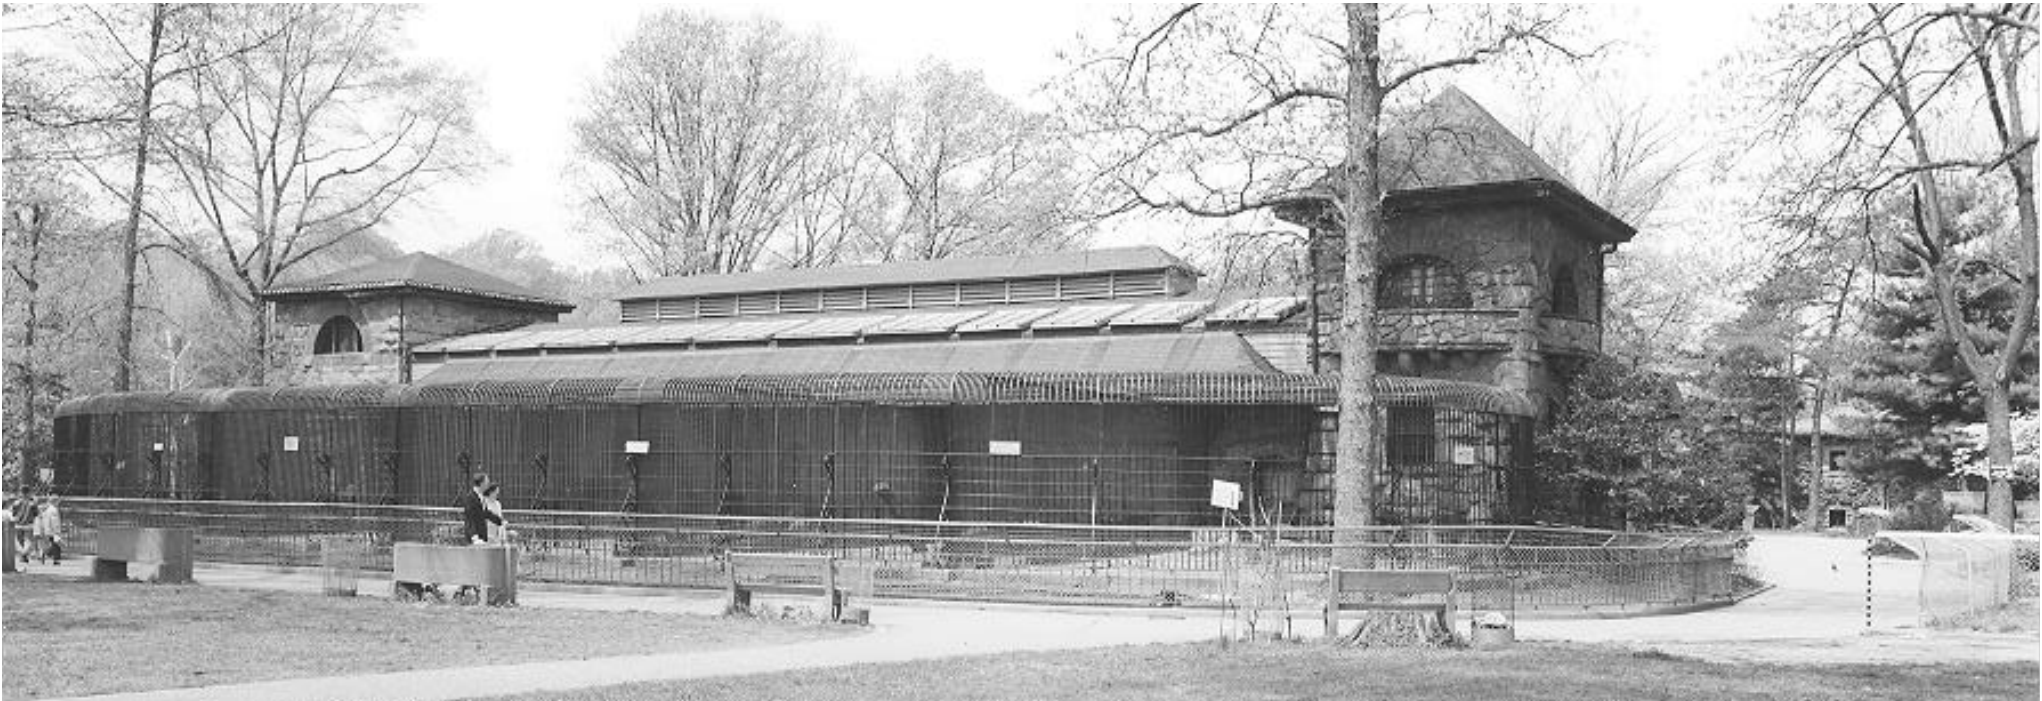
Figure 3.2.1.3: Animal (Lion) House, 1891  
Note: Carnivore exhibit with outdoor enclosure connected and adjacent to animal care building (demolished)

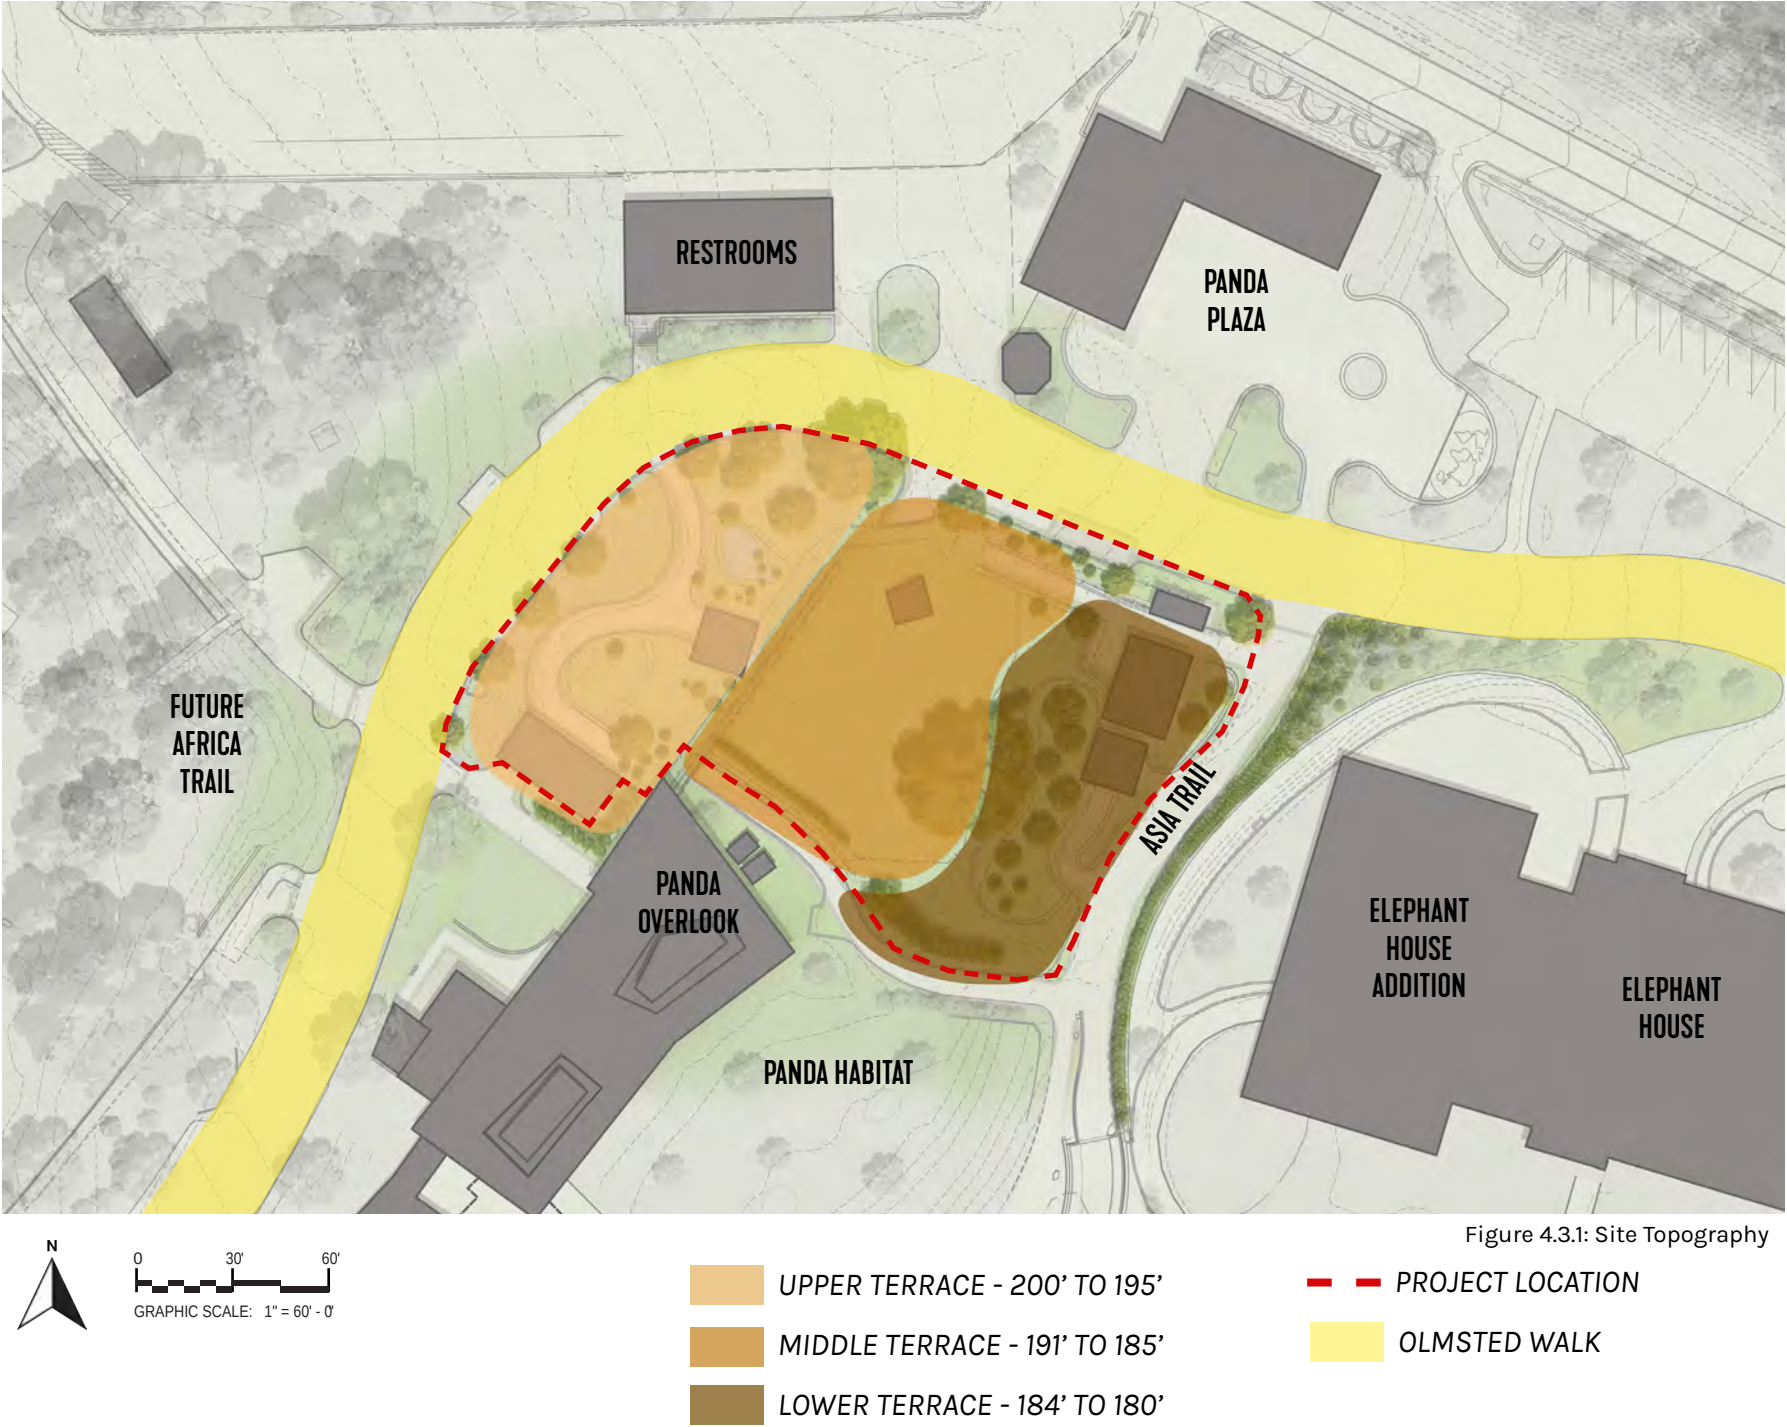
The service entrance to the former Bison Habitat is located at the northeast corner, adjacent to an existing one-story, concrete Bison Care Building, and a separate cement block shed. A ramp near the entrance provides access to the main habitat area. Site elevations range from approximately 180 feet at the southeast corner to 200 feet at the northwest corner, with the highest elevation within the Bison exhibit in the center of the site reaching 191.3 feet. Surface water generally drains southeast toward an abandoned, concrete encased pond which served as a past exhibit. A retaining wall along the southern edge of the site creates an elevated zone within the habitat, enhancing spatial definition and site containment, and contains bamboo screening from the Asia Trail. A Carderock retaining wall bisects the site to allow for an upper viewing platform to the west.

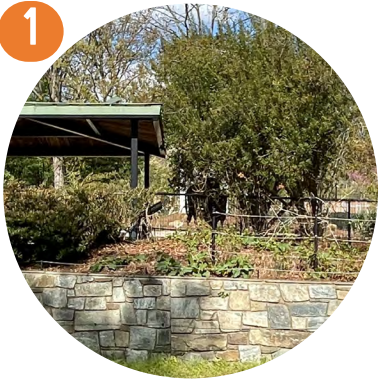
STONE RETAINING WALL

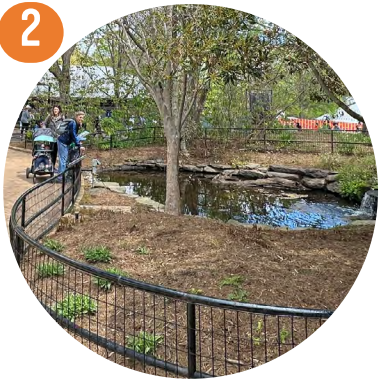
ORNAMENTAL POND

**Zoo in Your Backyard Exhibit** - The Zoo in Your Backyard exhibit features concrete sidewalks, black painted steel tube railing, and concrete seat walls. There is a small ornamental pond, edged with irregular flagstones and featuring a small waterfall with recirculating water. Signage explains the value of native plants and how to incorporate them into visitors' yards and everyday experience. There is a small pergola and several pavilions with metal roofs for shade, providing comfortable resting areas.

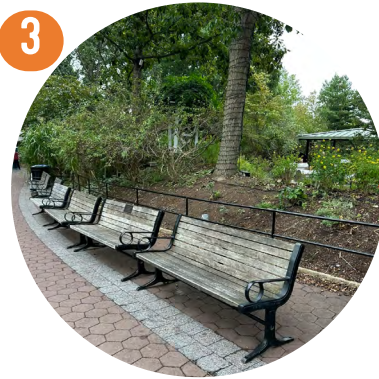
OLMSTED FURNITURE

**Olmsted Walk** - Olmsted Walk features a standard set of furniture, including a water fountain, trash receptacles, wood and steel benches, and signage. These features are inset in several 'niches' of 3 to 5 feet horizontal distance that allow comfortable spacing from the main thoroughfare. The paving material is hexagonal asphalt unit pavers bound by low concrete curbs. Black steel tube forms the primary railing along this portion of Olmsted Walk. Existing furnishings along the Walk will be protected or removed and replaced.

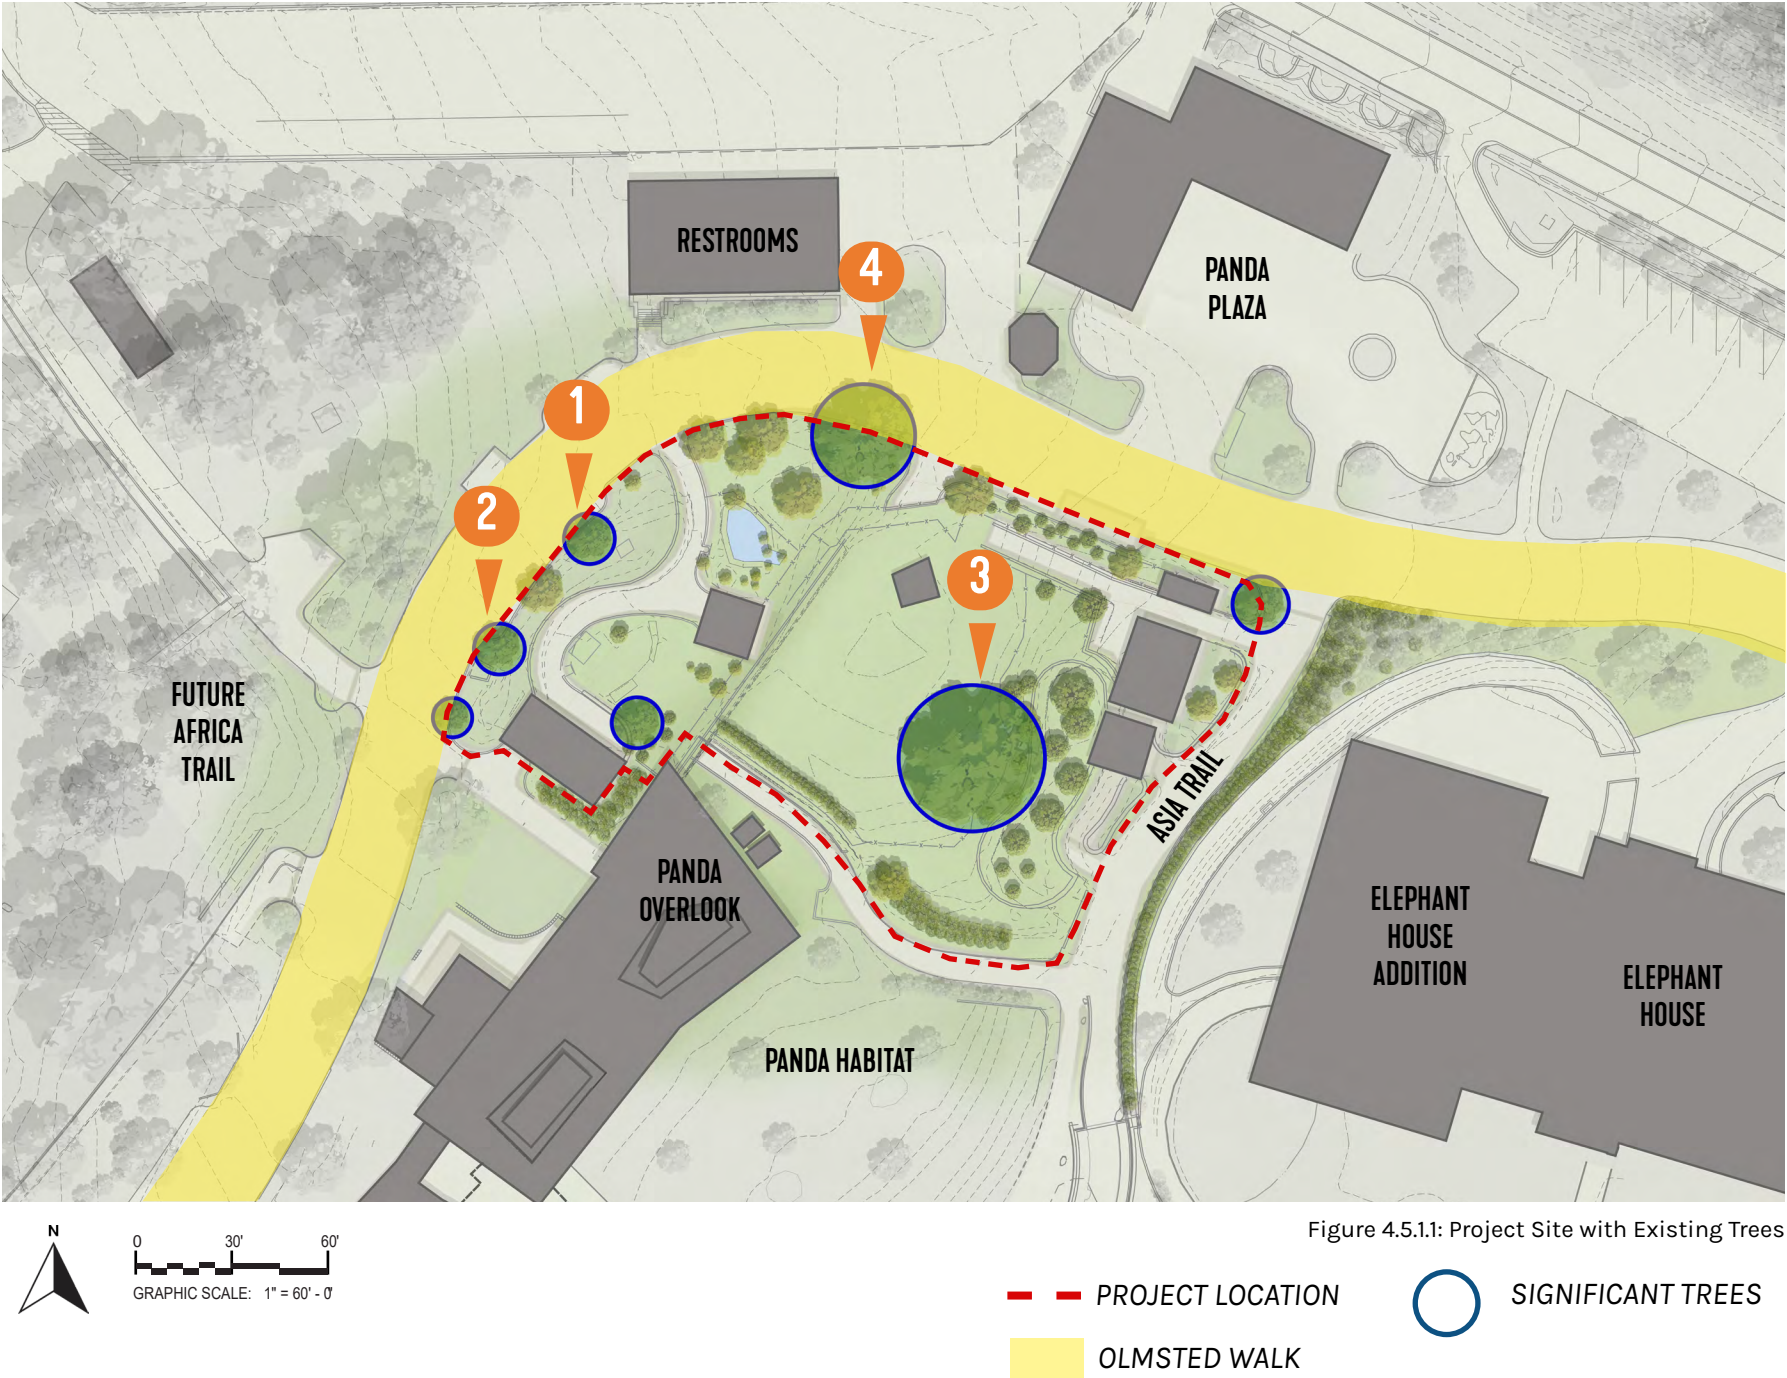
Figure 4.5.1.1: Project Site with Existing Trees

Shade trees on the site have been surveyed by a Certified Arborist and NZCBI Horticulture. NZCBI Horticulture has noted seven which are most significant and important for preservation. All of the seven noted were deemed to be in good condition per the Tree Inventory provided by the Arborist. While not all can be saved due to the disruption necessary for constructing the new habitat, the design will make every effort to protect and preserve as many as possible. The project has identified existing trees, 4 of which were deemed significant to NZCBI Horticulture, for preservation.

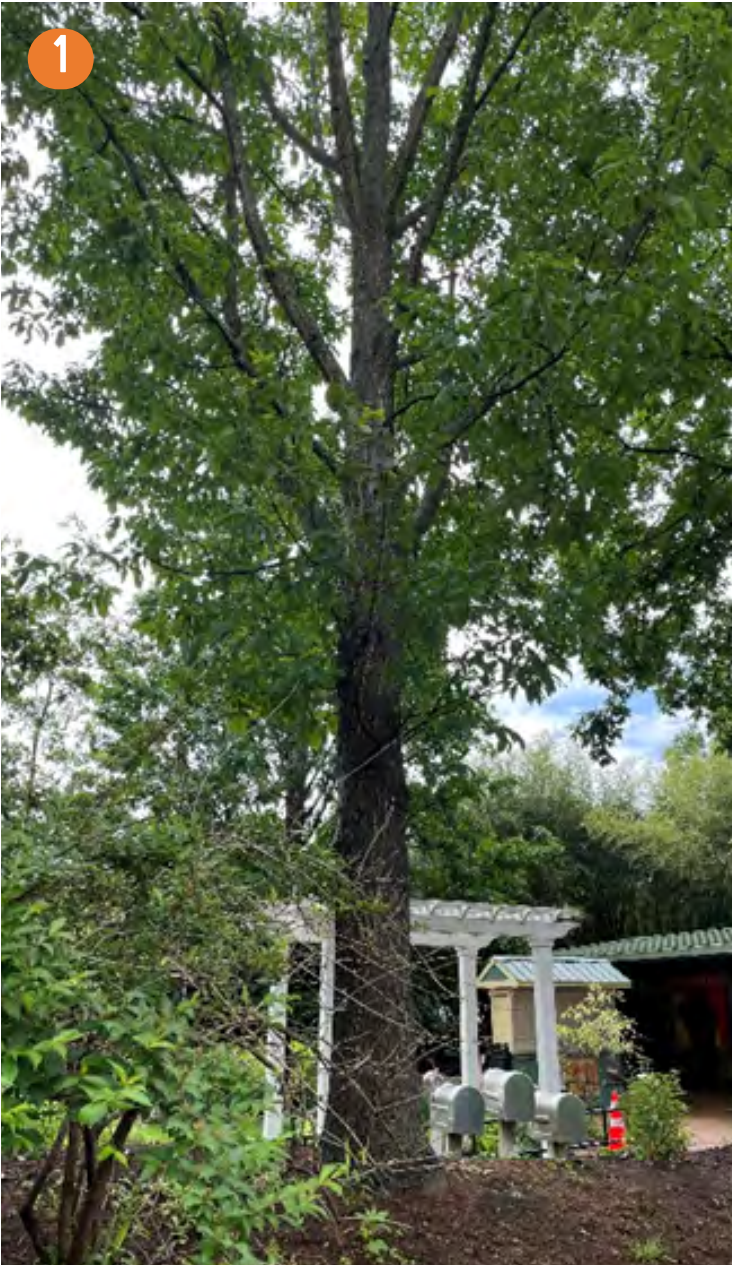
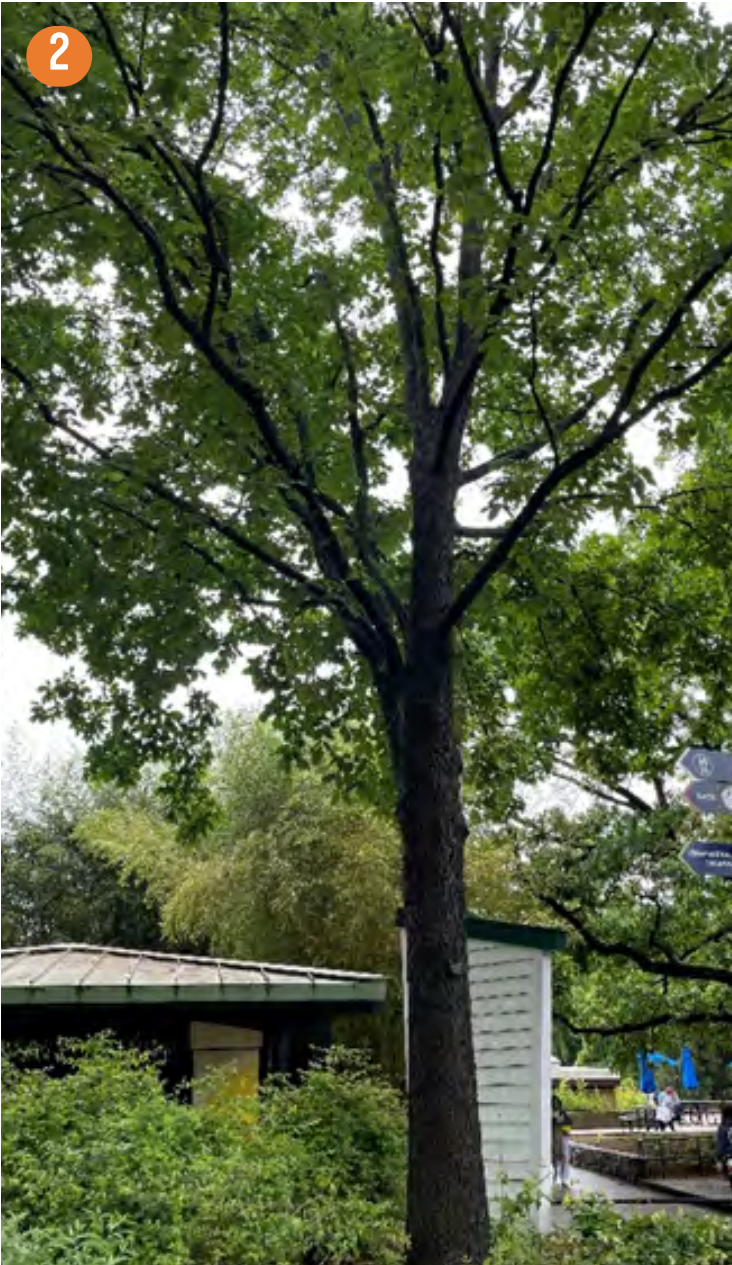
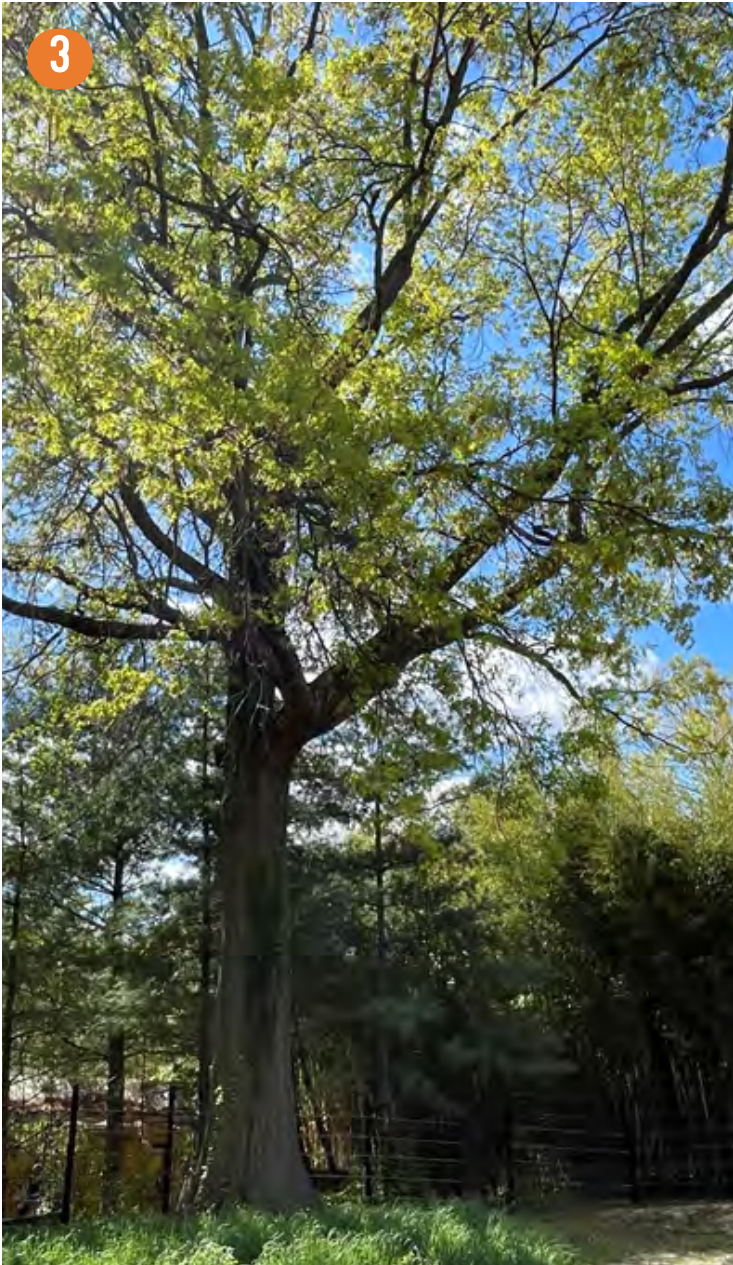
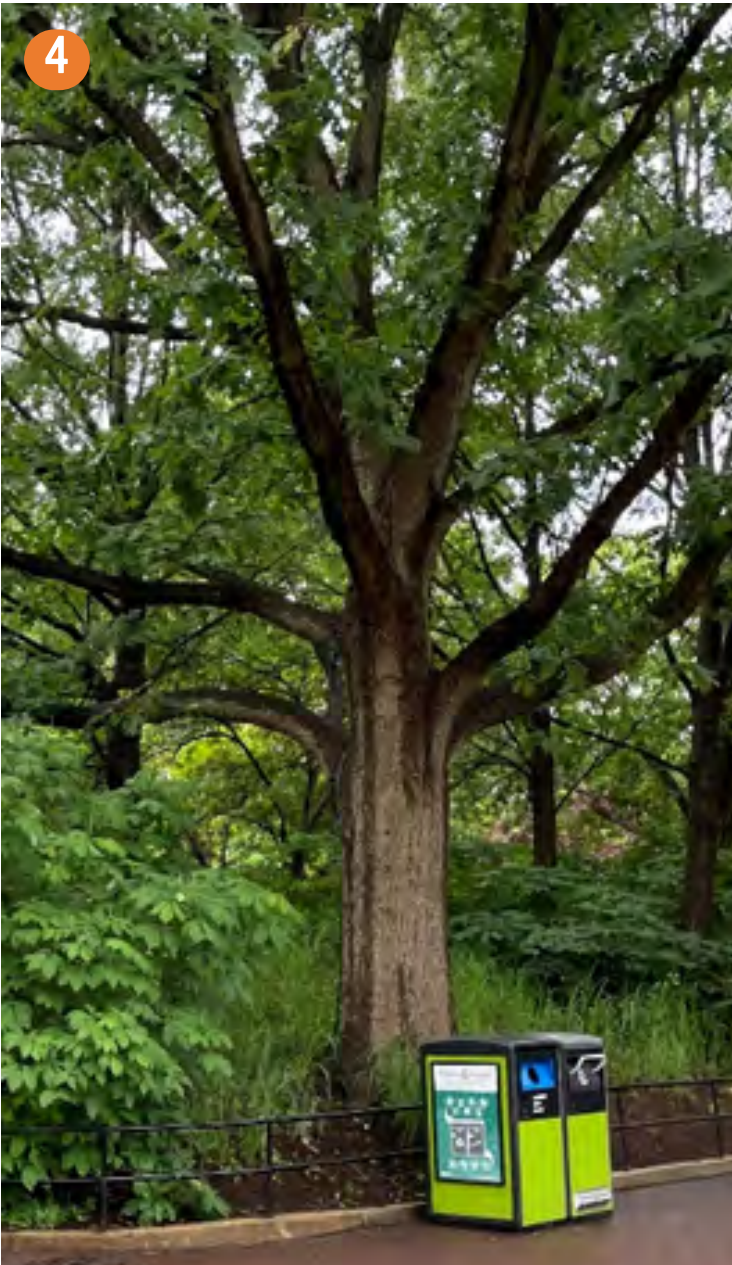
Figure 4.5.1.2,3: Mature Hickory trees along northwestern edge of site

Figure 4.5.1.4: 46" Oak Tree within the Bison Habitat

Figure 4.5.1.5: 36" Oak Tree at northern edge of site

Mature shade trees line the outer edges of the site along Olmsted Walk. These include Oak and Hickory, and range from 12 inches in diameter to a significant anchoring oak at 36 inches in diameter at the north corner of the site. See figures 4.5.1.2 to 4.5.1.5 for tree images. Within the upper Zoo in Your Backyard site, there are several smaller to mid-sized understory trees, including Sweetbay Magnolia, Redbud, Amelanchier, and Holly. Within the Bison Yard site, there is one very large 49 inch Oak tree, and a cluster of medium sized White Pine trees at the eastern low end of the site. Thick bamboo forms a dense wall around the east and south ends of the site, which is a characteristic component of the Asia Trail running along these edges.

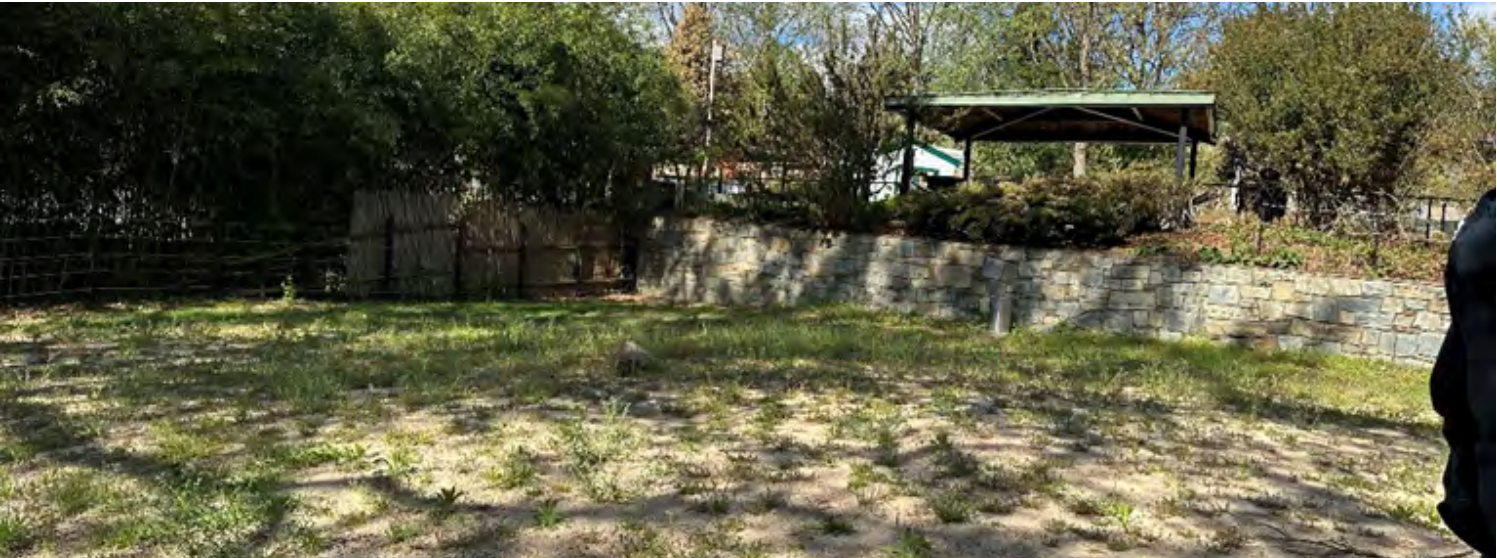
Figure 4.5.2.2: View from within Bison Habitat exhibit looking north to Zoo in Your Backyard exhibit, showing stone retaining wall, metal-roofed pavilion, deactivated electrical fence, tall bamboo, and typical sandy ground surface with sparse grass.

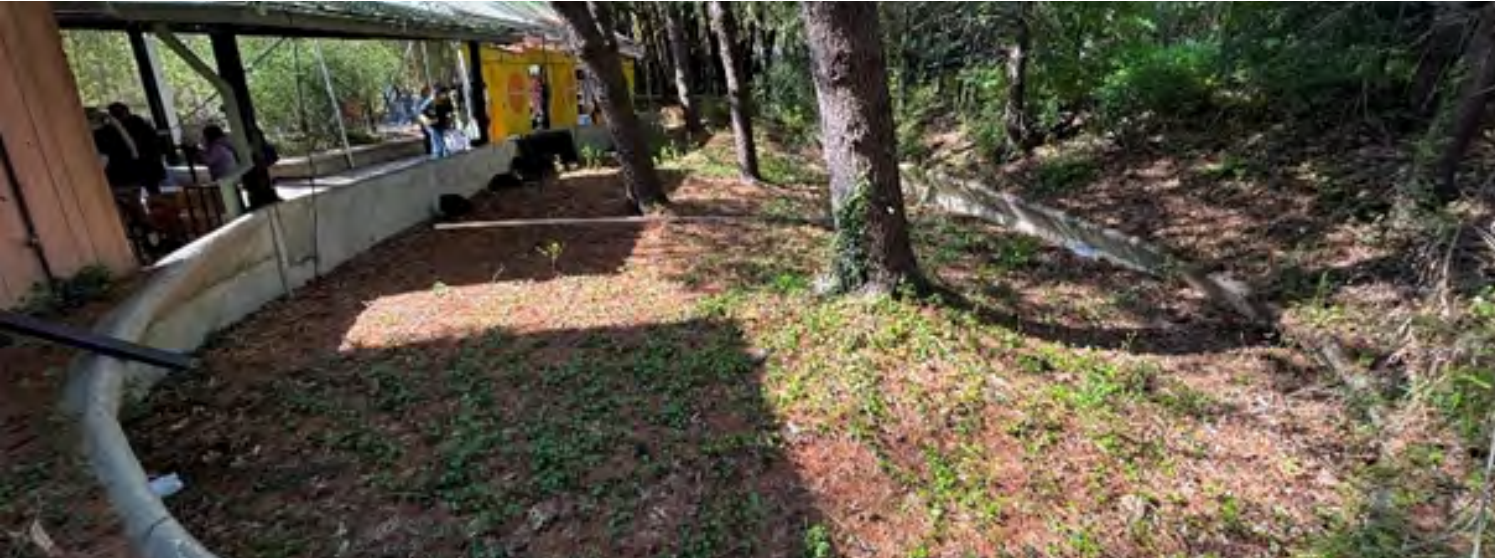
Figure 4.5.2.3: View from back of the Bison Care building looking south. The concrete retaining wall of the former prairie dog exhibit is filled with weeds and white pine trees. A metal-roofed pavilion covers a temporary panda-related vendor in the left background.

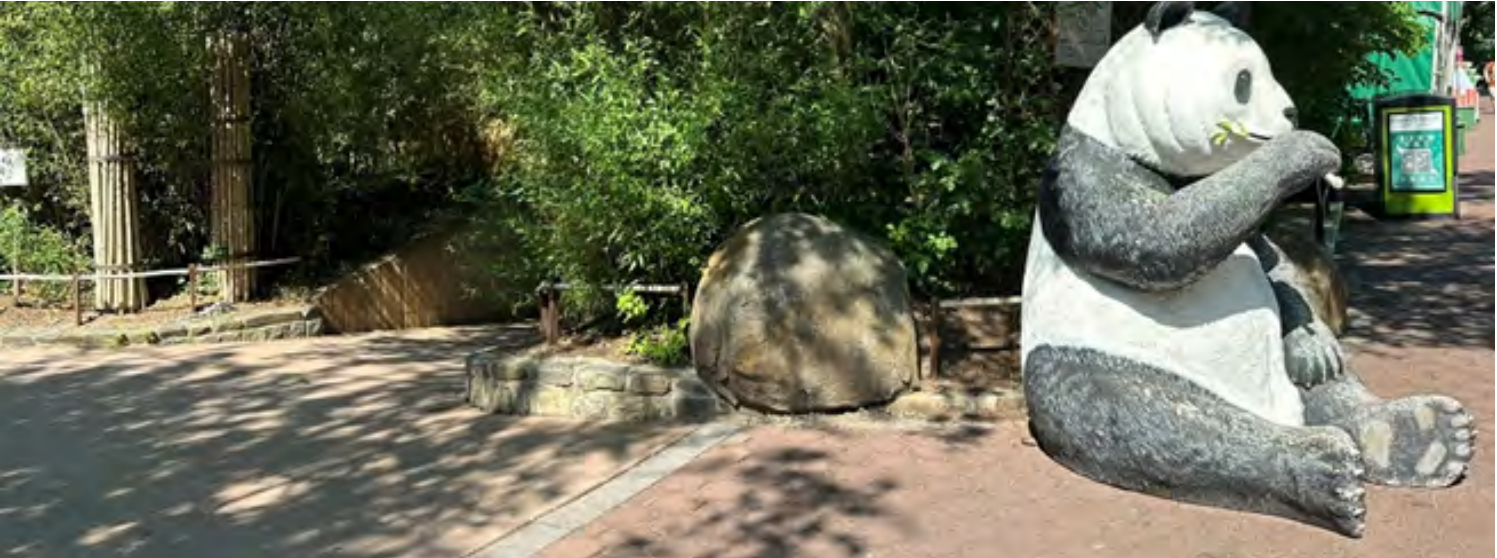
Figure 4.5.2.4: View from east boundary of site looking back to the West. Panda sculpture marks the exit/secondary entrance to the Asia Trail. The service entry to the existing Bison Yard care building can be seen to the left. The transition from Olmsted Walk hexagonal asphalt pavers to concrete paving of the Asia Trail is visible, as are the steel-and bamboo landscape railings.
