CONSTRUCT ARABIAN LEOPARD HABITAT  
NCPC FINAL REPORT

SMITHSONIAN PROJECT CODE: 2533105

SEPTEMBER 3, 2026

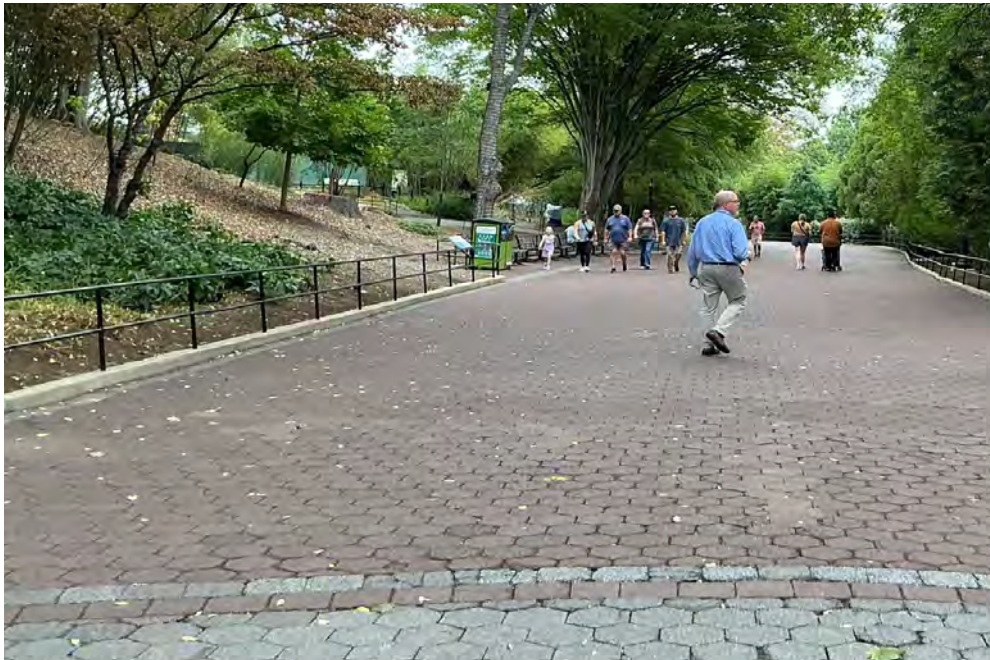
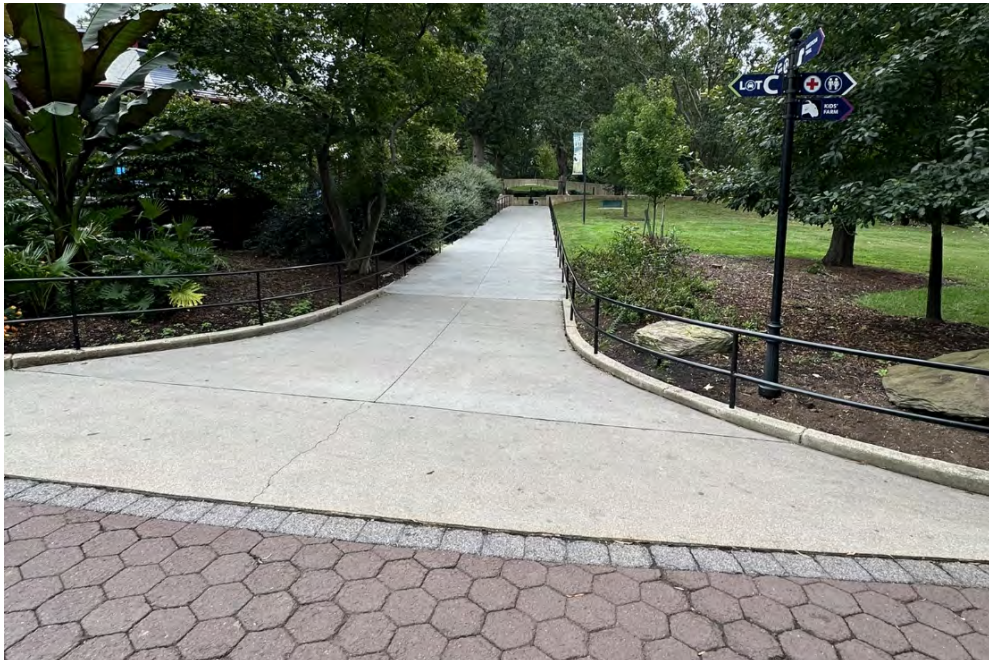
A change in paving along Olmsted Walk is utilized to signify transition to exhibit and vendor zones. The paving material is hexagonal asphalt unit, bound by low concrete curbs.

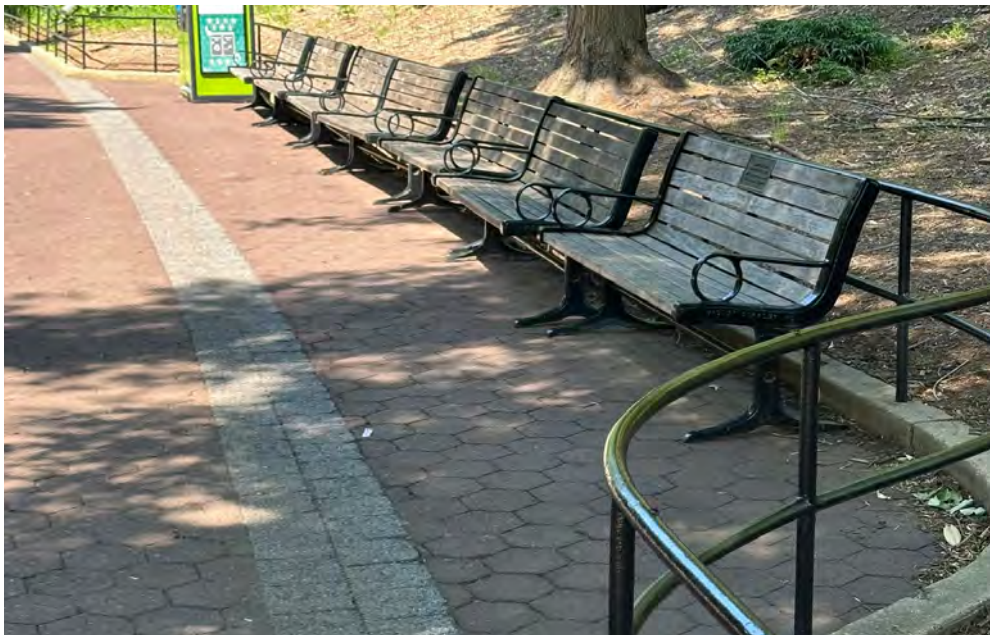
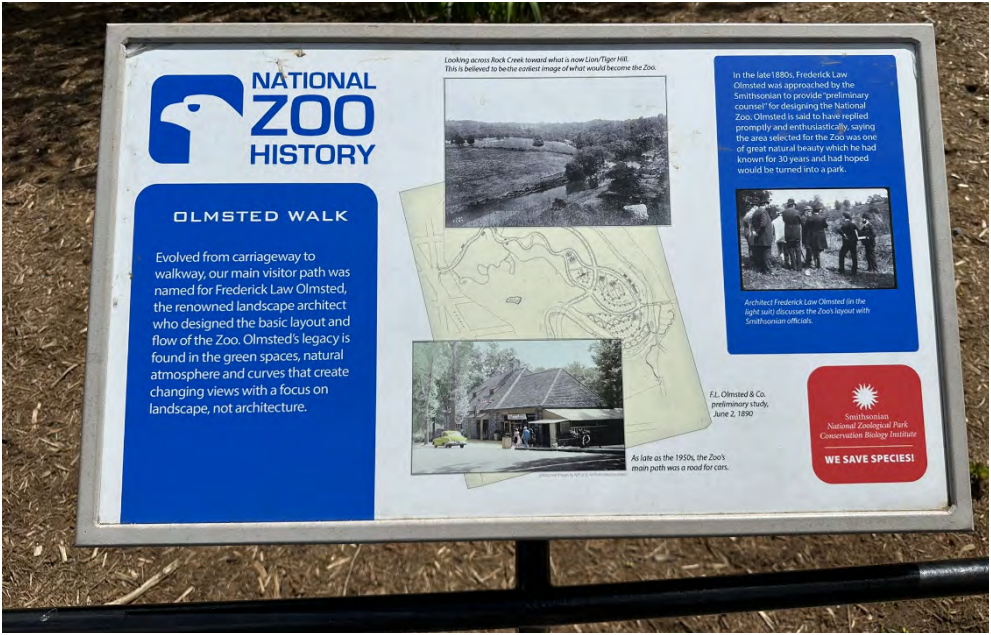
Figure 4.6.7.1: Existing Features and Furnishings along Olmsted Walk

Olmsted Walk features a standard set of site furnishings including a water fountain, trash receptacles, wood and steel benches, and signage. Black steel tube forms the primary railing along this portion of Olmsted Walk.

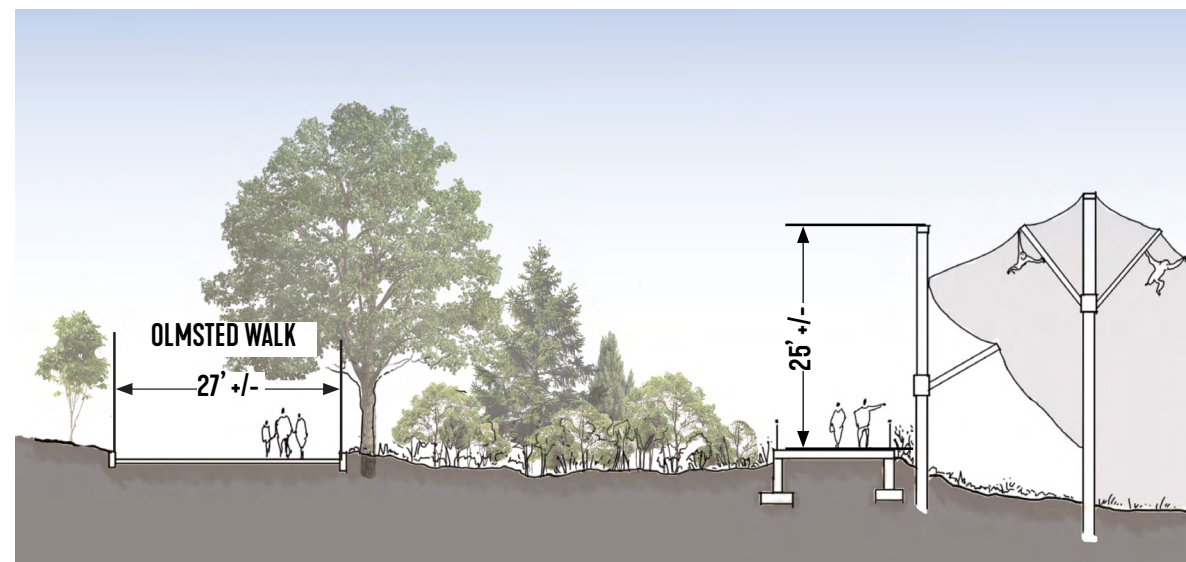
Figure 4.7.2: Existing Conditions Section - Gibbon Habitat Enclosure

## GIBBON HABITAT ENCLOSURE - MASTED TENSILE MESH STRUCTURE

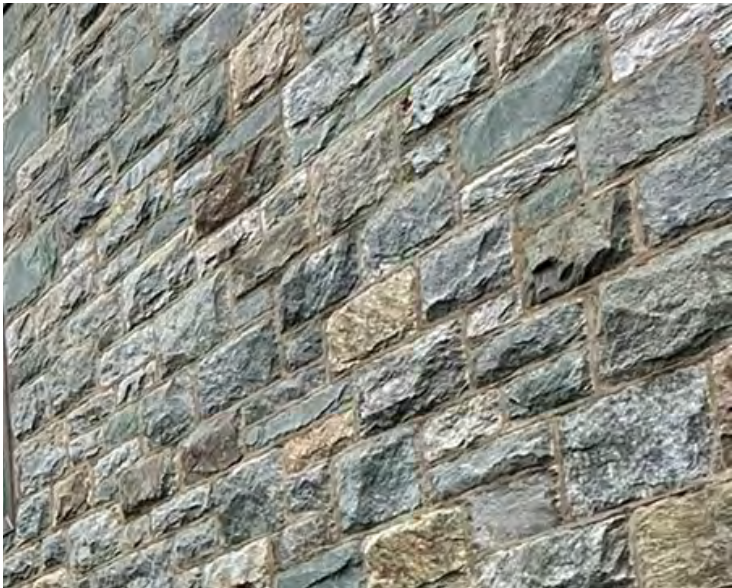
Figure 5.2.1.1: Proposed Facade Material  
Carderock, Ashlar Coursing

- Carderock is the most prevalent material throughout the Zoo. The natural range of Carderock installations throughout the historic district feature a wide range in tonality. For this project, a subtle warm beige tone in addition to the typical blue-grey tones more common in Carderock will be utilized to complement the natural habitat aesthetic throughout the exhibit.
- A common ashlar coursing pattern of stone is proposed, inspired by the typical coursing pattern of Carderock found throughout the historic district.
- Basis of Design: Tri-State Stone, Carderock, Ashlar Veneer - 3-1/2", 7-1/2", and 11-1/2"H by Random Lengths

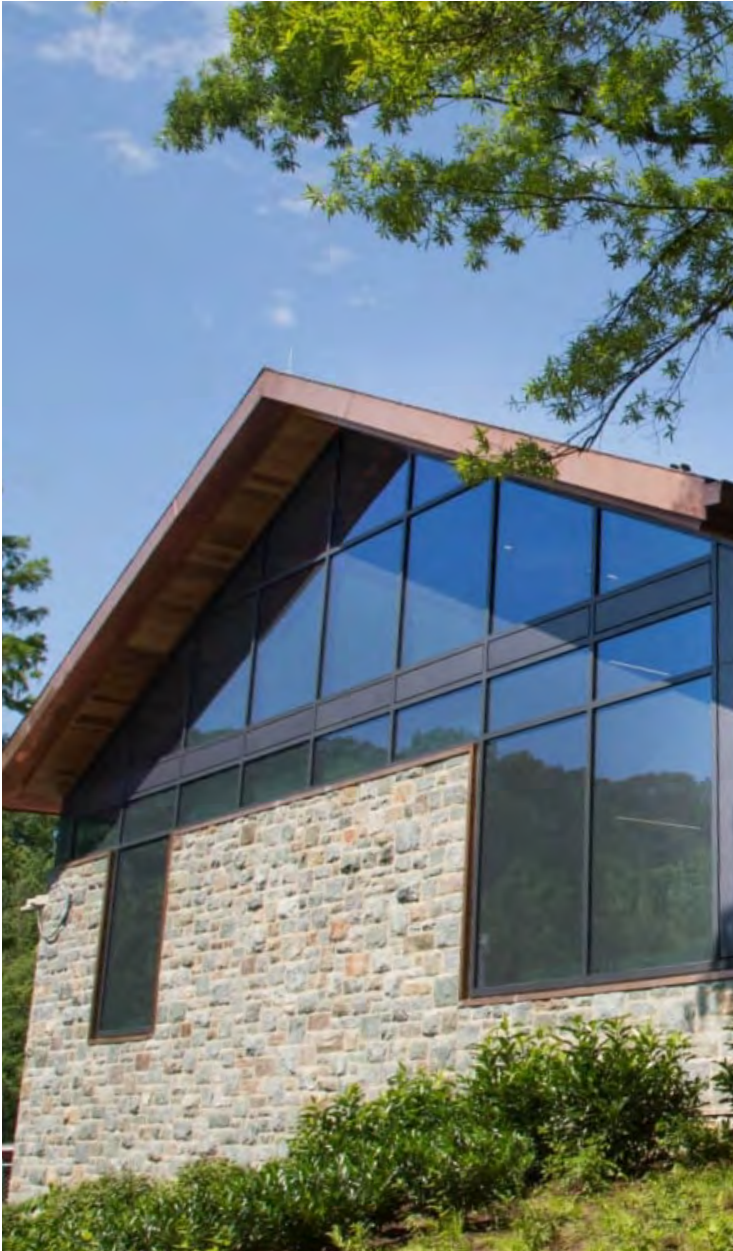
Conservation Pavilion featuring Carderock, ashlar coursing

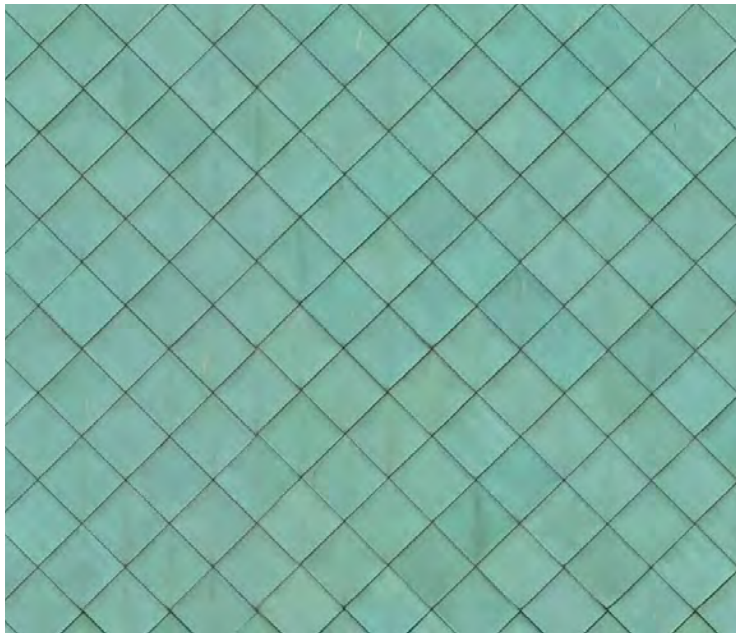
Pre-formed, interlocking, metal roofing is proposed as the preferred material for the project. Specifically, pre-patinated copper shingles in a diamond shape are proposed.

- Its weathered green tones harmonize with the tree canopy, stone, and vegetated roofs in the historic district, allowing the structure to recede into the landscape while maintaining a crafted, expressive presence.
- Diamond pattern geometries introduce a subtle rhythm that unifies the building’s silhouette along Olmsted Walk. The roof’s geometric language transforms a functional surface into an architectural field of light and shadow, echoing terracotta roofs on early Zoo structures such as the Think Tank, Bird House, and Reptile House.
- Basis of Design: Spengler Industries, Pre-Patinated Copper Diamond Shape Shingles, Approximately 12"W by 17"L

Figure 5.2.2.1: Proposed Roof Material - Pre-Patinated Copper Diamond Shape Shingles

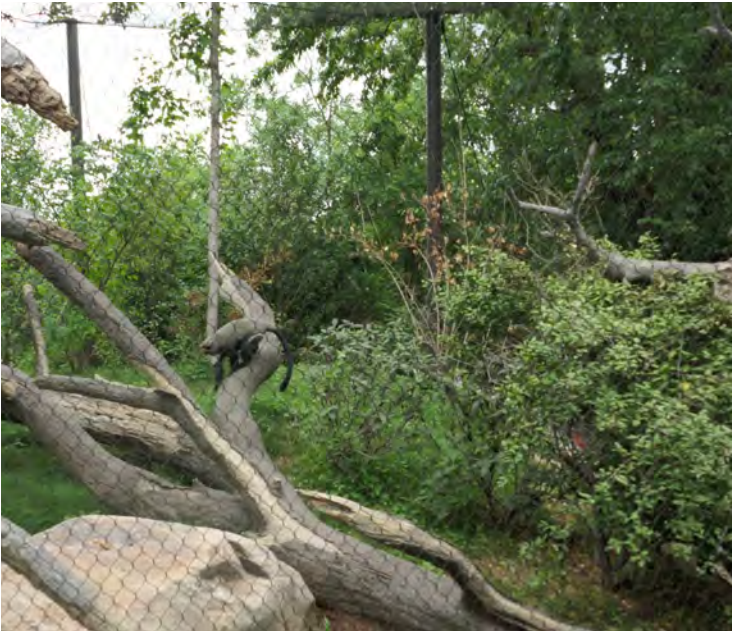
Figure 5.3.2.1: Stainless Steel Black Oxidized Finish Mesh

The enclosure mesh will be hand woven A316 stainless steel mesh. Mesh size is driven by the animal care program requirements and will be 2"x2"x1/8" to ensure the safety of both animal and human.

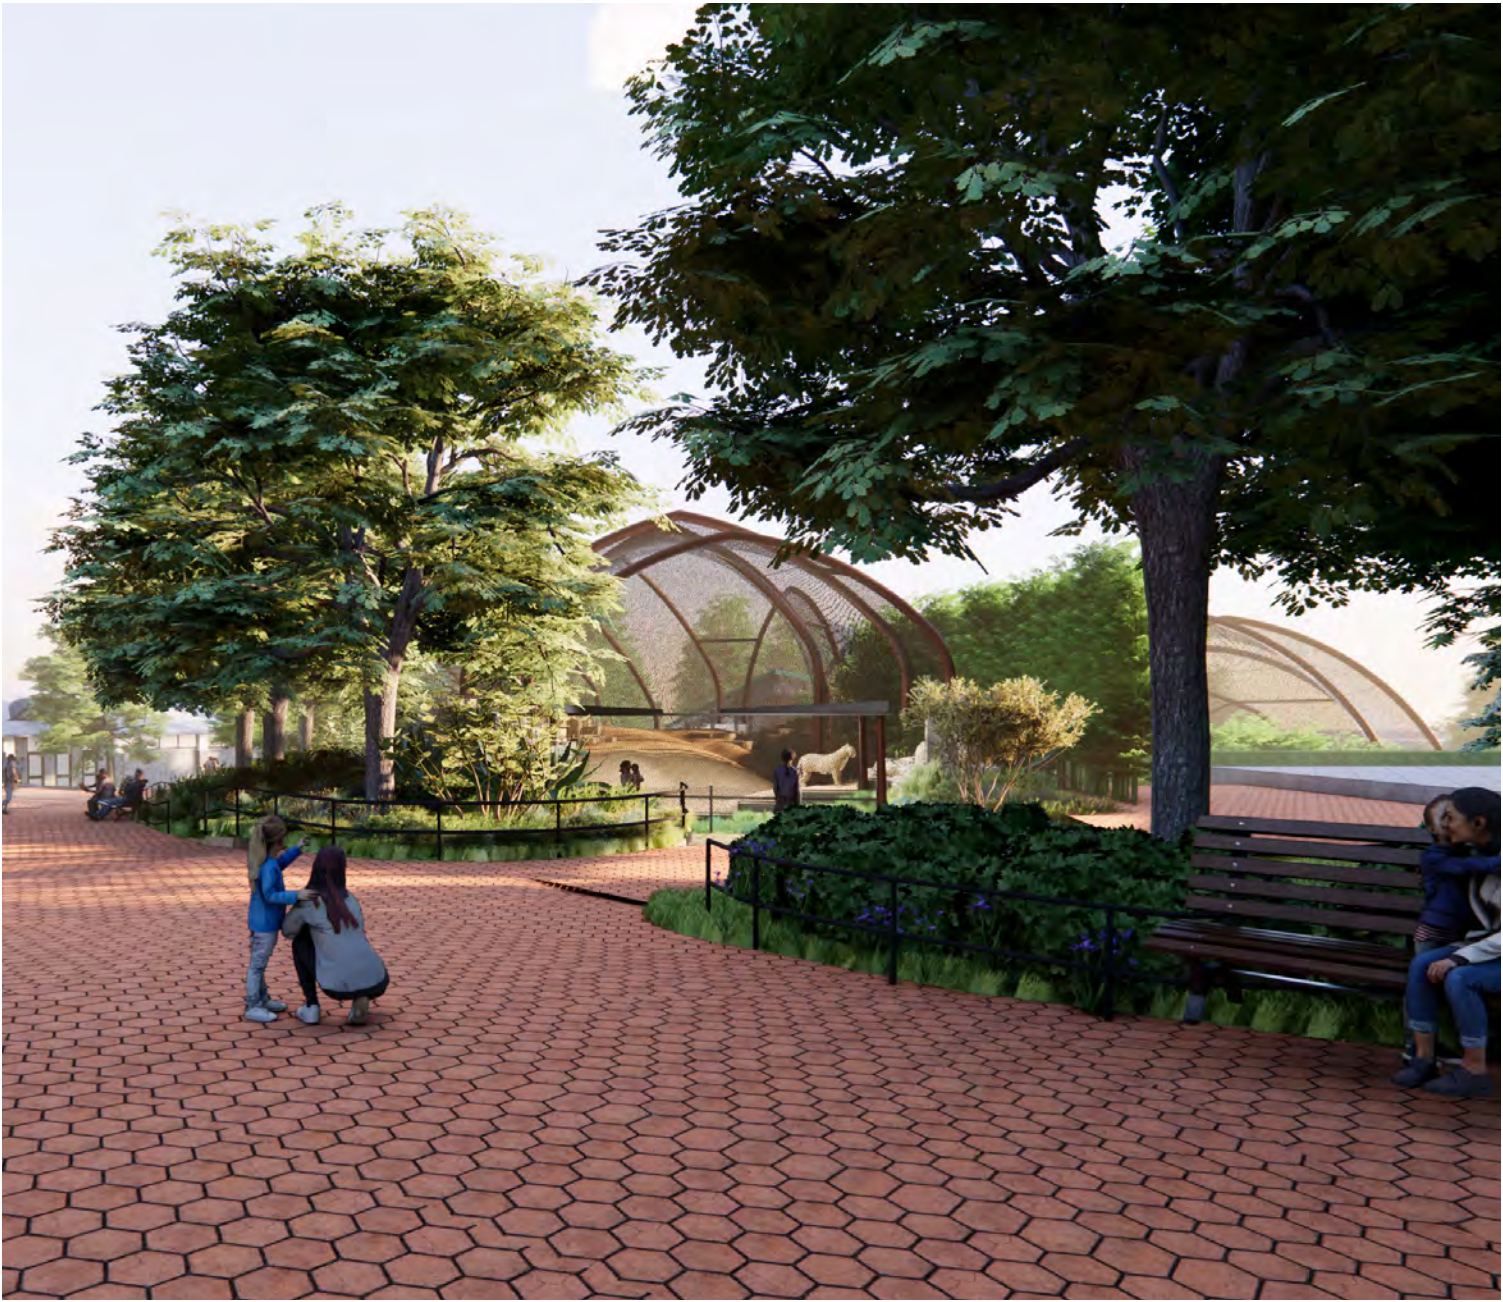
Figure 5.3.2.2: Proposed Enclosure Color Palette: Bronze Arches and Stainless Steel Black Oxidized Finish Mesh

The design team recommends the enclosure arches be colored bronze to allow the arches to disappear into the landscape of the Zoo. This recommendation differs from the prior submission. Upon further study, the bronze color blends into the landscape more to minimize visual clutter from Olmsted Walk. The mesh color proposed is black oxidized as it also falls into the landscape and allows for clear viewing from visitor to animal. Reference 6.3.2 Arched Structure and Color Palette for design studies.

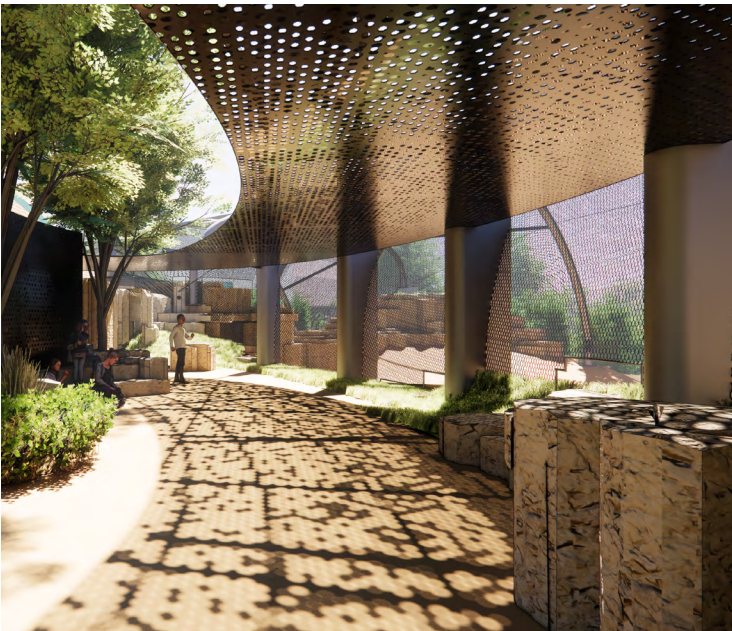
Figure 5.4.1.1: Preliminary Report Submission Shade Structure Preferred Option

In the previous submission, there was a shroud shown encompassing the structural support for both the shade and the enclosure structure as shown in Figure 5.4.1.1. The Commission recommended the project minimize the visual impact of the structures.

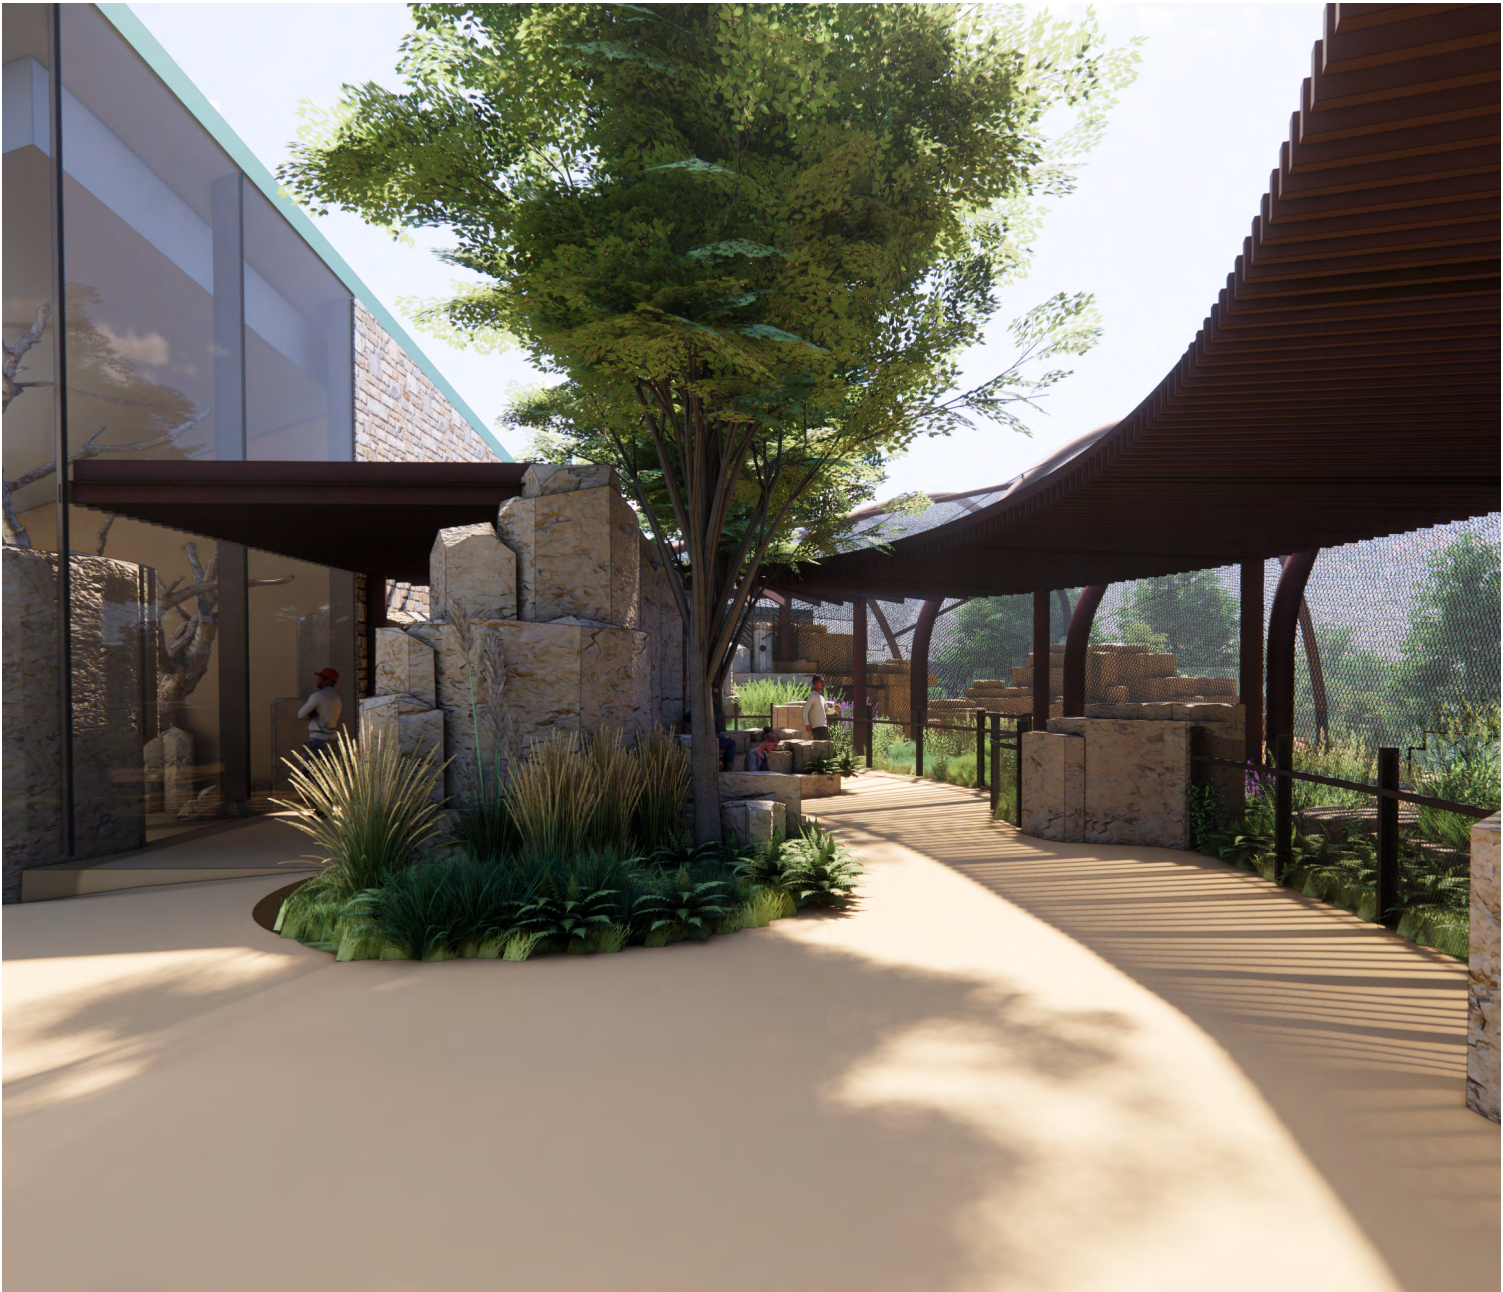
The use of painted metal slats with painted metal vertical supports is proposed for the materiality of the shade structures. Painted metal is currently found within the material palette of the project via painted metal railings that serve as visitor barriers/railings and painted metal arches supporting the enclosure; thus, creating less of a visual impact on the project site by limiting the number of materials within the project material palette.

Figure 5.4.1.2: Revised Shade Structure at Central Plaza - Painted Steel Supports Separated from Painted Steel Arch Supports at Enclosure

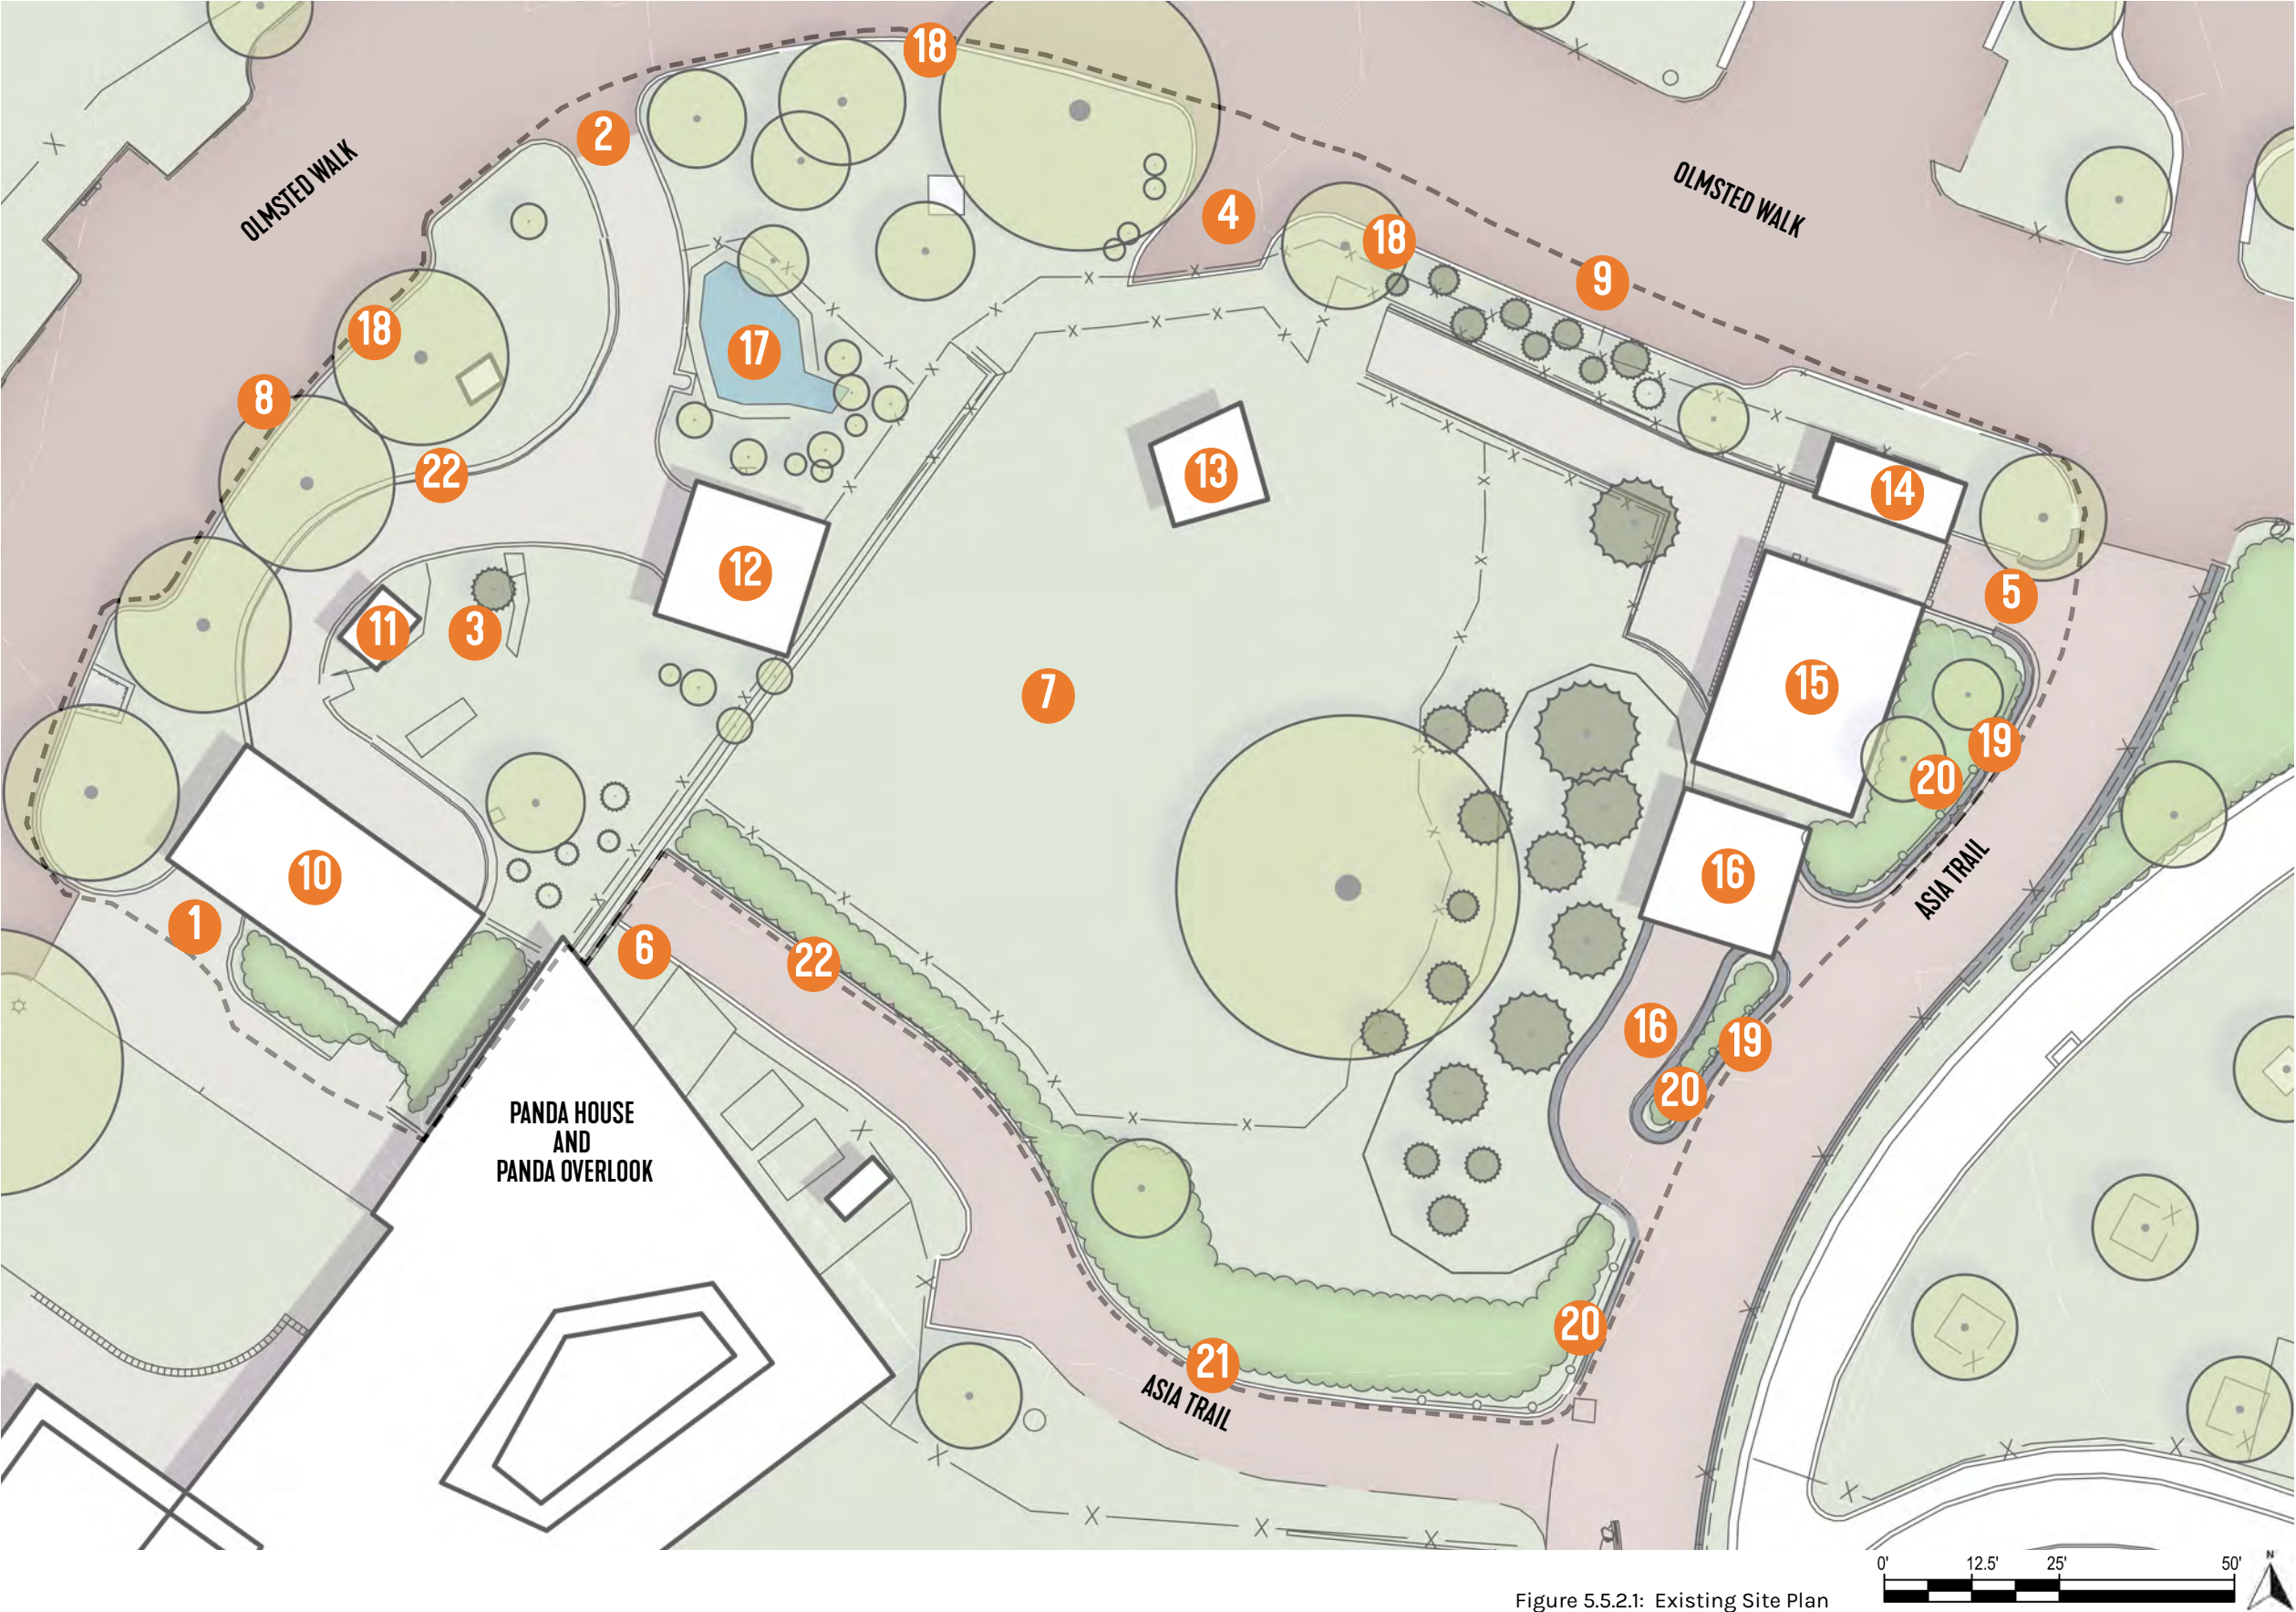
Figure 5.5.2.1: Existing Site Plan

- 1. West Entrance to Zoo in Your Backyard
- 2. Northwest entrance to Zoo in Your Backyard
- 3. Zoo in Your Backyard Exhibit
- 4. Viewing area for American Bison Exhibit
- 5. Service Access for American Bison Exhibit
- 6. Exit from Panda House
- 7. American Bison Yard
- 8. Olmsted Walk Bench Niche with Drinking Fountain
- 9. Vendor Area and Niche
- 10. Vending Shade Structure
- 11. Gazebo
- 12. Bison Overlook Structure
- 13. Bison Habitat Shade Structure
- 14. Bison Care Shed
- 15. Bison Care Building
- 16. Panda Concession Shade Structure and Vending Area
- 17. Pond
- 18. Olmsted Rail & Curb
- 19. Carderock Wall
- 20. Bamboo Arch
- 21. Bamboo Landscape Rail and Curb
- 22. Retaining Wall

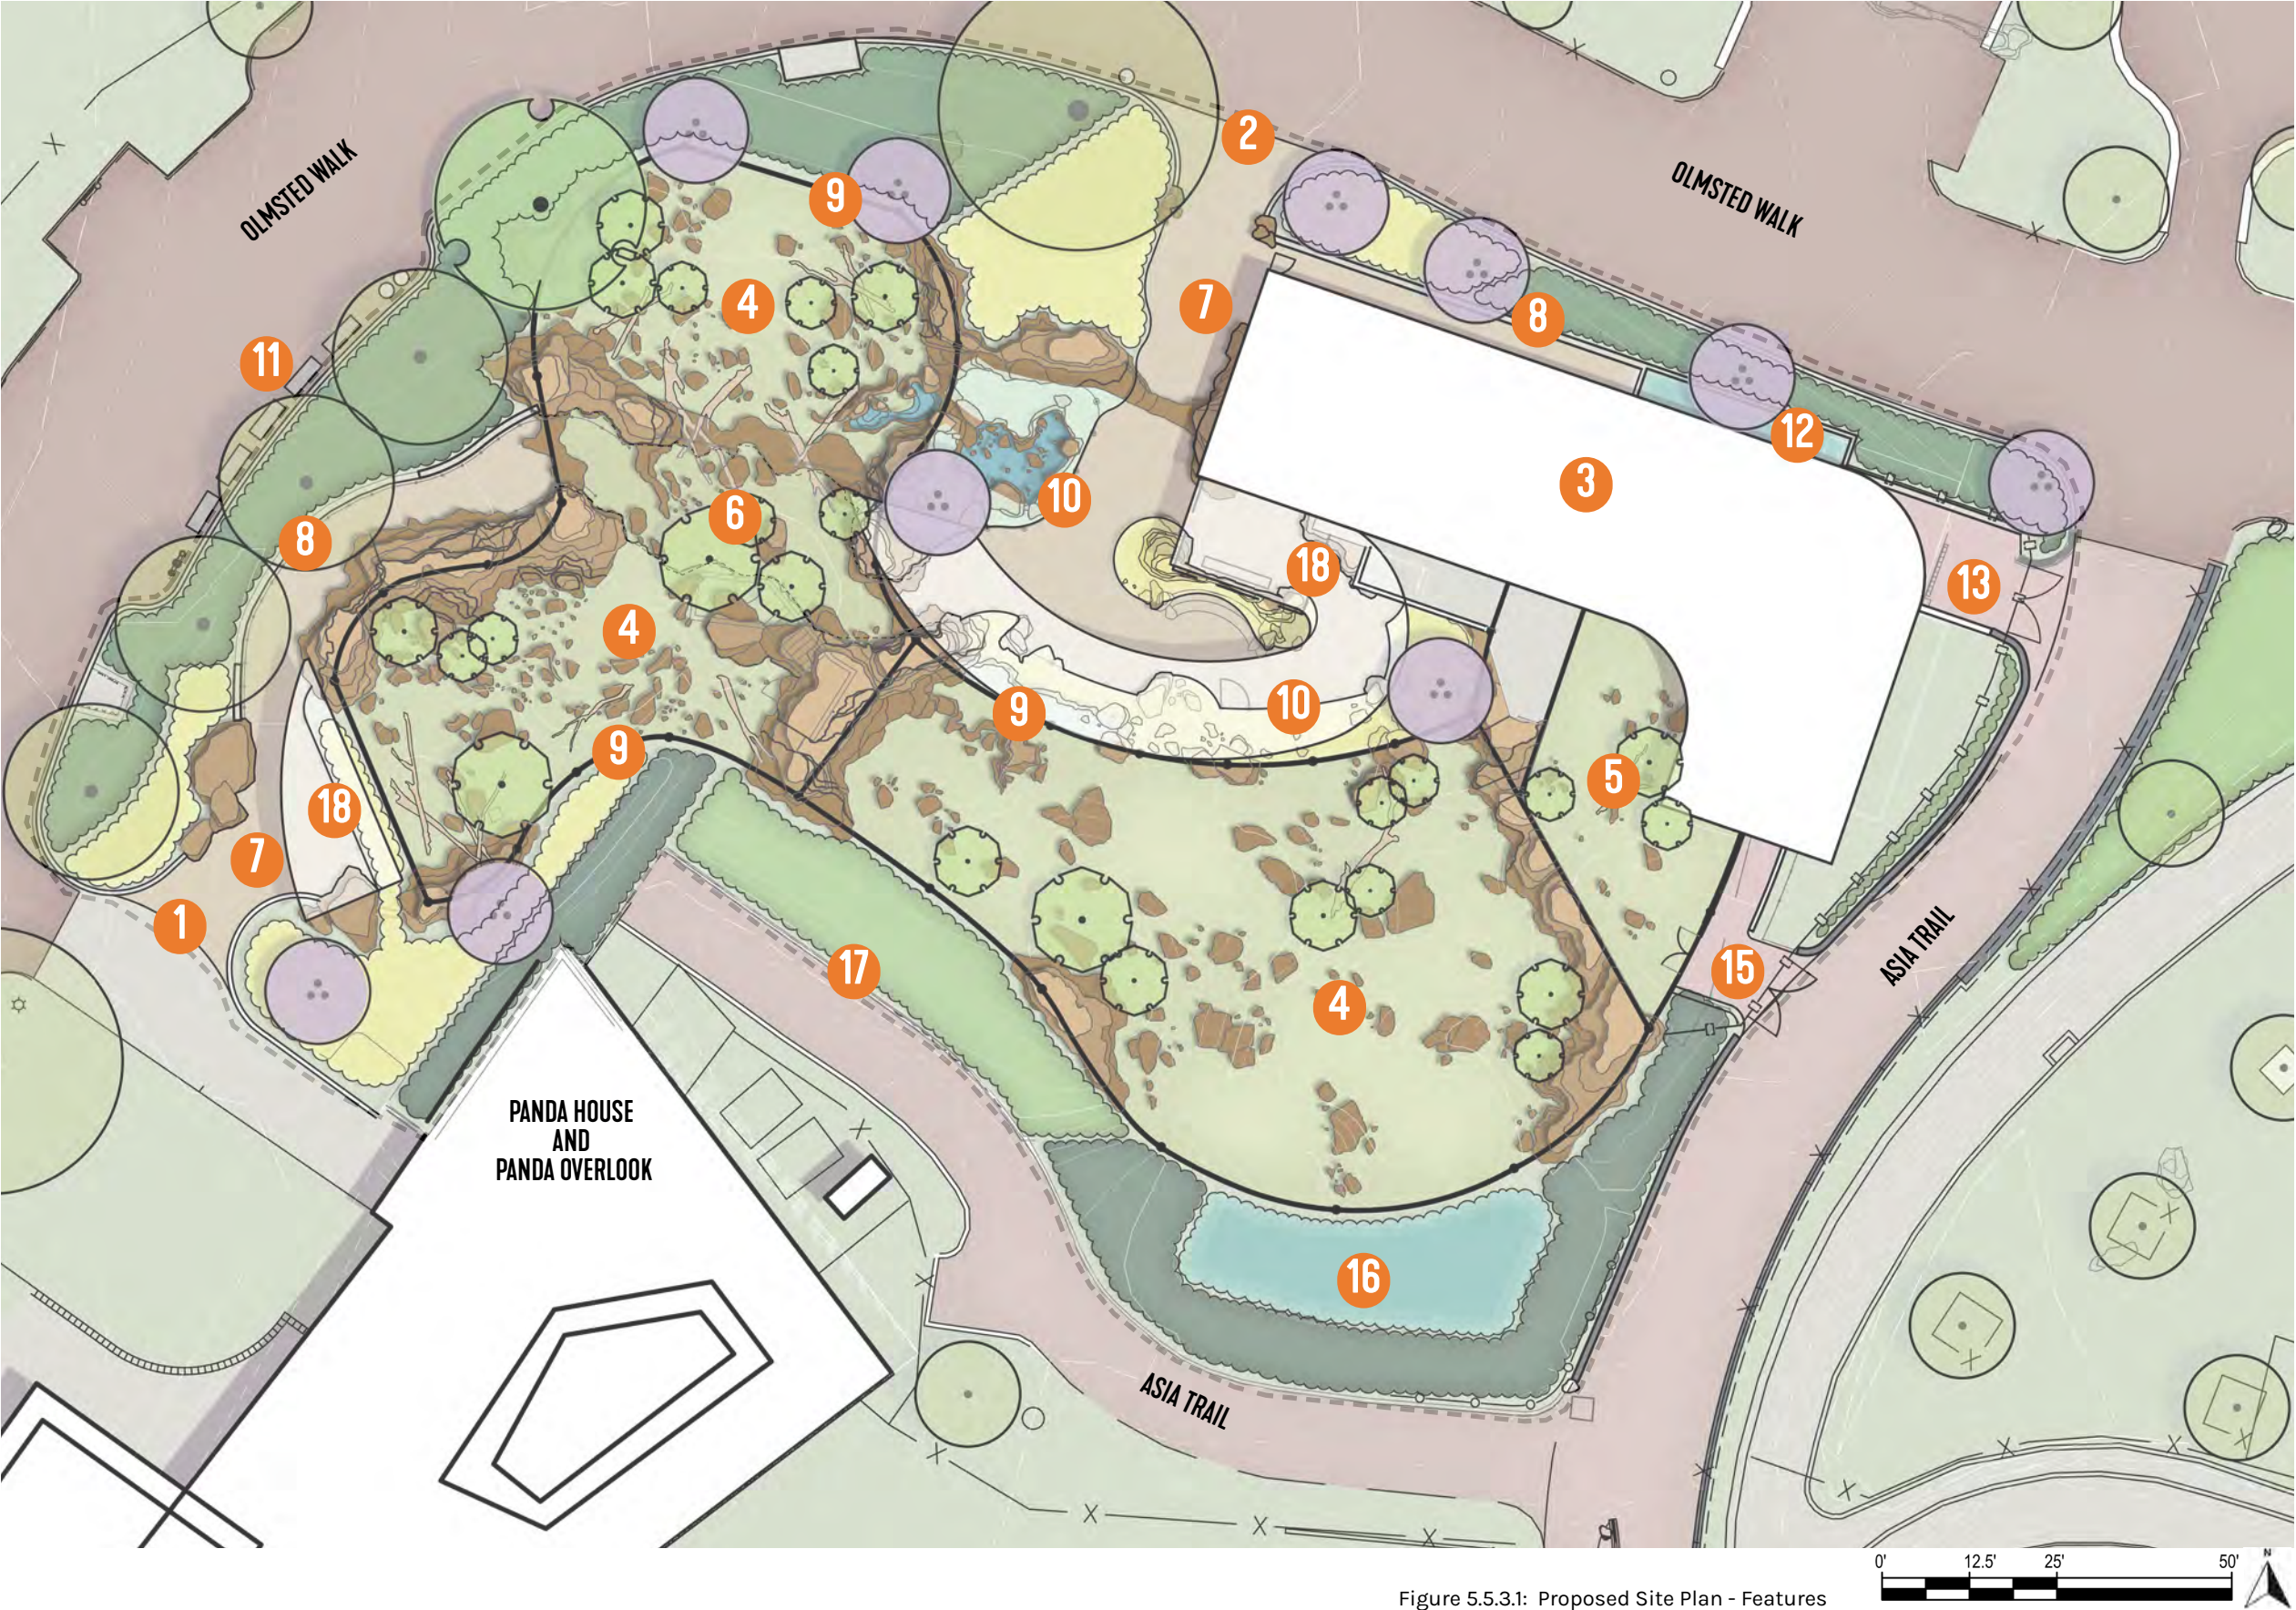
Figure 5.5.3.1: Proposed Site Plan - Features

- 1. West Entrance to Arabian Leopard Exhibit
- 2. North Entrance to Arabian Leopard Exhibit
- 3. New Arabian Leopard Care Building (one-story plus basement)
- 4. New Arabian Leopard Habitat with Custom Faux Rockwork
- 5. New Off-view Arabian Leopard Habitat
- 6. New Pedestrian Tunnel through Exhibit, with Poured-in-place Rubber Surfacing
- 7. New Pedestrian Pathway with Exposed Aggregate Concrete Pavement
- 8. New Retaining Wall
- 9. New Habitat Enclosure
- 10. New guardrail
- 11. Existing Benches and Niche to Remain
- 12. New Urban Planter
- 13. New Service Access, Existing Curb Cut and Service Access
- 14. New Screen Fence
- 15. New Service Access, Existing Curb Cut
- 16. New Bioretention
- 17. Existing Retaining Wall
- 18. Shade Structure

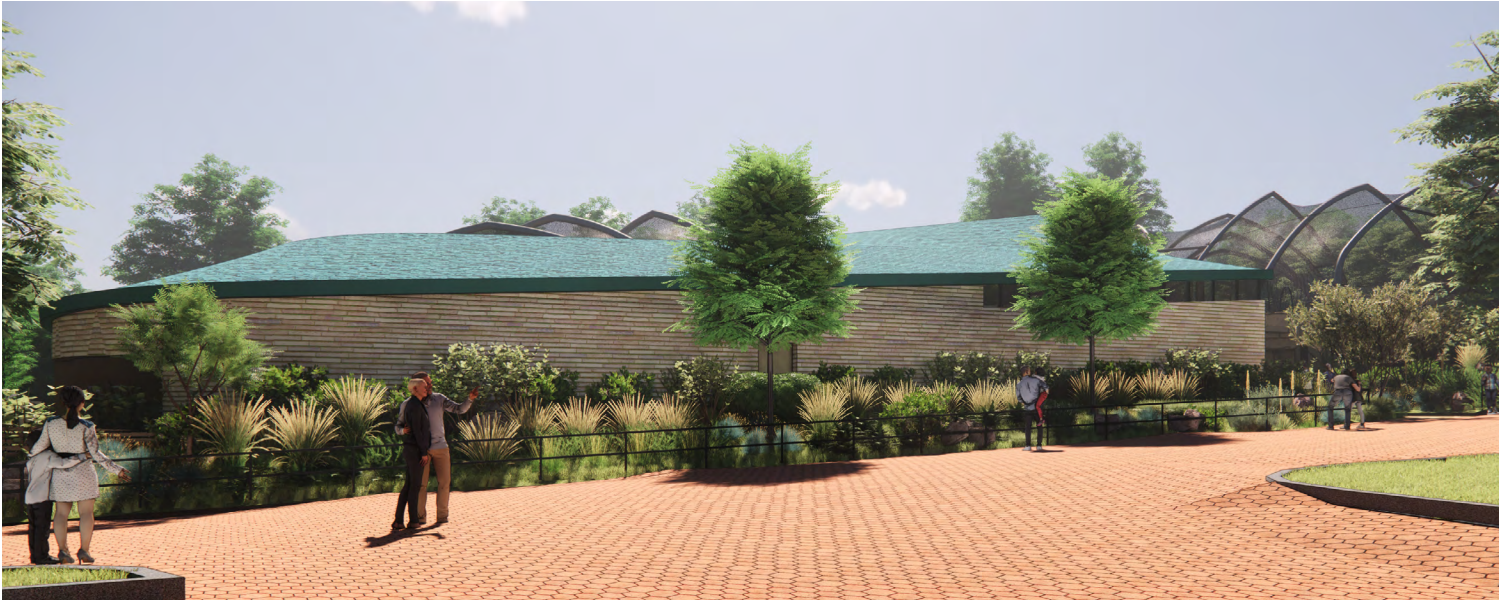
Figure 5.6.1.1: Preliminary Roof Profile

the geometry of the roof to mitigate visual impact. See 6.2 Animal Care Building and Animal Habitat Refinement for additional information on proposed options during the Section 106 process.

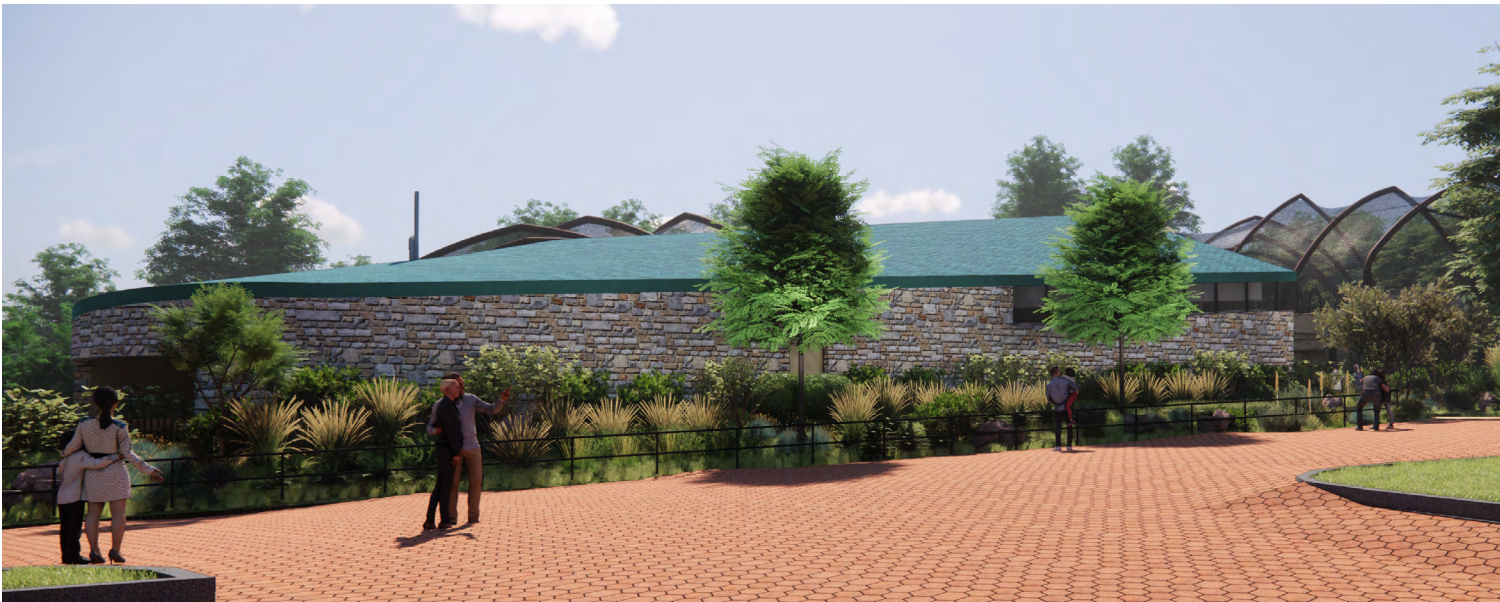
Figure 5.6.1.2: Final Roof Profile

The contiguous shed roof was the preferred option as it appeared too flattened when viewed from Olmsted Walk, referencing the low slope roofs prevalent in the historic district. See Figure 5.6.1.2 for reference.
