CONSTRUCT ARABIAN LEOPARD HABITAT  
NCPC FINAL REPORT

SMITHSONIAN PROJECT CODE: 2533105

SEPTEMBER 3, 2026

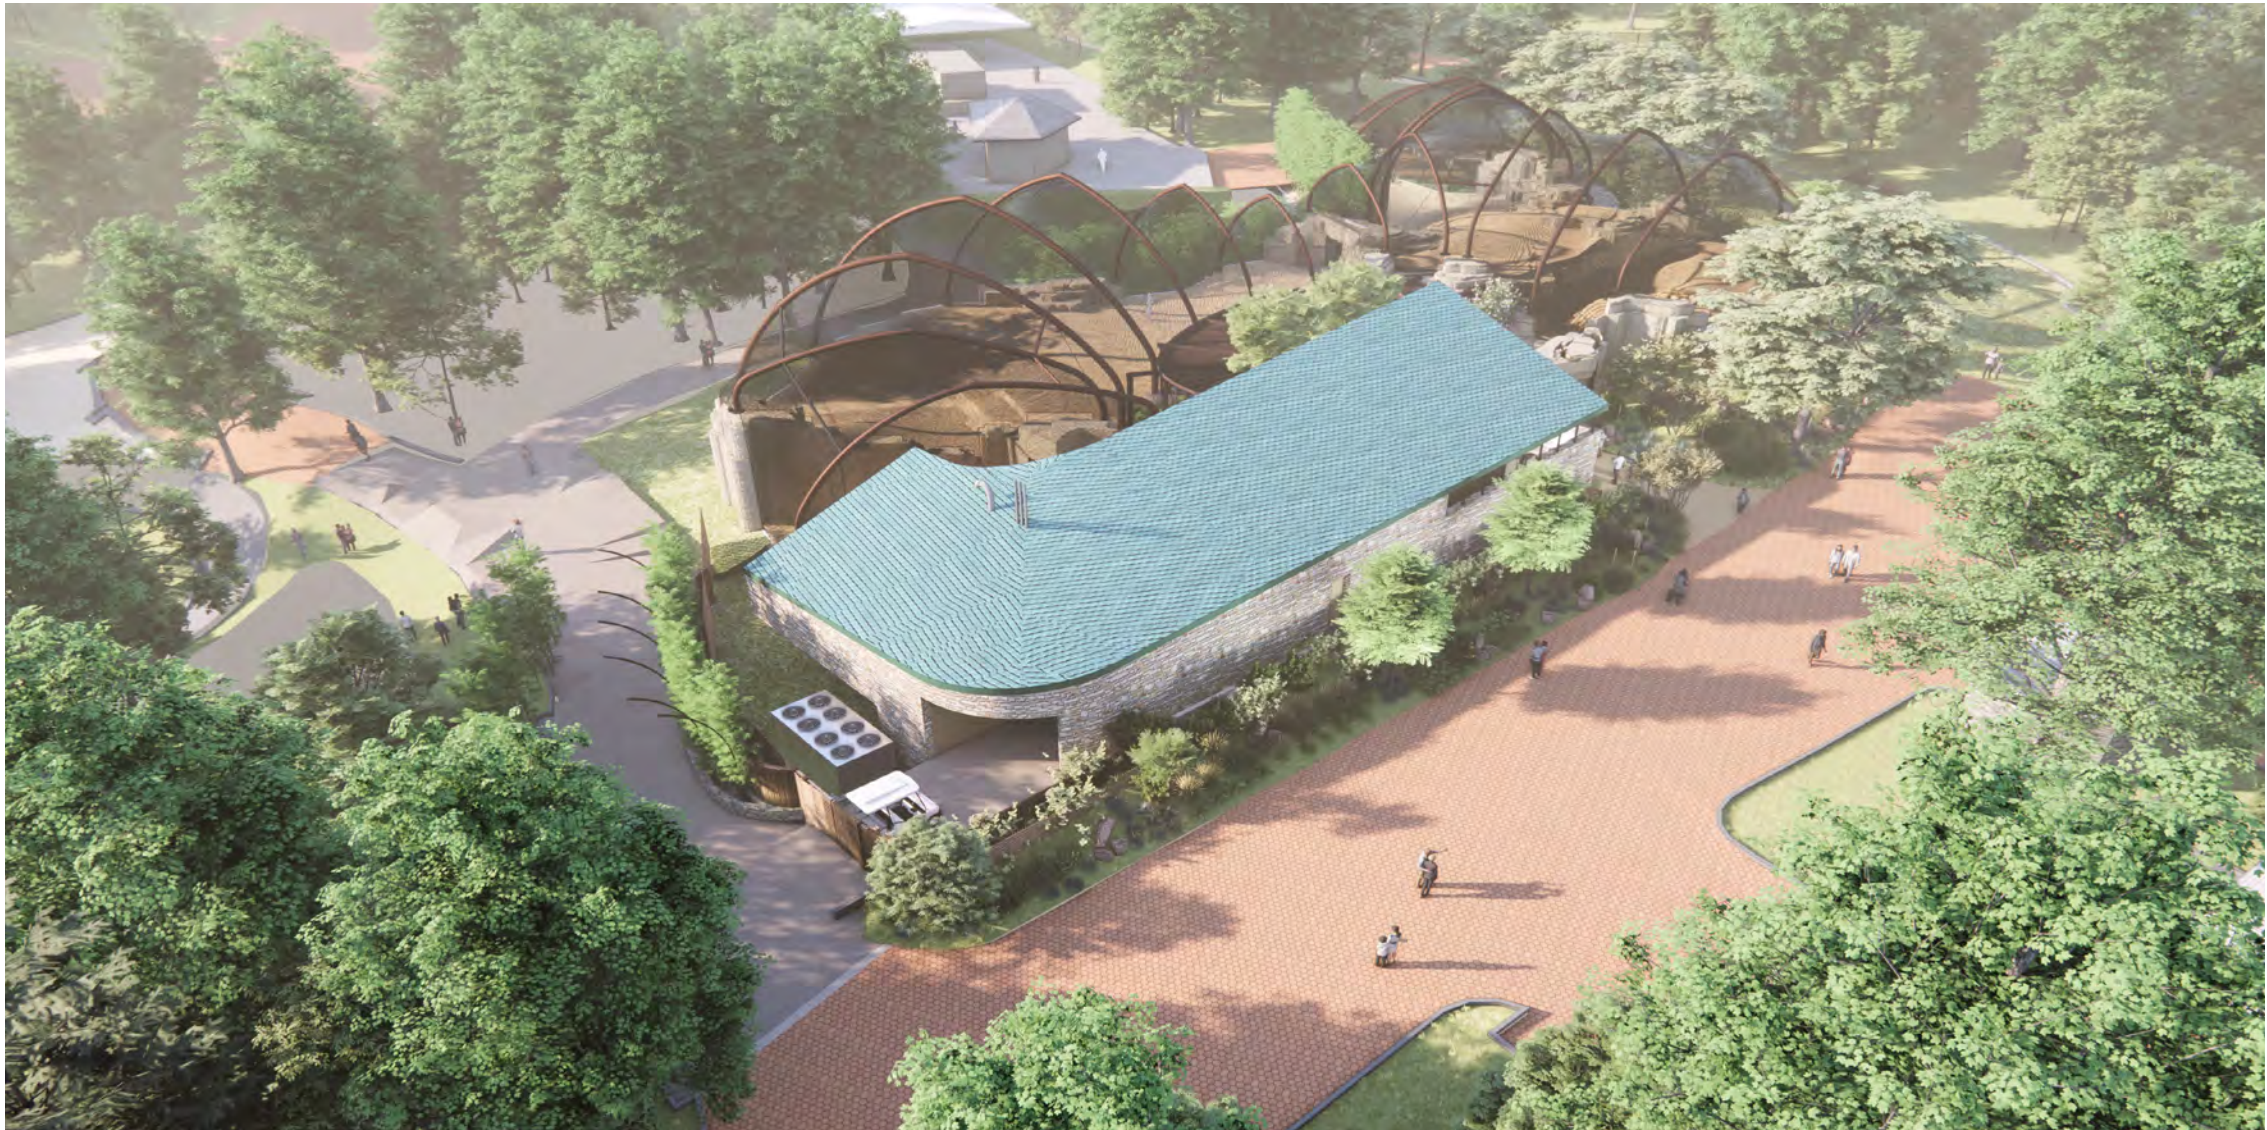
Figure 5.7.1.1: Final Enclosure Design

In this configuration, the primary structure is located entirely at the perimeter, eliminating internal supports and maintaining clear sight-lines through the habitat. Placing the primary structure at the perimeter provides the greatest flexibility for future adjustments to climbing structures and the habitats to support changing animal care requirements. The superstructure presents a sculptural profile along Olmsted Walk maintaining no more than 35 feet above grade at any given point to reduce visual impacts. The arch shape can be found within the historic district used as an entry gateway into contributing historic buildings.

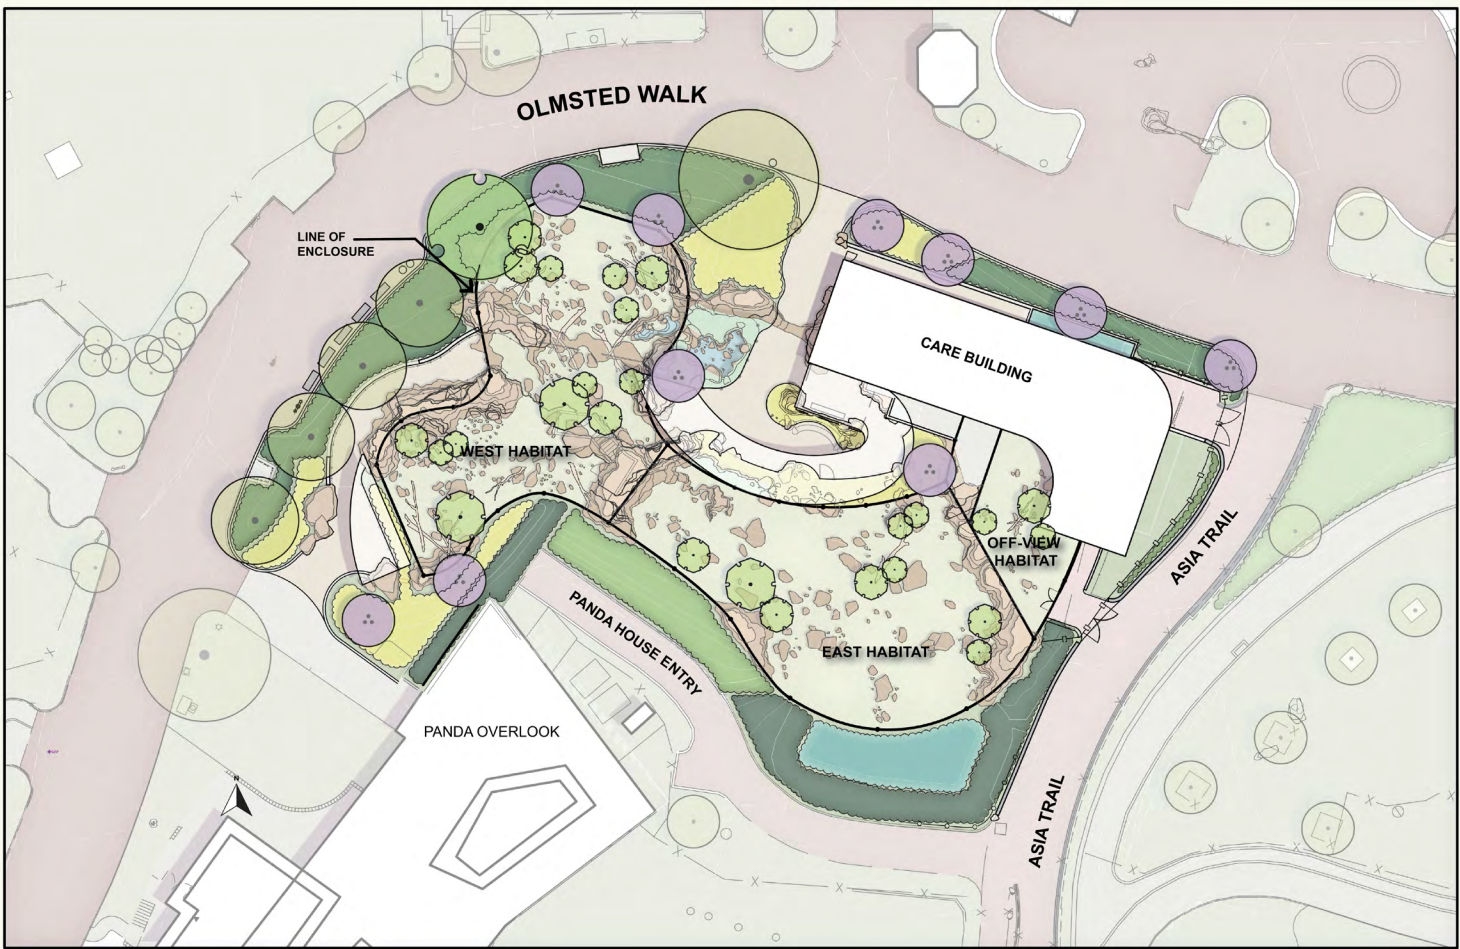
Figure 5.8.1.1: Proposed Planting Plan

If existing topsoil depth is sufficient, then amendments can be tilled into existing soil to create the top horizon of the amended soil layer.

Imported horticultural soils will be used to form new plant beds as needed for areas along the site perimeter walks.

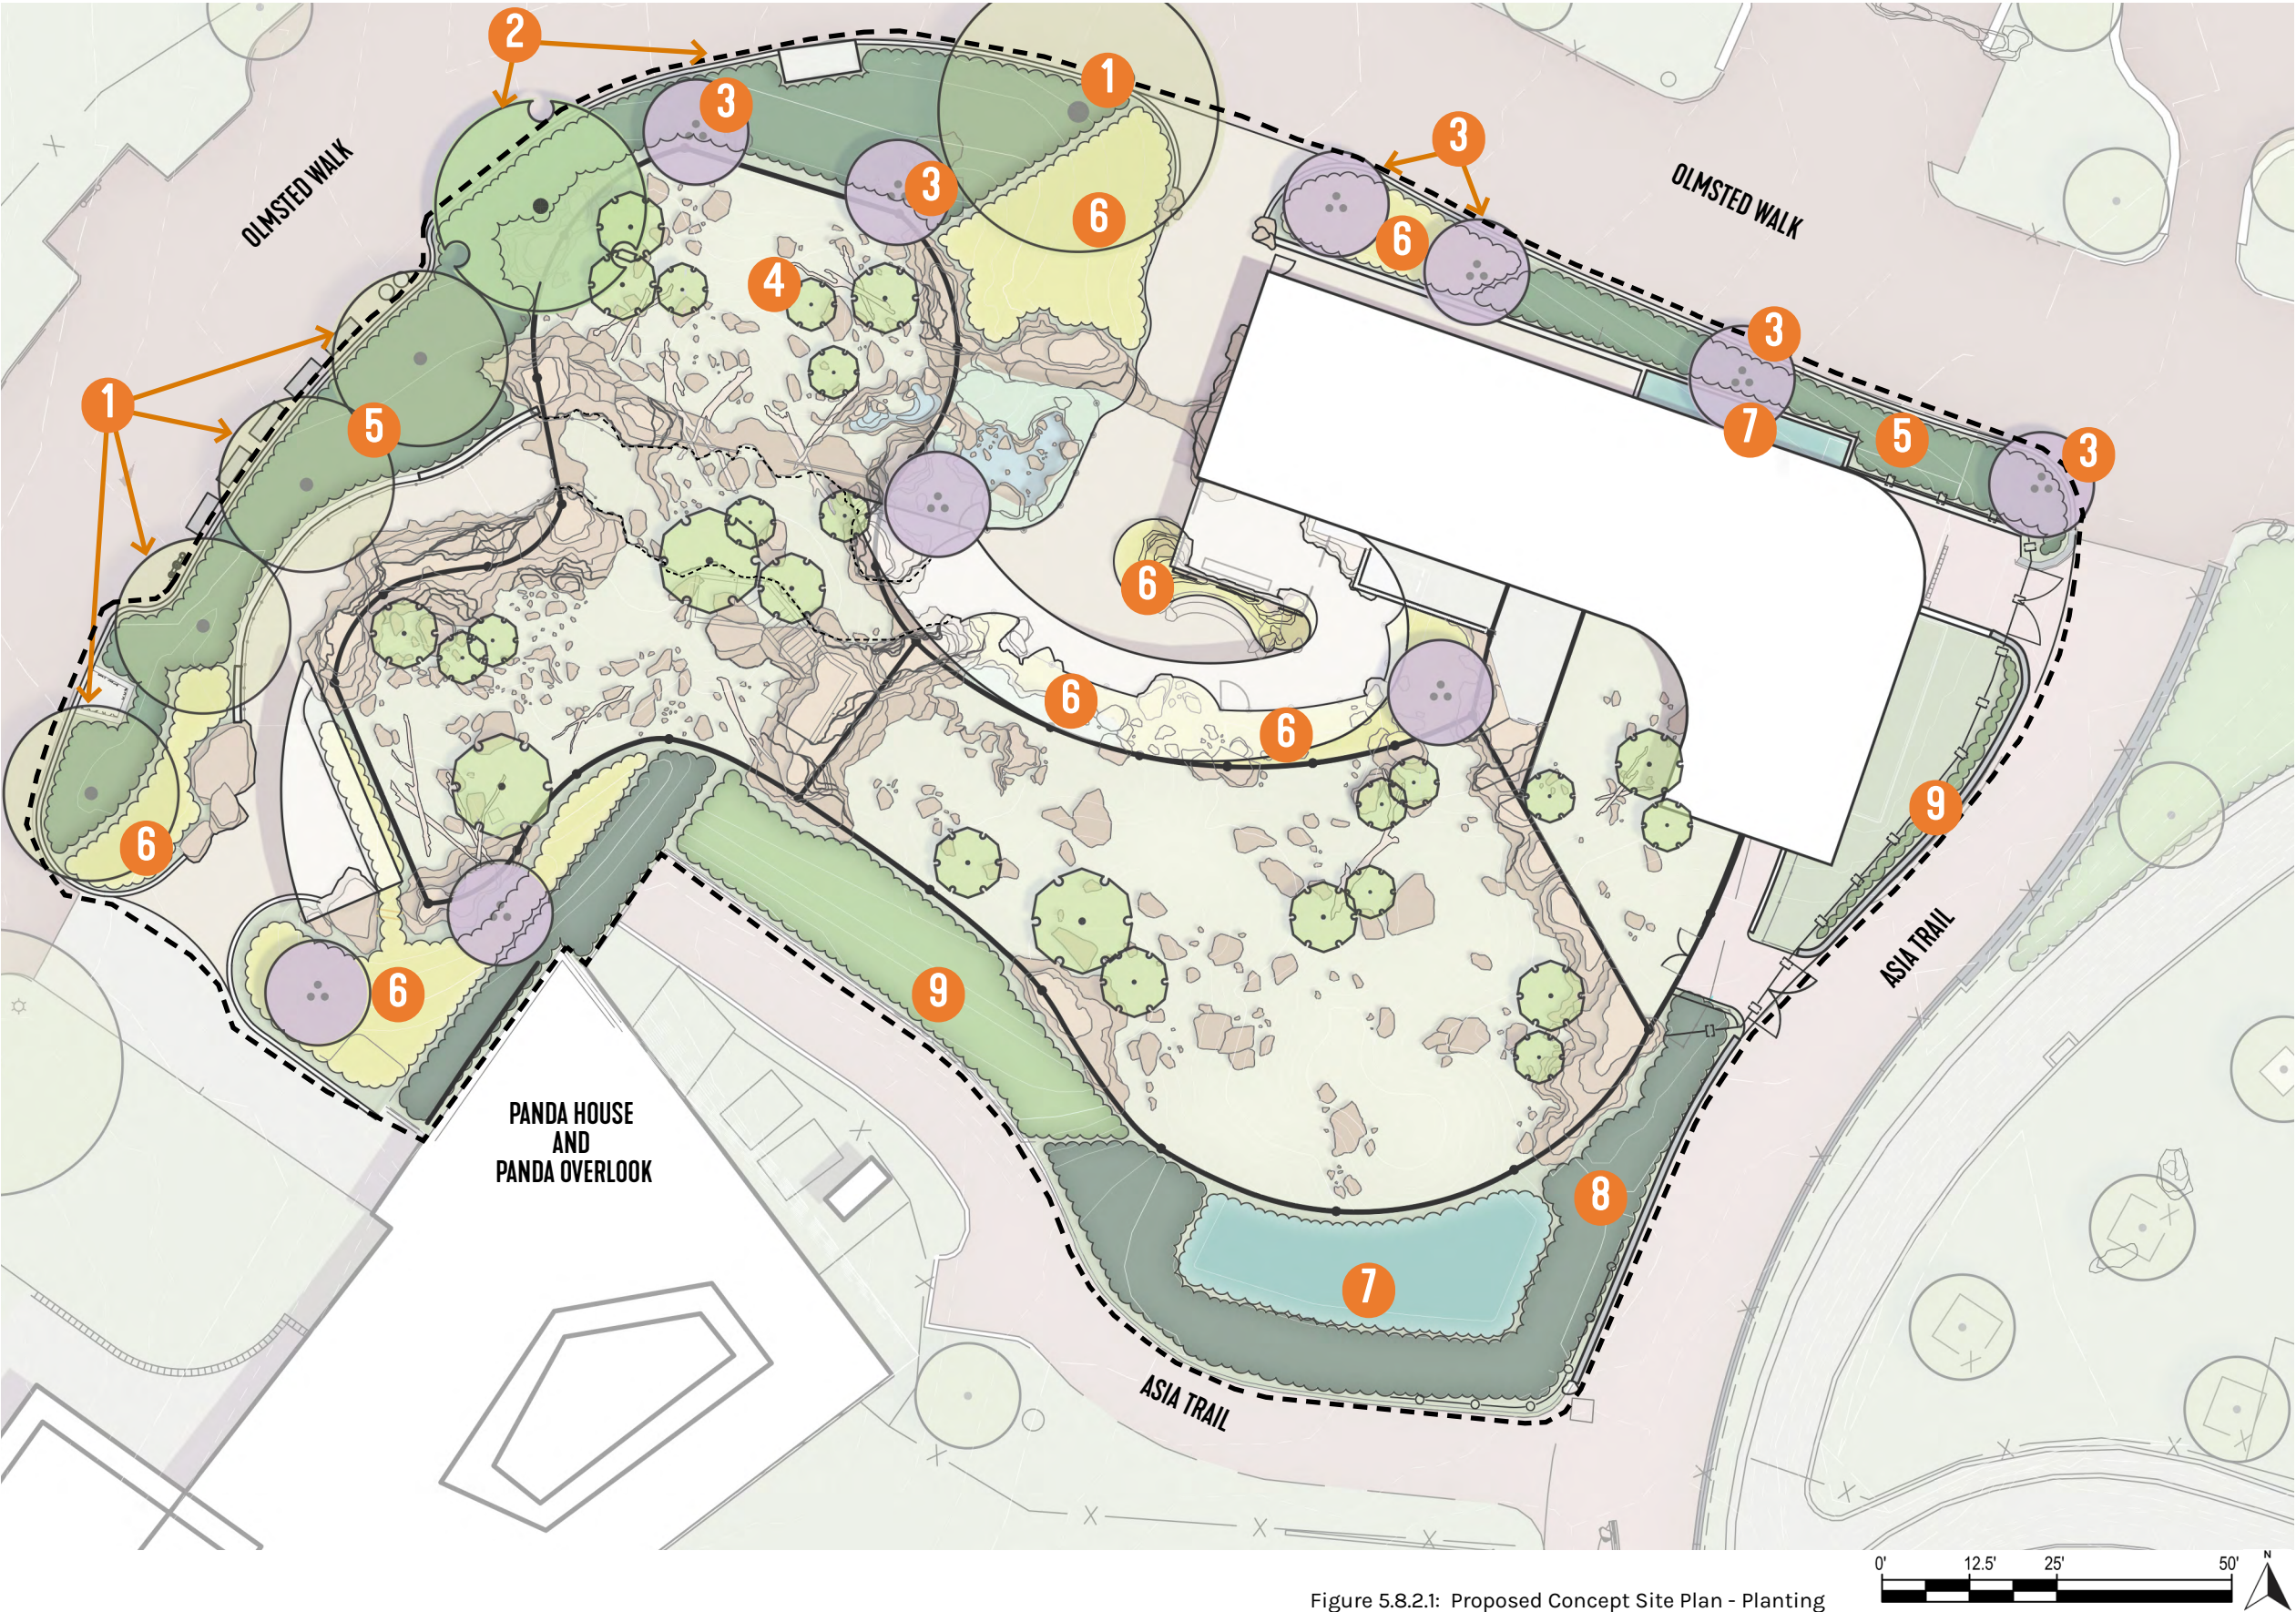
Figure 5.8.2.1: Proposed Concept Site Plan - Planting

- 1. Existing Tree to Remain
- 2. New Canopy Tree
- 3. New Understory Tree
- 4. New Habitat Tree
- 5. Olmsted Walk Planting Palette
- 6. Wadi and Oasis Planting Palettes
- 7. Bioretention Planting Palette
- 8. Asia Trail Planting Palette
- 9. Bamboo

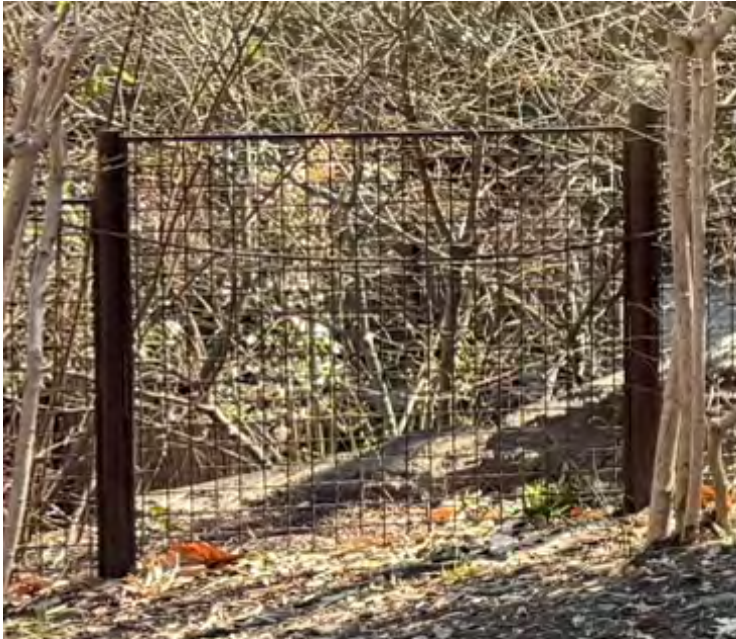
Secondary Pedestrian Rail (42”H)

The Secondary Pedestrian Rail is in isolated locations and setback from the Olmsted Rail. It will incorporate infill panels of 2-inch by 2-inch mesh to ensure visitor safety creating a secure physical barrier adjacent to the animal enclosure. Per Zoo standards and safety protocols, a human can never get closer than 6 feet to a leopard where there is perforated barrier. Use of the Secondary Pedestrian Barrier ensures a continuous barrier is provided and maintains the Olmsted Barrier currently utilized throughout Olmsted Walk.

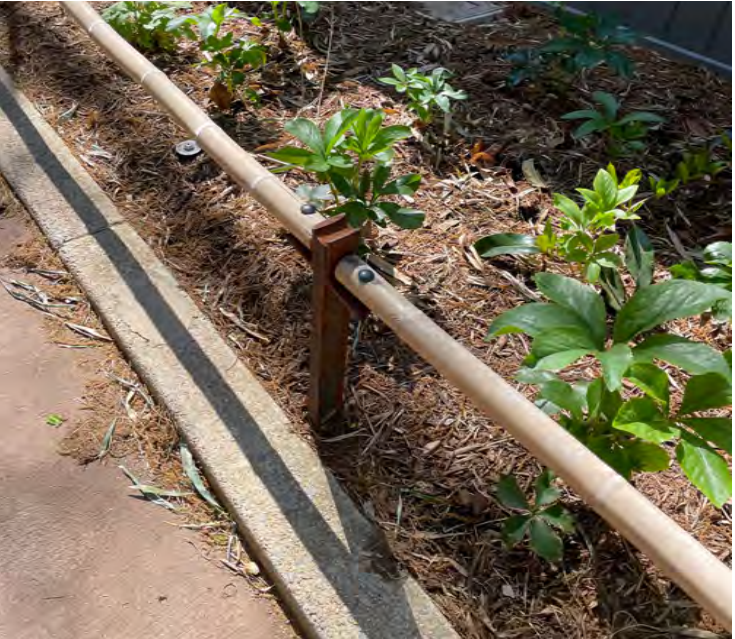
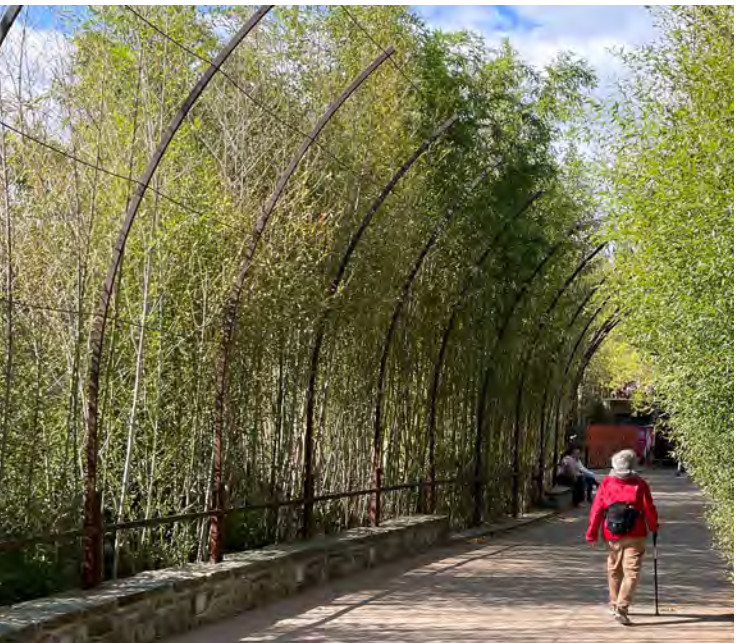
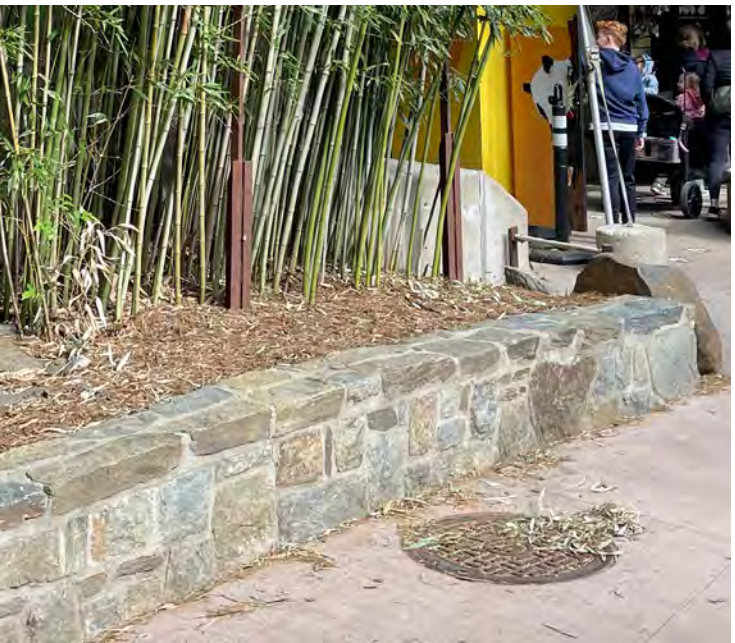
Along Asia Trail, the established design vocabulary will be maintained or restored through the continued use of Carderock walls, bamboo landscape railings, and bamboo arch elements. Ornamental screening fencing constructed of vertical metal panels is proposed at the loading dock, mechanical enclosure, and the east exhibit access point to provide appropriate visual screening while remaining consistent with the broader design context.

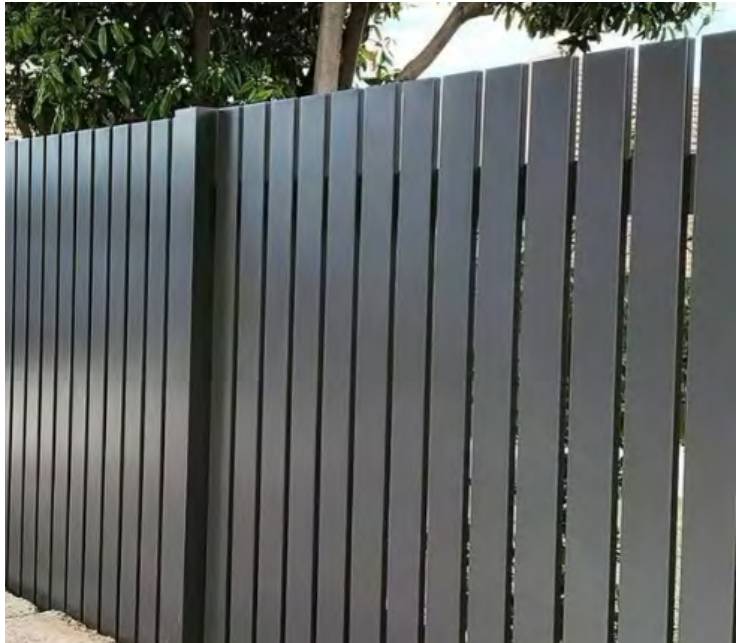
Screen Fence

Existing railing types along the Asia Trail will be retained or replaced in kind to preserve the established character. Additionally, a metal panel screen fence will be used at the service access, around the mechanical enclosure, and along the east habitat access.

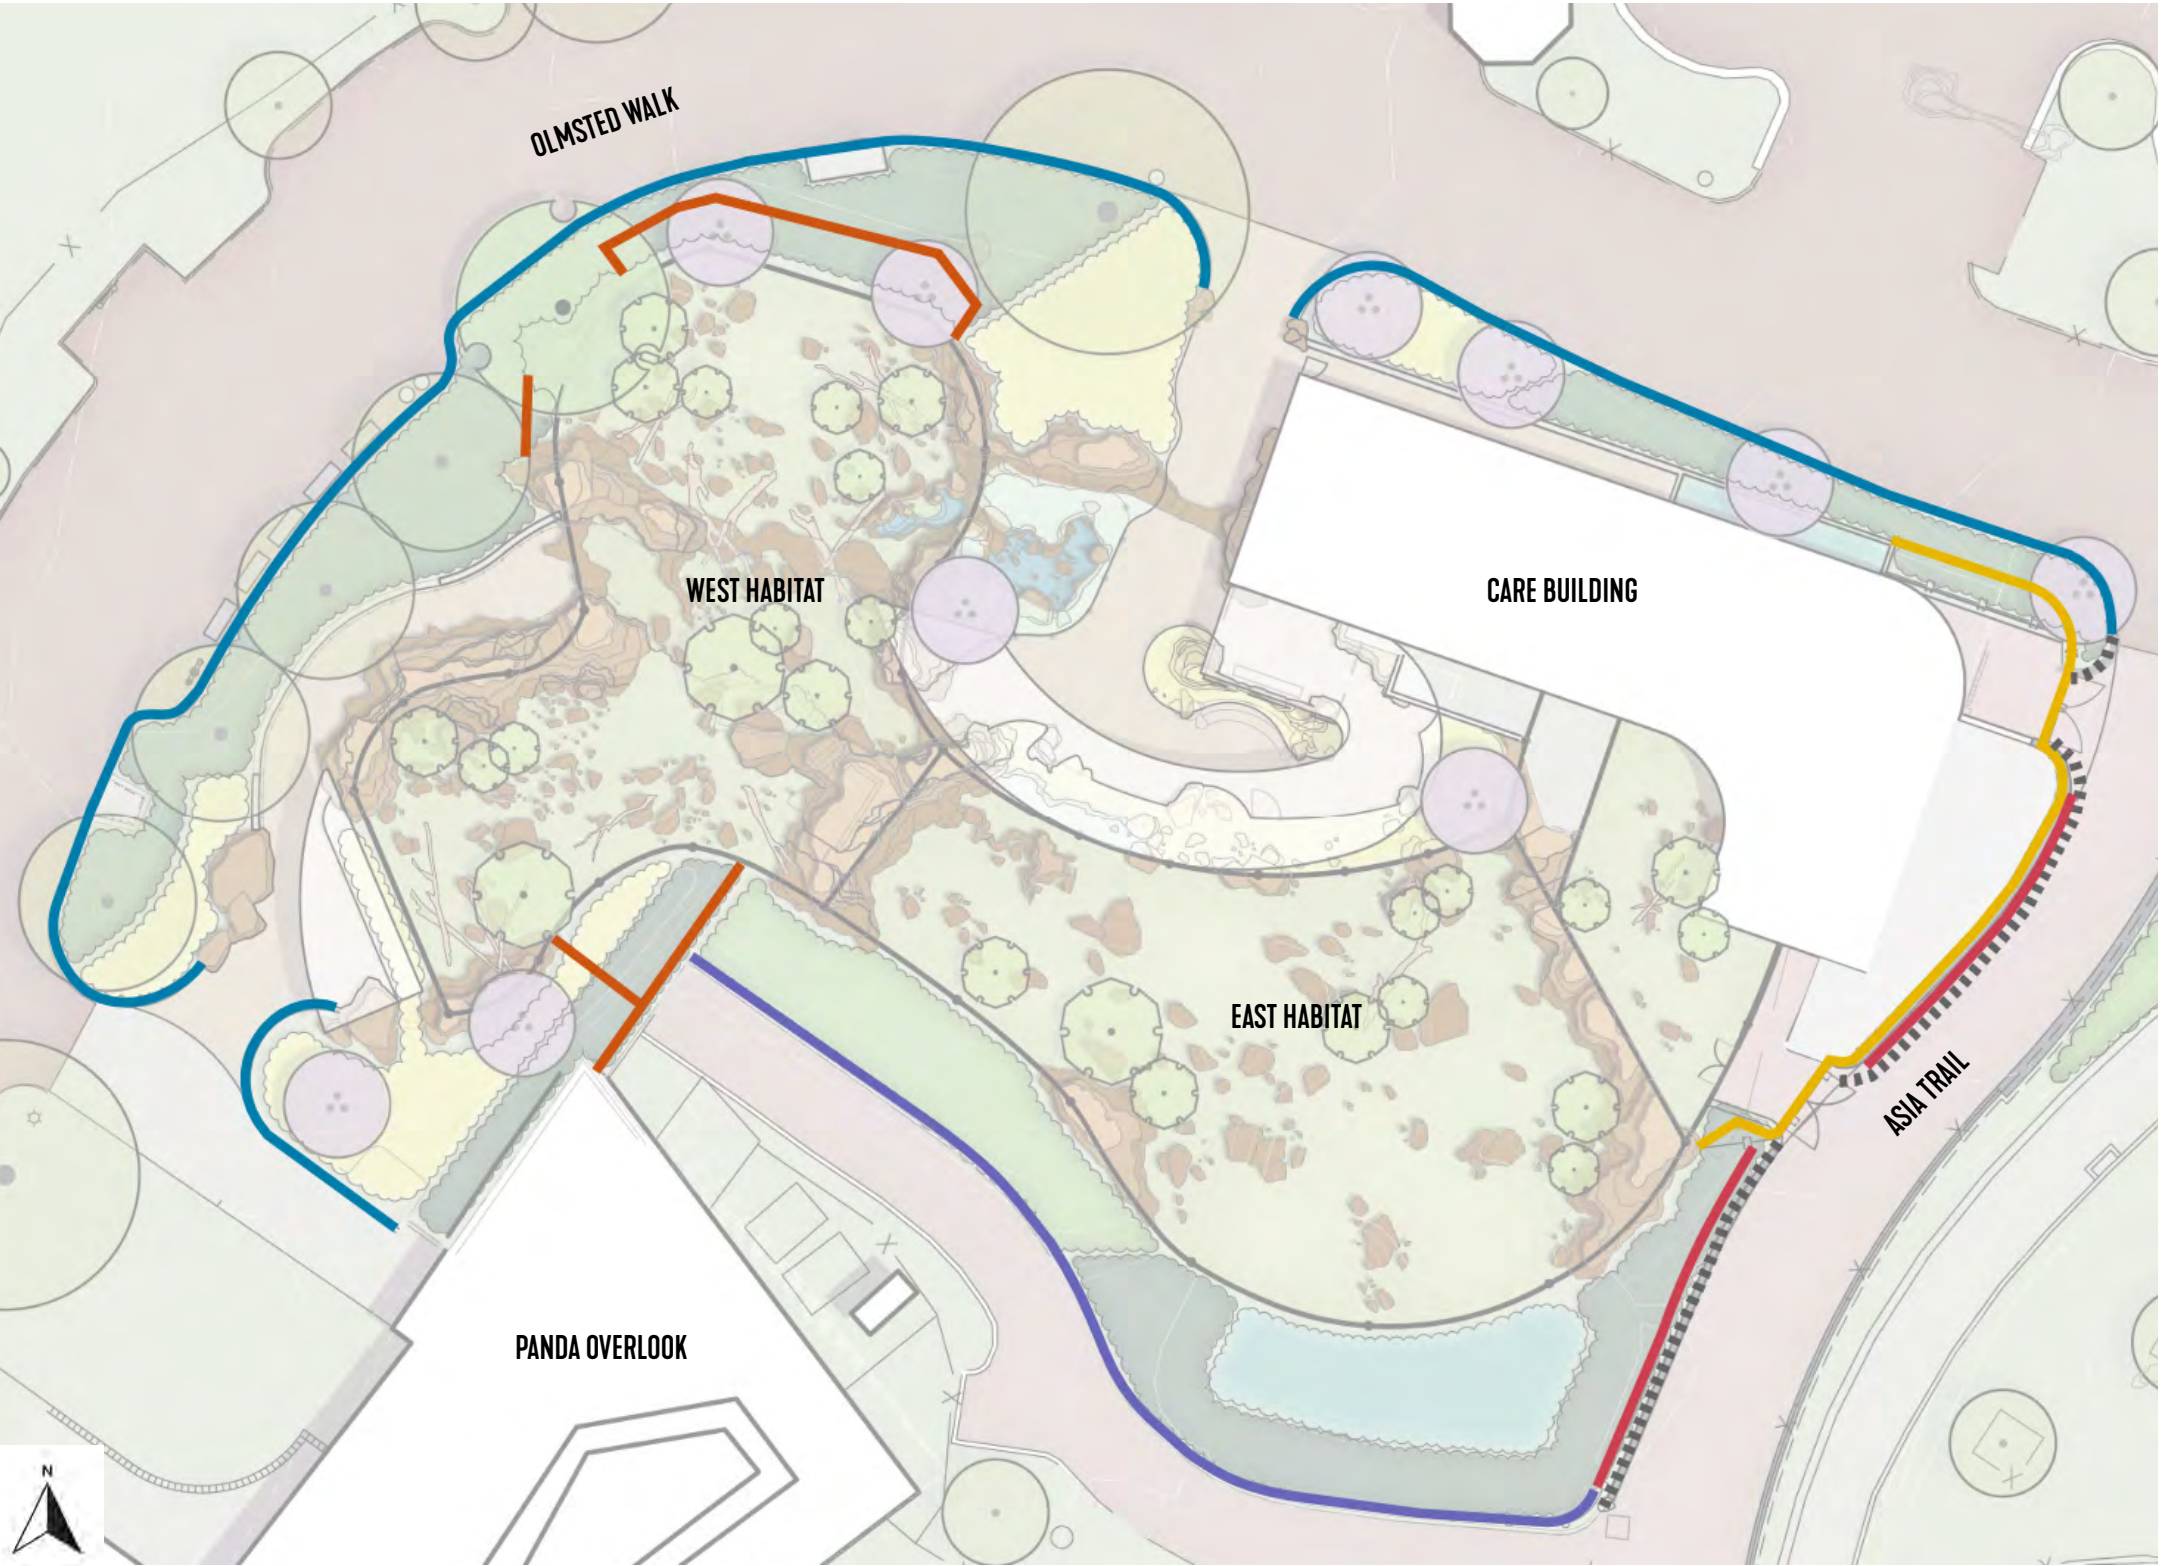
Figure 5.8.10.1: Site Plan - Railing Type Location Diagram

- SECONDARY PEDESTRIAN BARRIER (42" H)
- OLMSTED RAIL (36" H)
- BAMBOO LANDSCAPE RAIL
- BAMBOO ARCH
- SCREEN FENCE
- CARDEROCK WALL

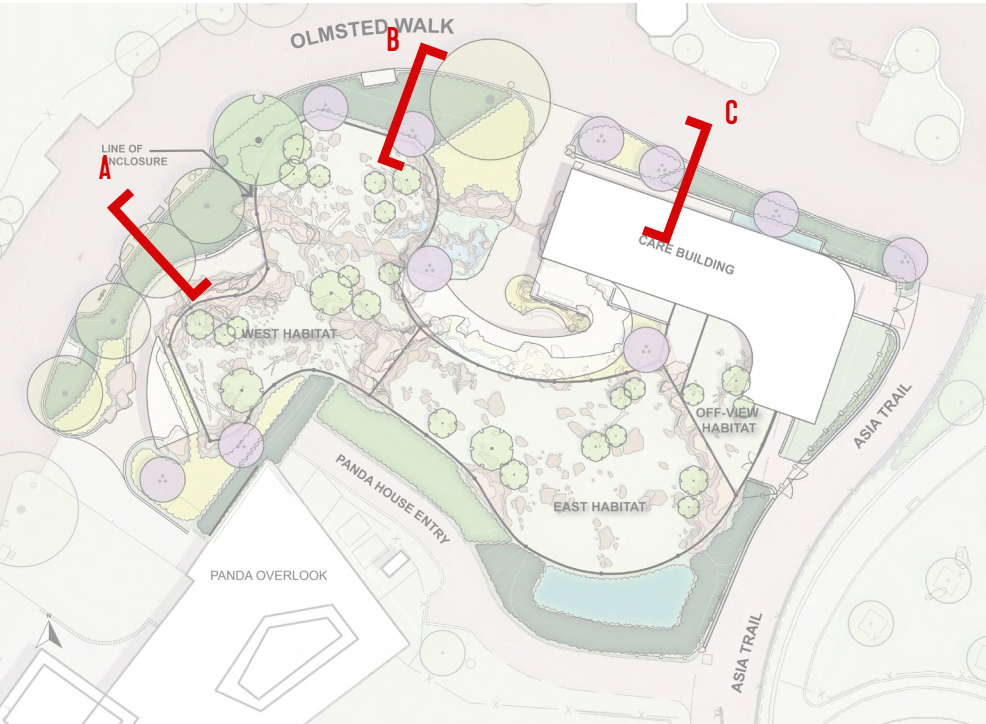
Figure 5.8.12.1: Planting Plan Key Plan - Berm Locations

To integrate the exhibit and building design with the landscape along Olmsted Walk, strategic berms - up to 4 feet tall - and careful plant selection will ground the building in the landscape and soften background views of the exhibition. This will ensure that visitors have a consistent experience as they travel along Olmsted Walk from nearby exhibits.

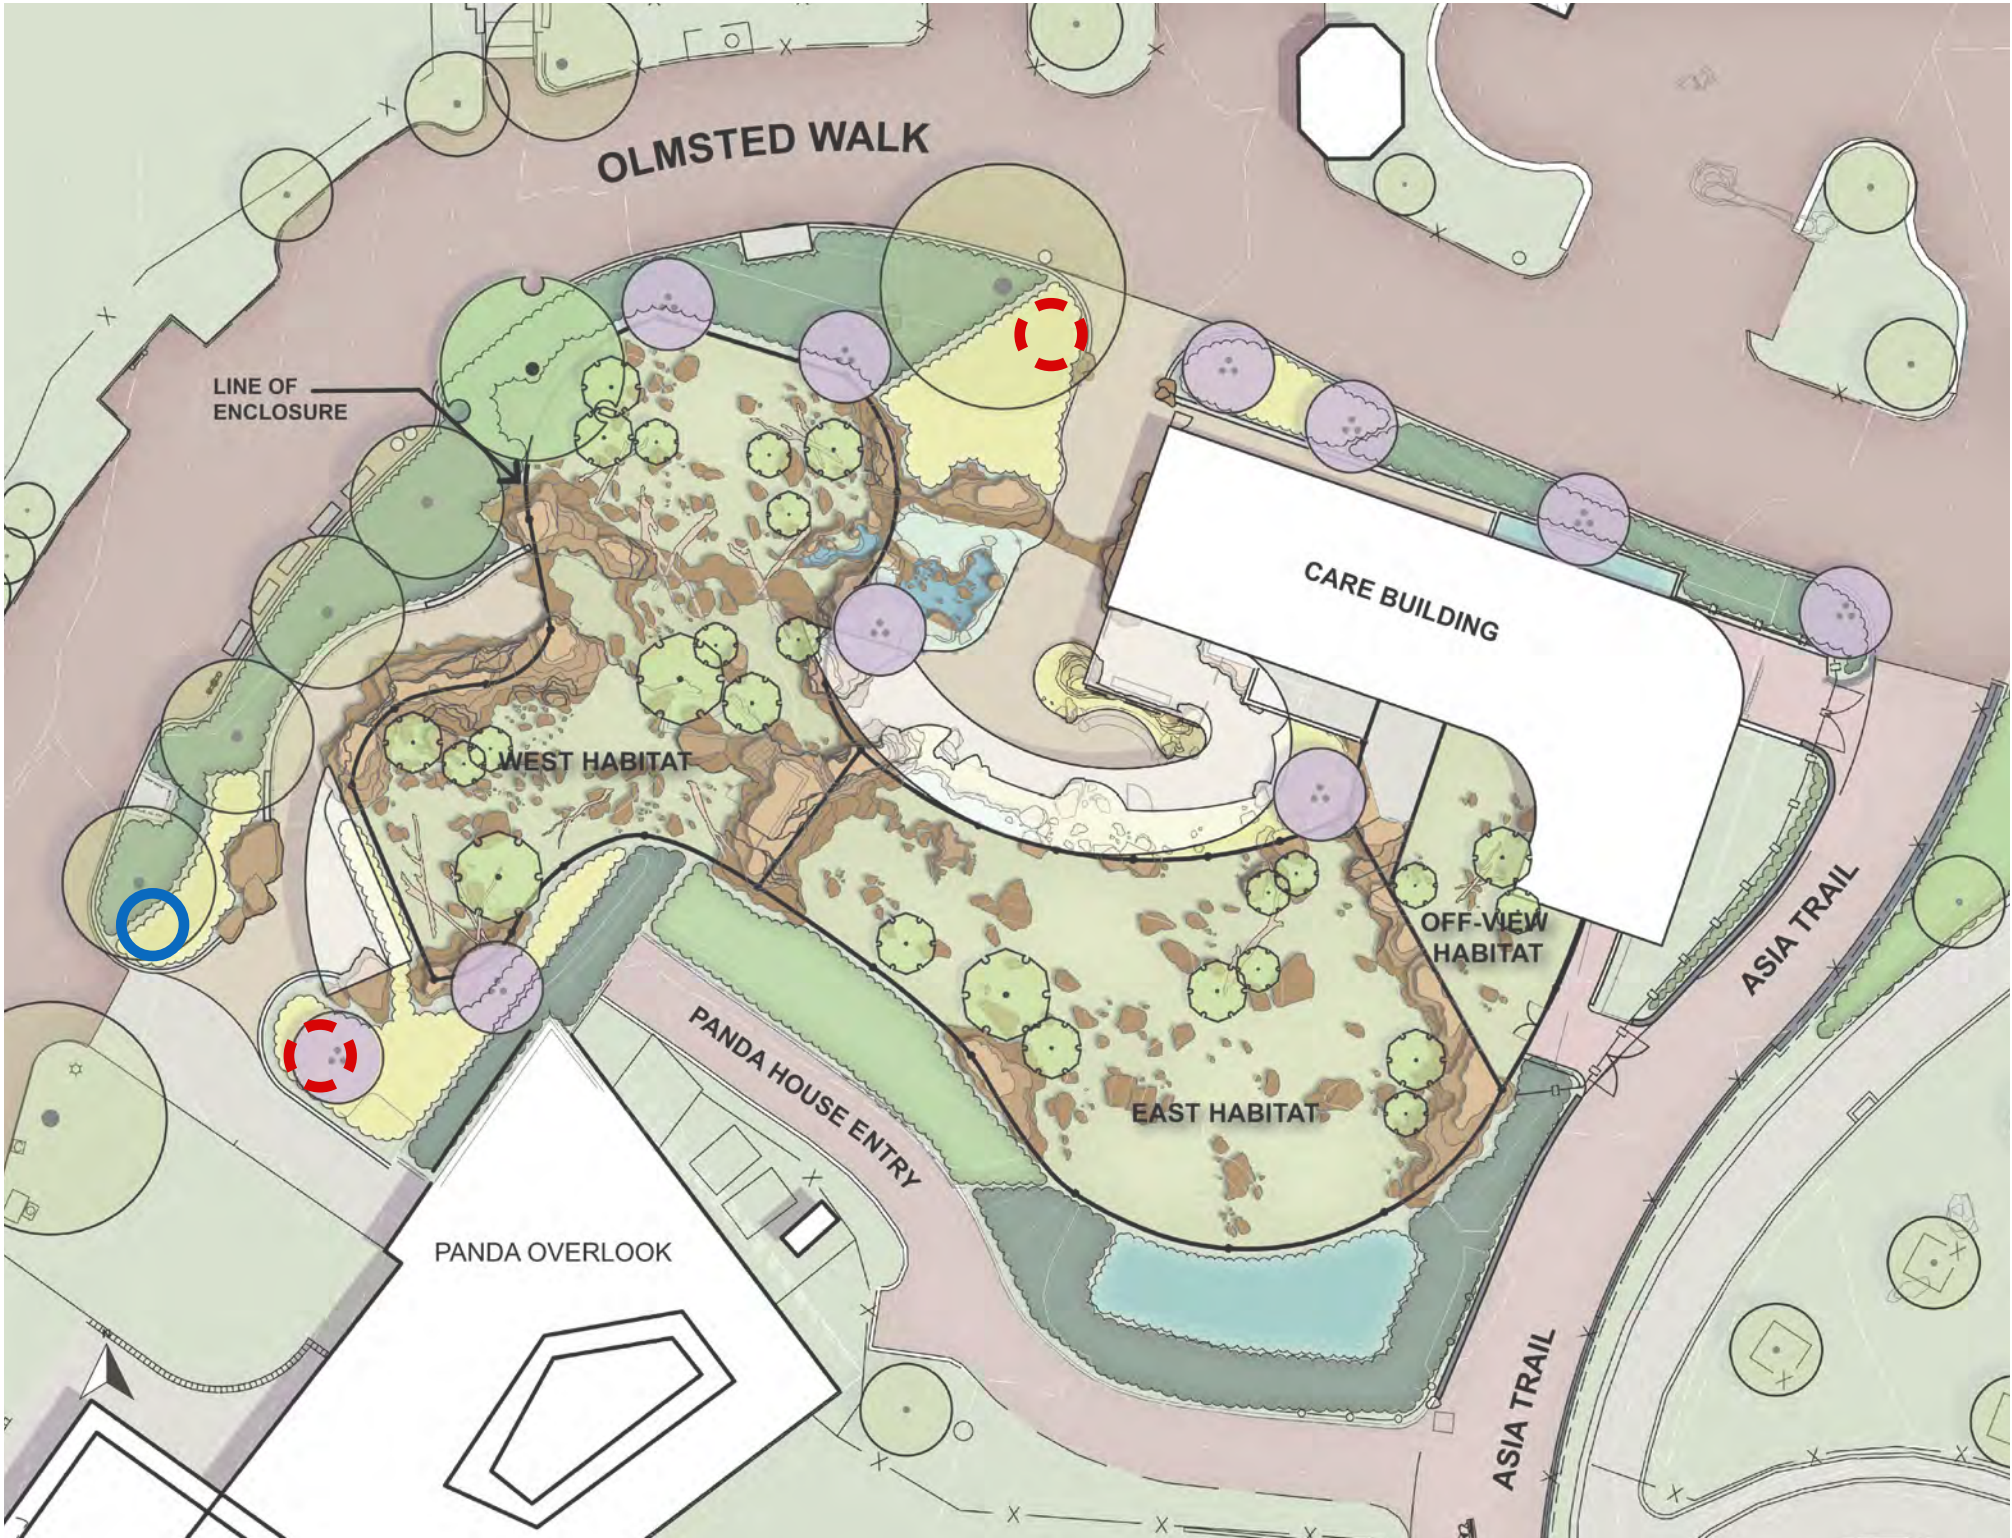
Figure 5.9.3: Site Plan - Signage and Wayfinding Locations

- PROPOSED EXHIBIT ENTRY SIGNAGE
- EXISTING OLMSTED DIRECTIONAL BLADE SIGN

The Zoo has a well established standard for wayfinding and signage throughout as described within the Olmsted Walk Design Guidelines. The existing location of the Olmsted Directional Blade Sign will remain. There are two proposed locations for the exhibit entry signage indicated on Figure 5.9.3.

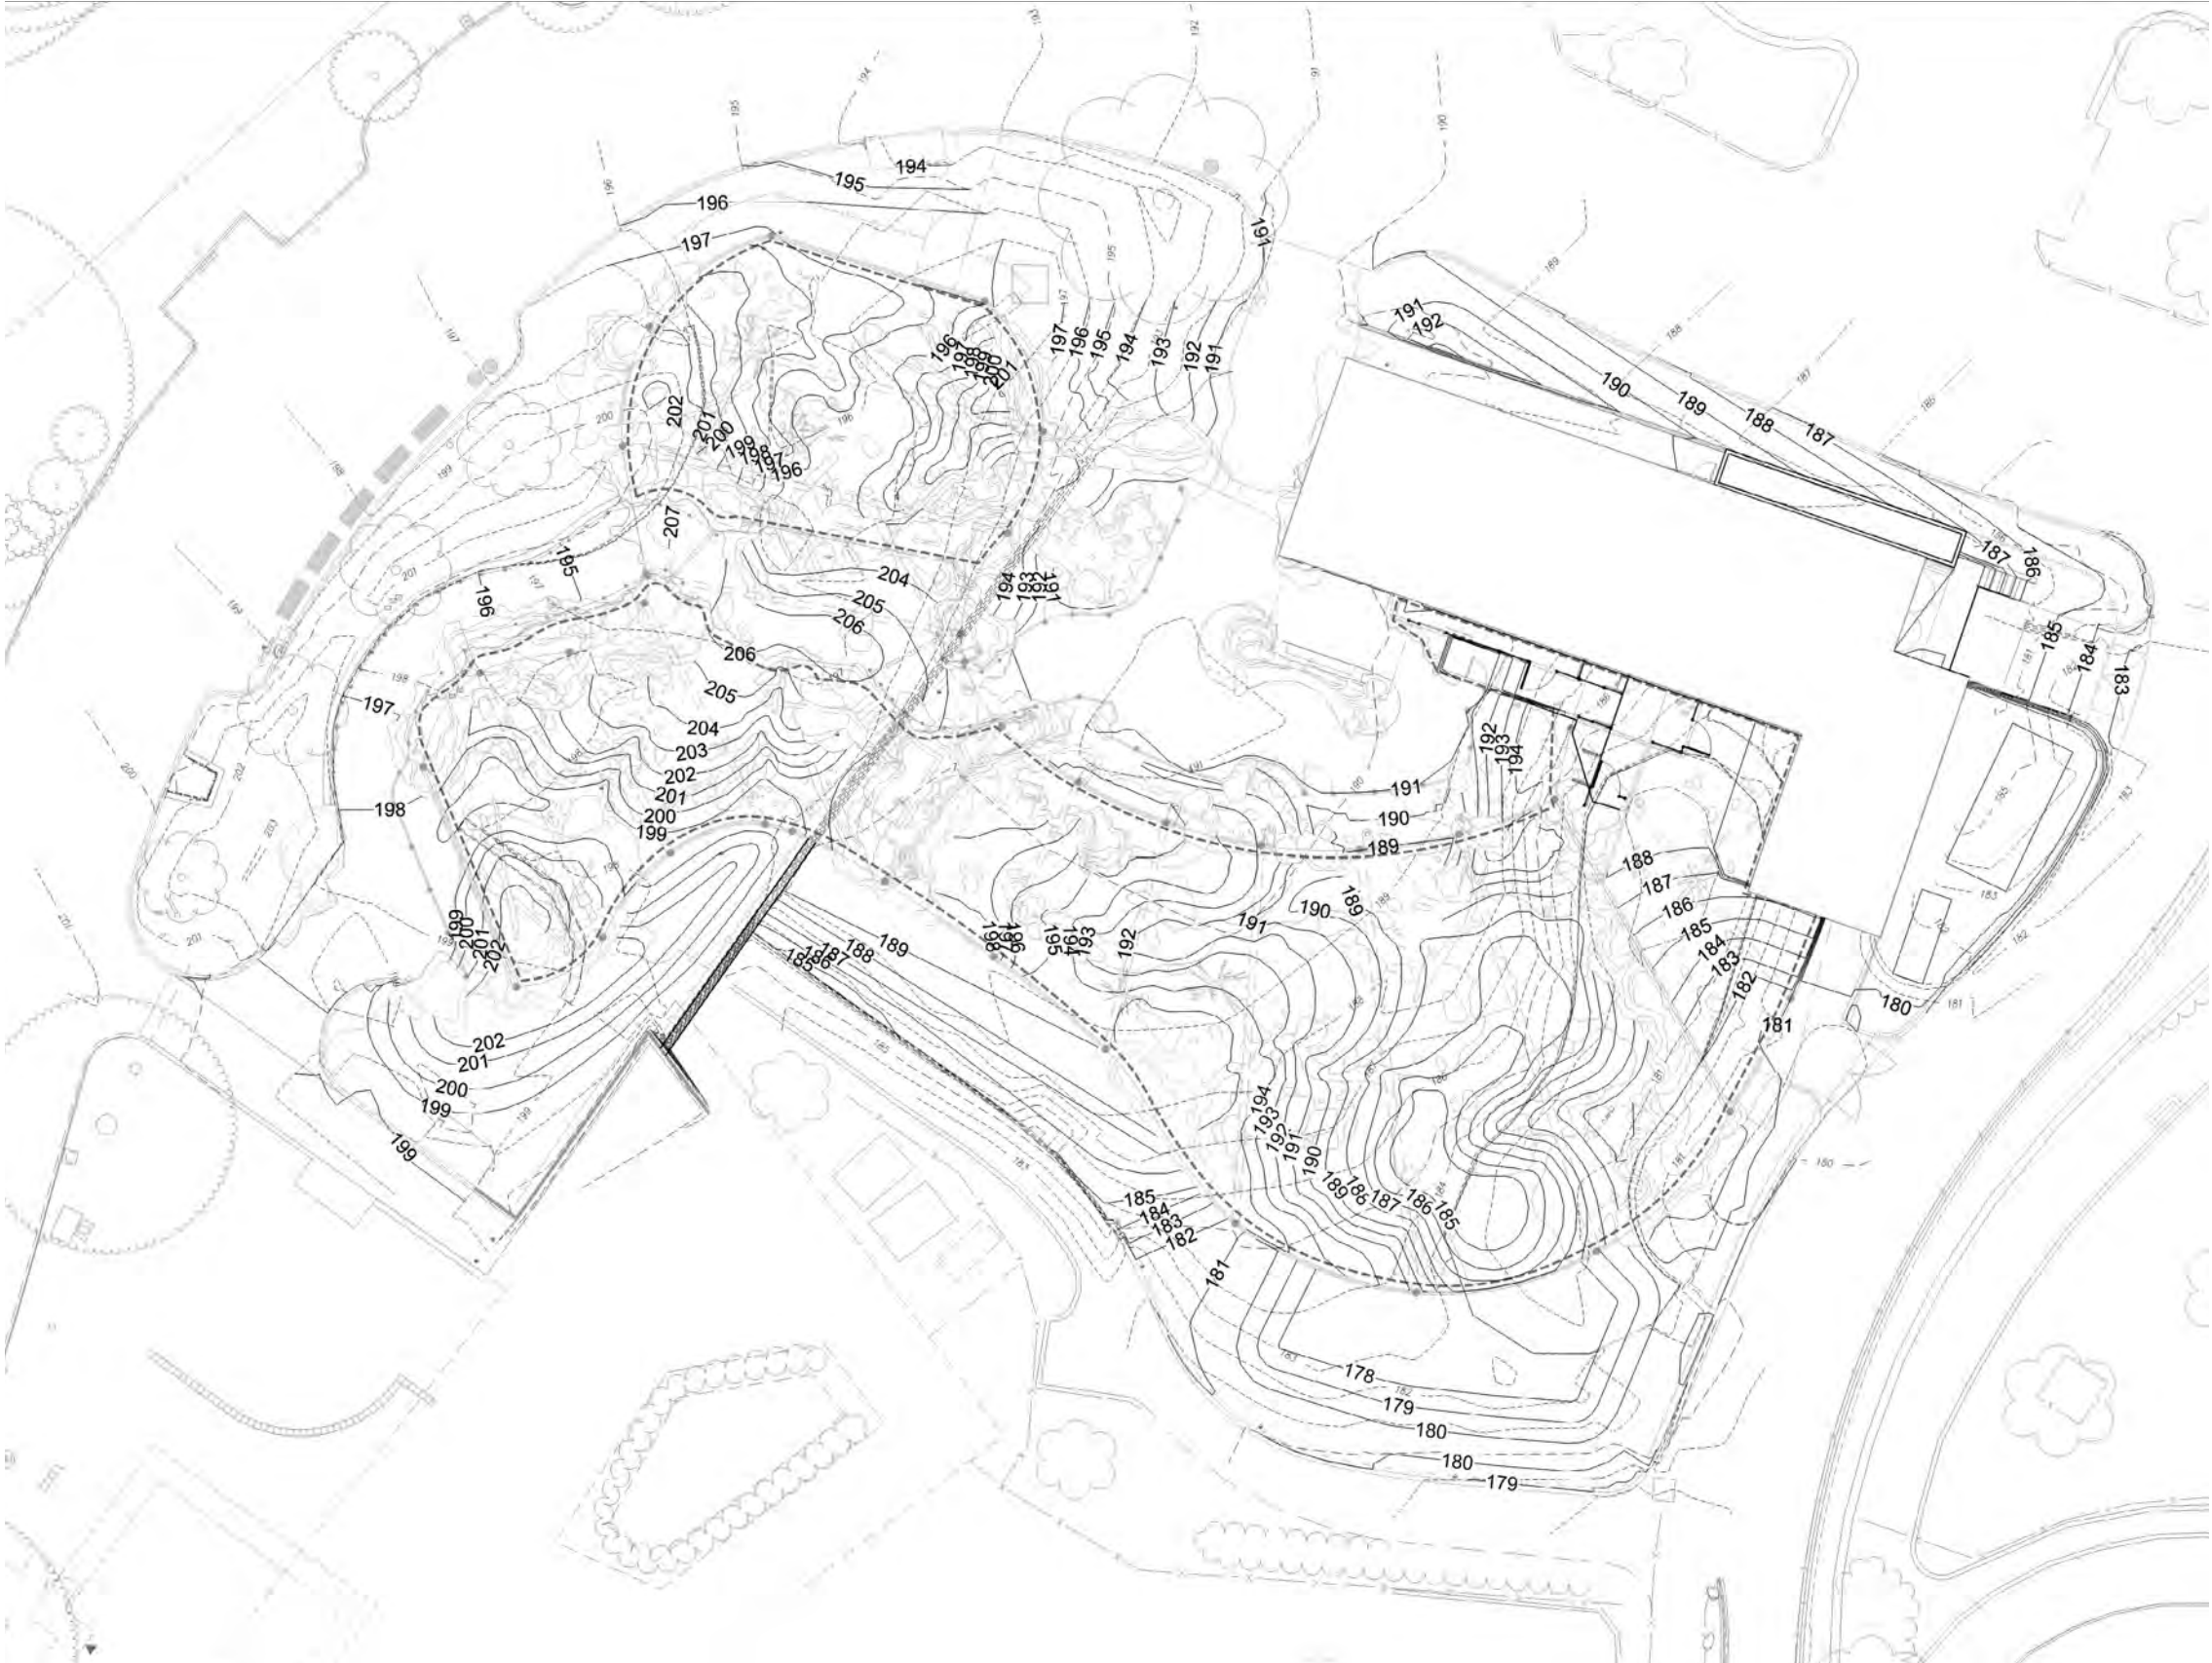
Figure 5.10.2.1: Grading Plan - New Work

Along the perimeter of the site, the topography has been maintained to the greatest extent possible to support the sustained growth of the existing trees along Olmsted Walk. The topography within the site has been modified to support the inclusion of the animal habitat as well as accessible visitor paths. The care building is positioned to minimize the amount of disturbance to the existing grade.
