CONSTRUCT ARABIAN LEOPARD HABITAT  
NCPC FINAL REPORT

SMITHSONIAN PROJECT CODE: 2533105

SEPTEMBER 3, 2026

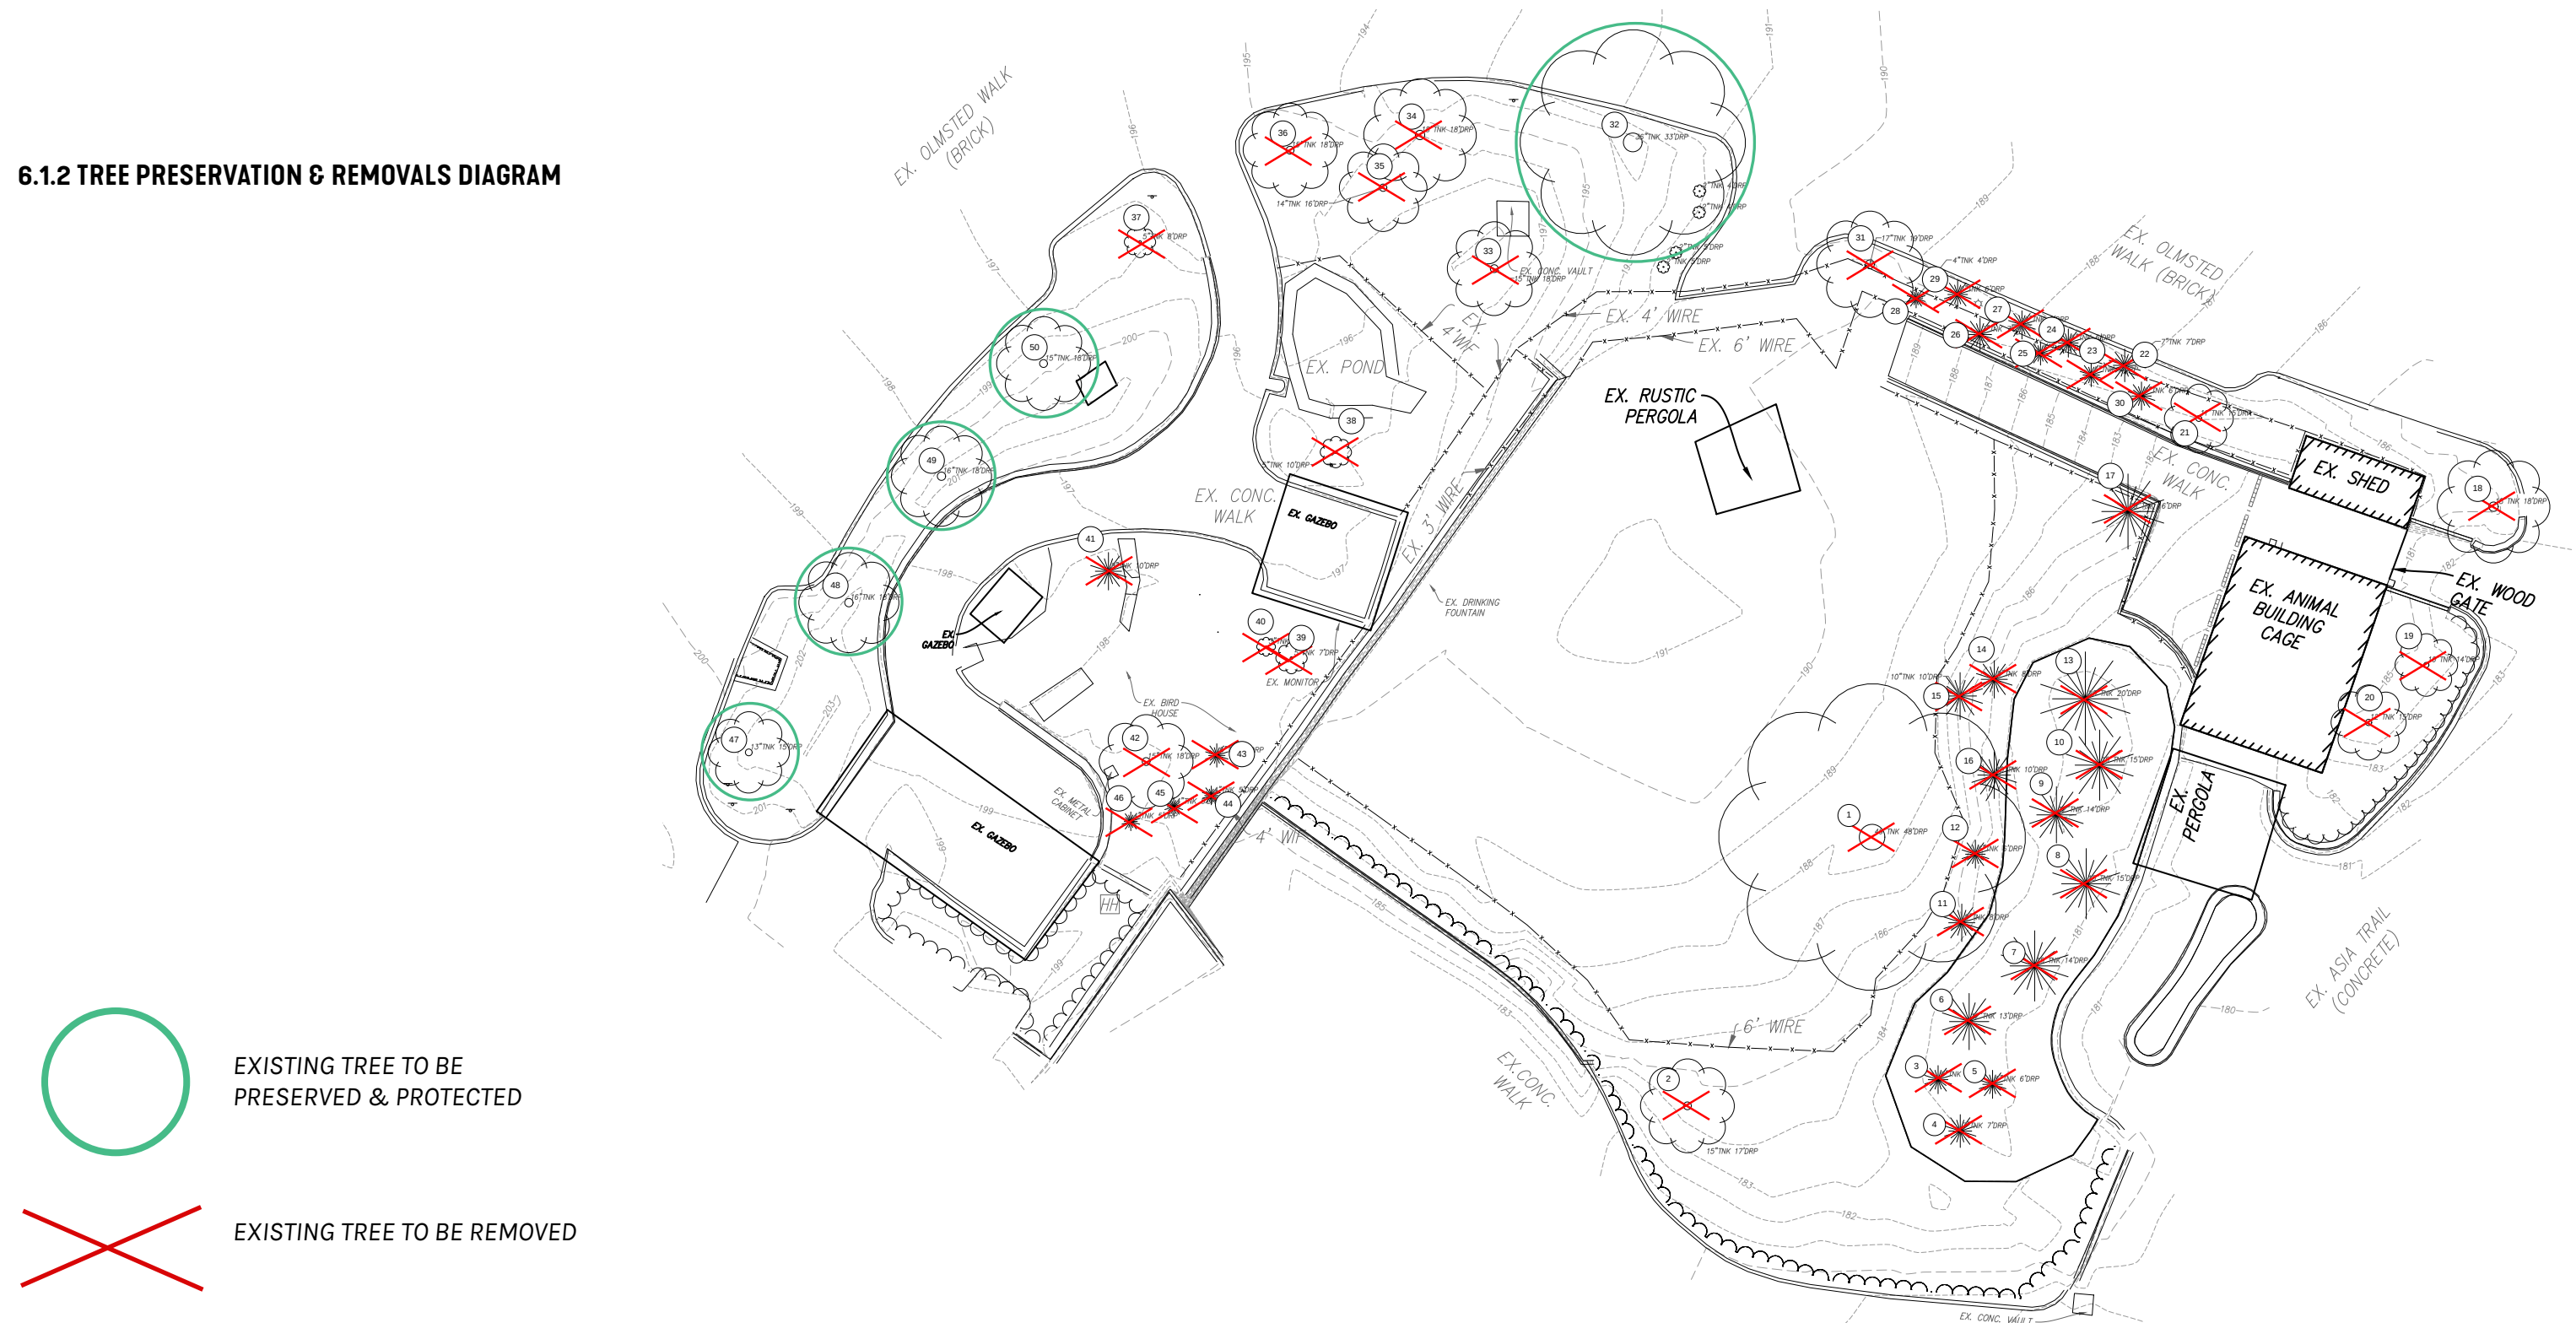
Figure 6.1.2.1: Tree Preservation and Replacement Plan

Significant and important trees within project limits have been identified by both NZCBI Horticulture and a Certified Arborist to be preserved. See 6.2 Tree Inventory for the full report. Preservation effort has been focused on the significant shade trees along Olmsted Walk with most removals occurring within new habitat and care building limits. An assessment of existing trees on site was completed by a Certified Arborist and is shown in Figure 6.1.1.1.

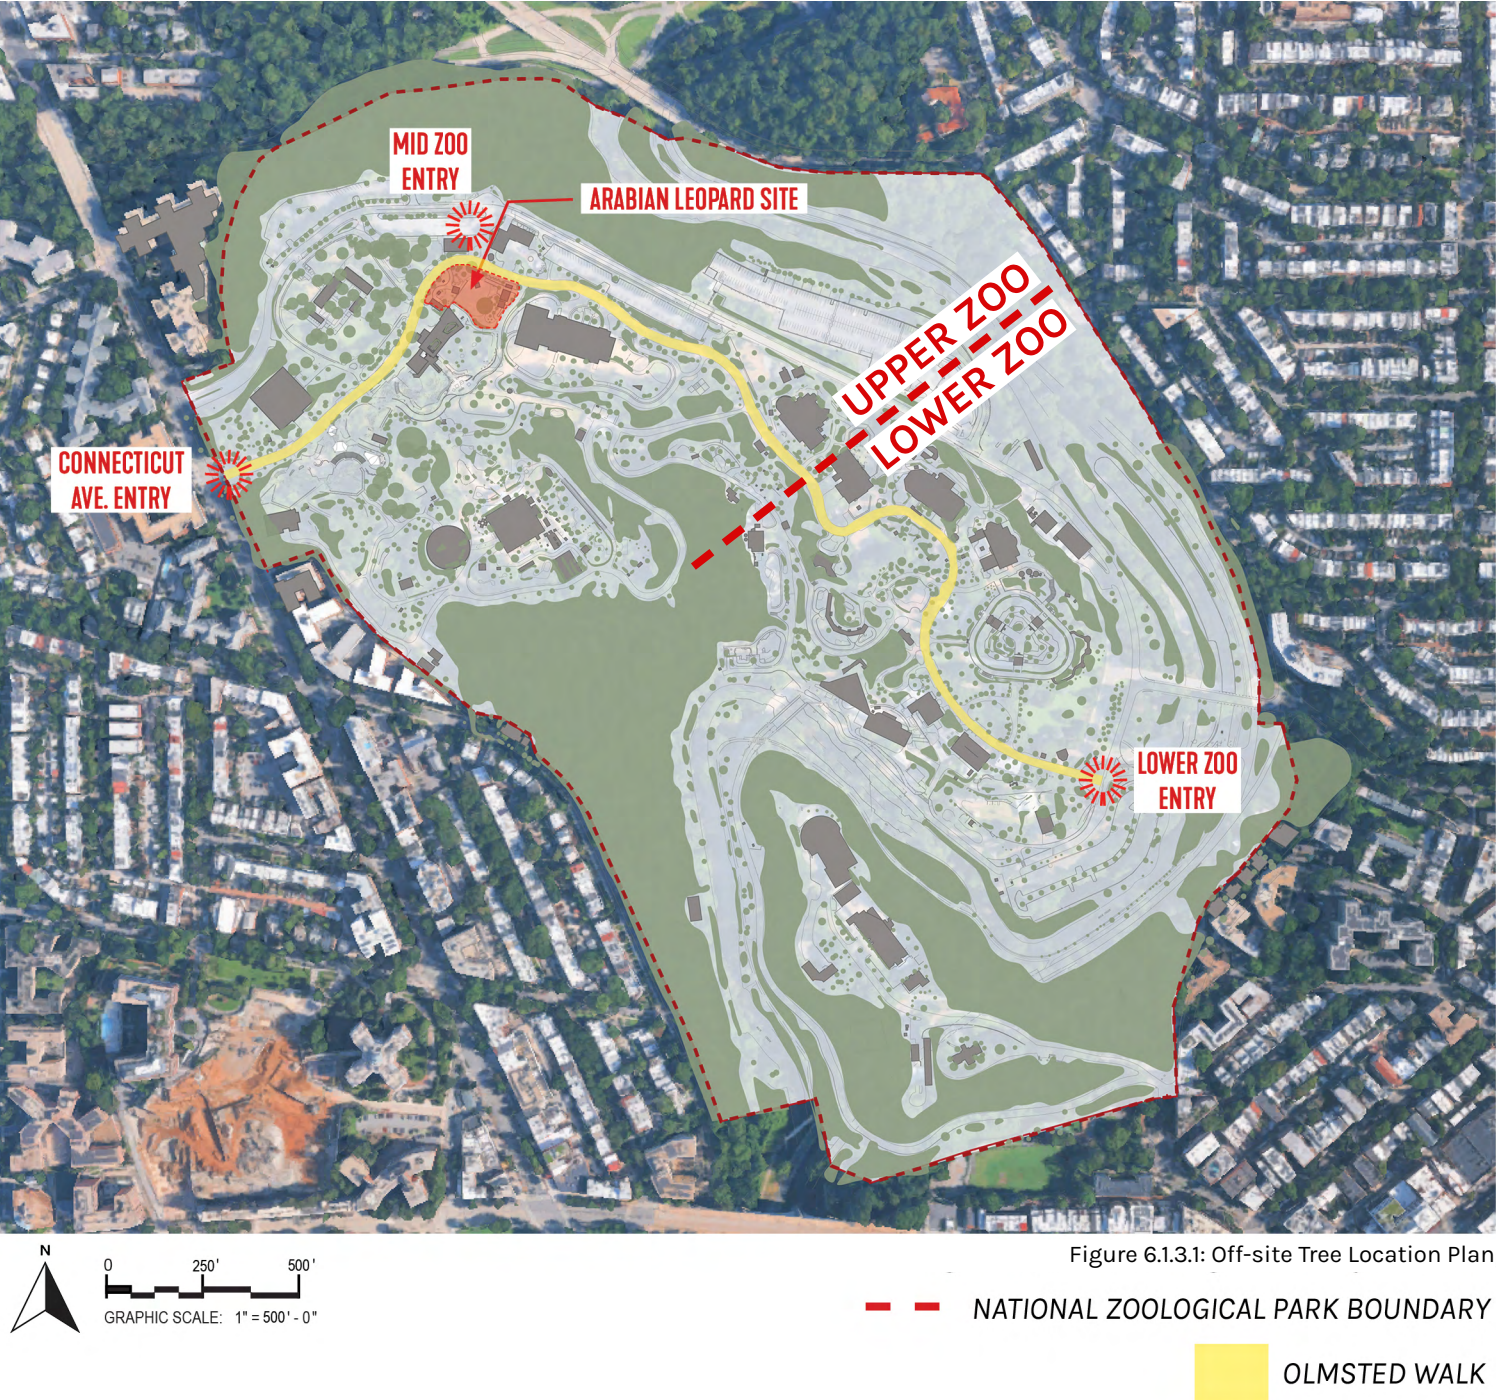
6.1.3 OFF-SITE TREE LOCATION PLAN

The 12 additional trees that are required to meet the total tree replacement needed for the project are proposed to be planted off the project site, throughout the Zoo along Olmsted Walk.

The upper part of the Zoo, from Connecticut Avenue to approximately Small Mammal House will receive 6 replacement trees. The lower part of the Zoo, from Great Ape House to the Animal Hospital will receive 6 replacement trees. The exact locations will be determined when the planting period nears.

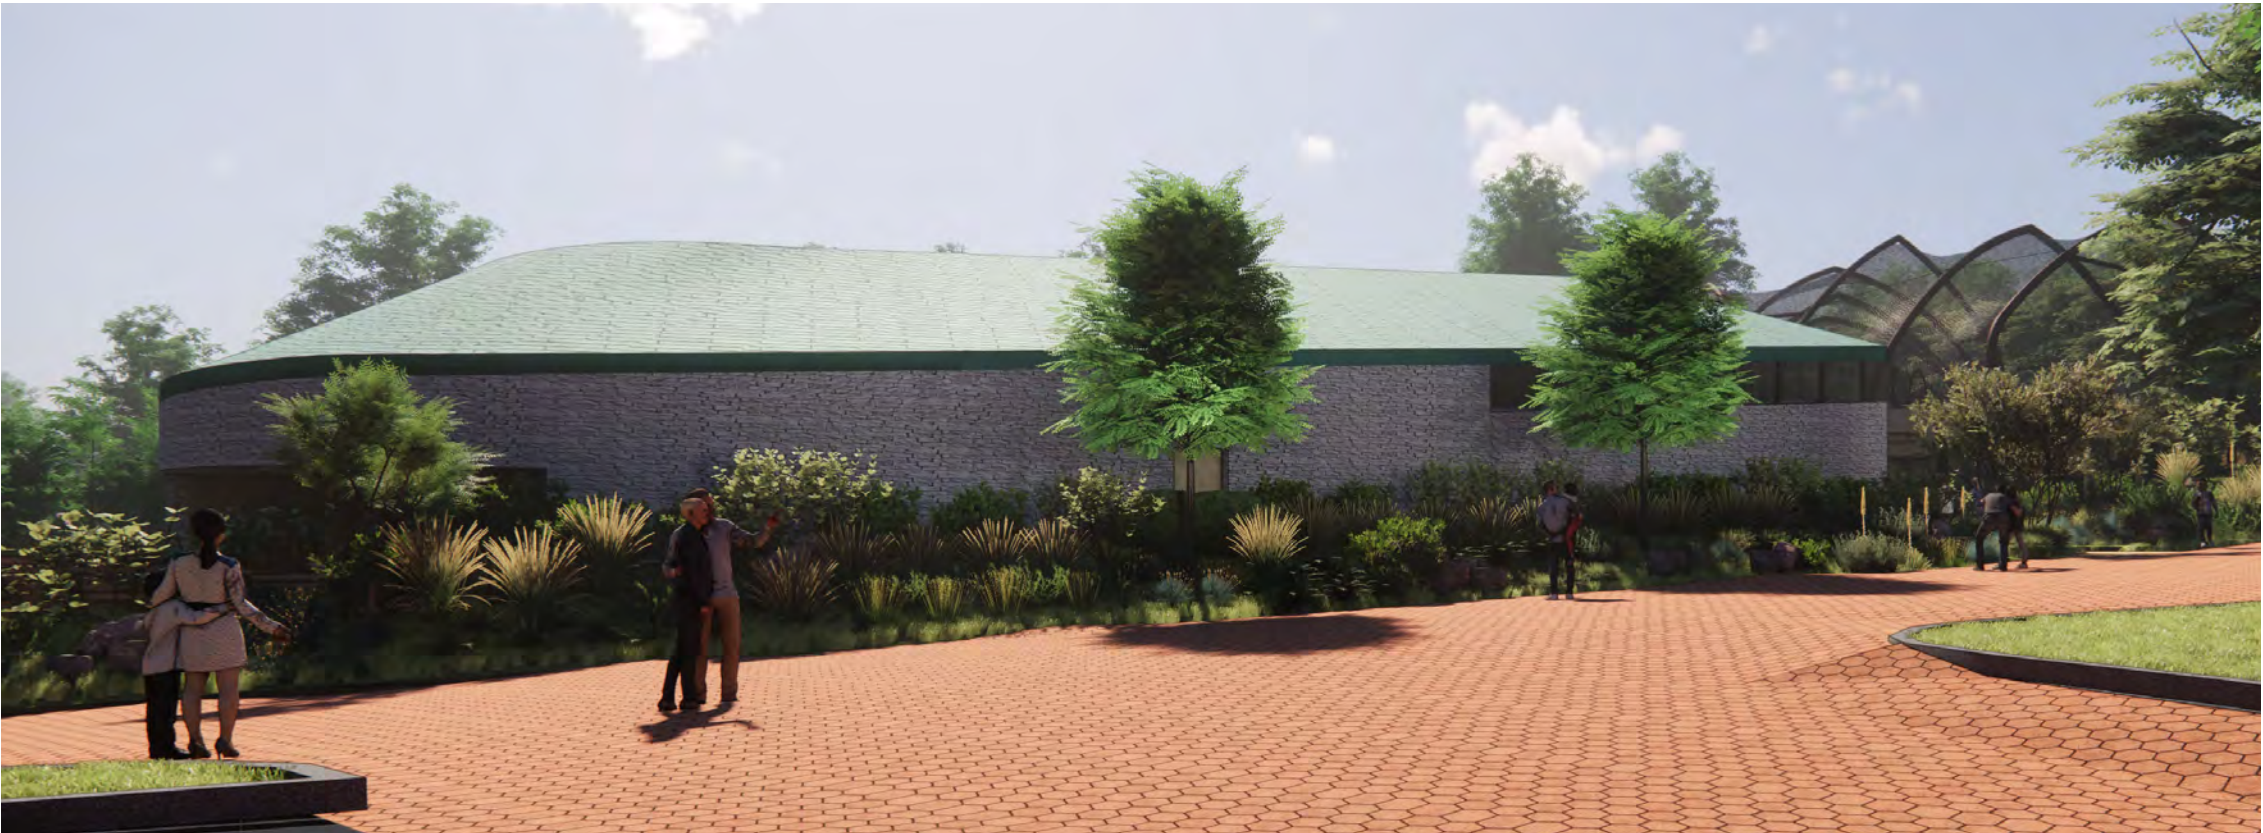
Figure 6.3.1.1: Option #1 - Half Gable Roof

- Option #1 - Half Gable: A gable roof that transitioned to a shed roof above the Day Room.
- Option #2 - Shed: A contiguous shed roof swept along the outline of the building.

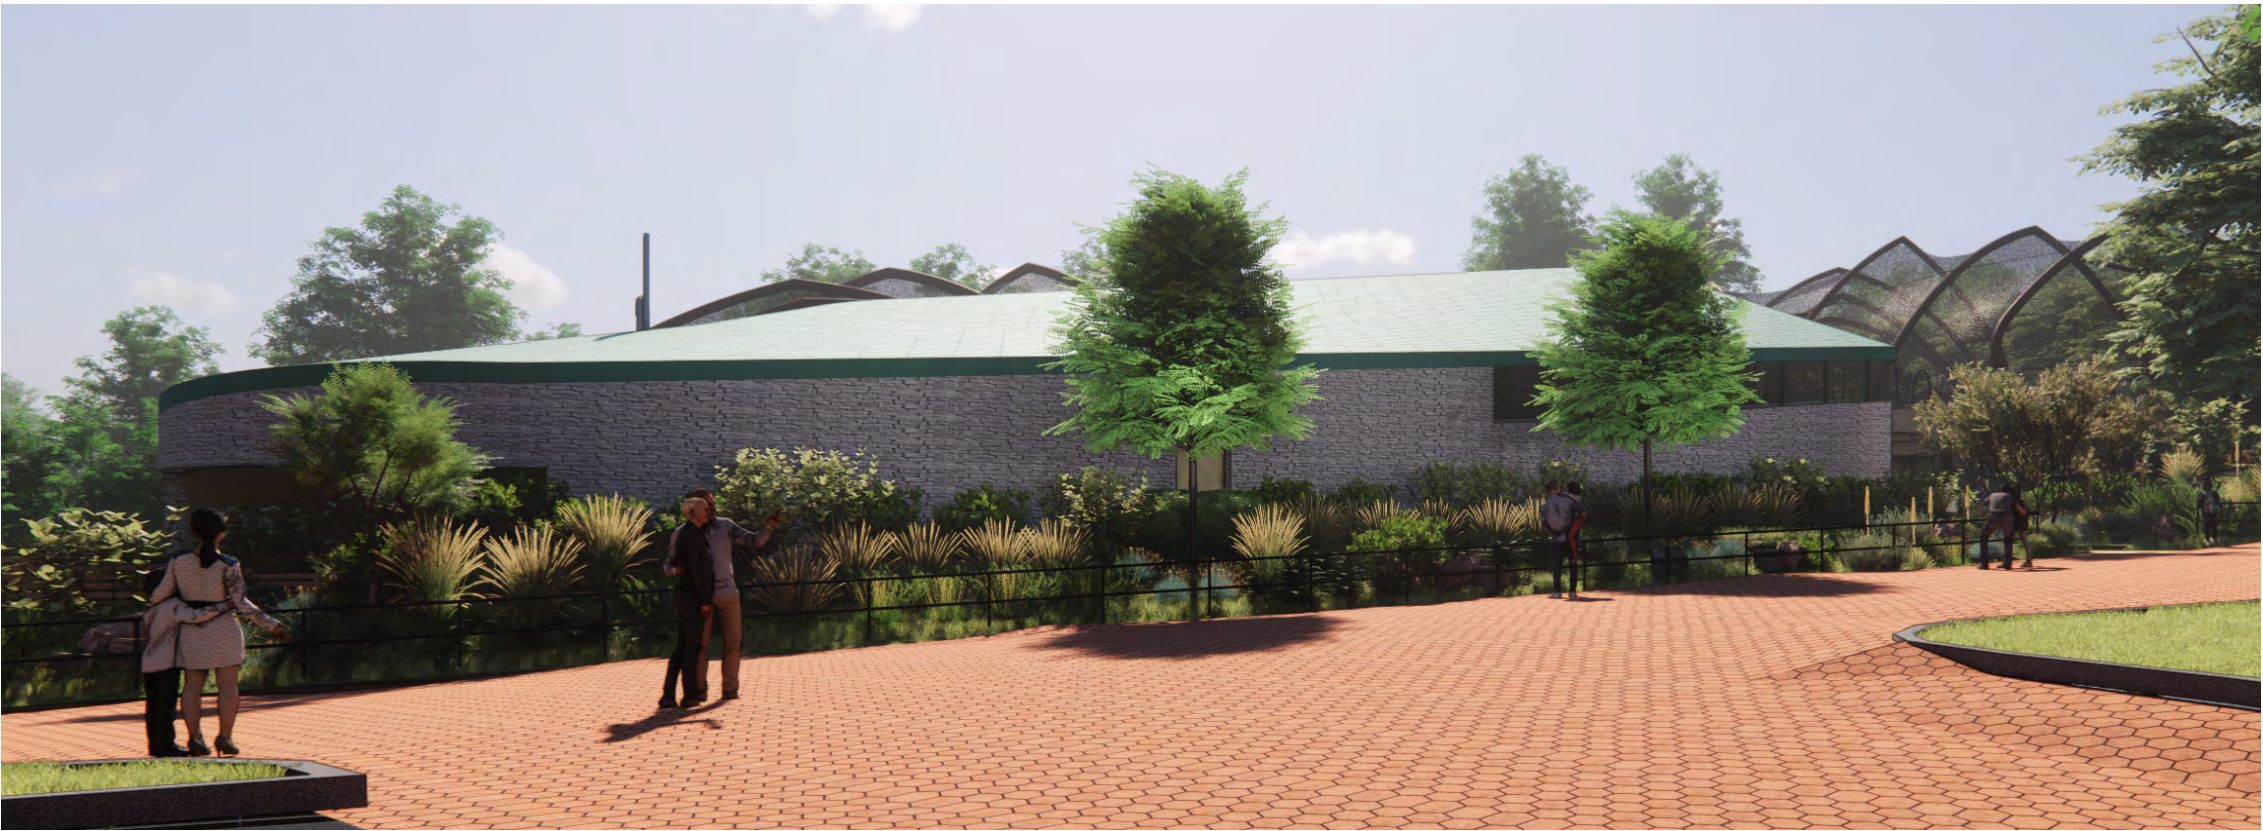
Figure 6.3.1.2: Option #2 - Shed Roof

The contiguous shed roof, Option #2, was preferred as it appeared to flatten when viewed from Olmsted Walk, referencing the low slope roofs prevalent in the historic district. See Figure 6.3.1.2 for reference. The one con for this option is that the roof line no longer hides utility flues and piping that are required for the systems of the building. The flues and pipes cannot be relocated to a different location due to the programmatic layout needed to meet animal care needs and the only potential revised location, would push them closer to Olmsted Walk. This has prompted the utilities to remain and the Consulting Parties agreed the piping shall remain exposed as it is less visually intrusive then an additional enclosure.

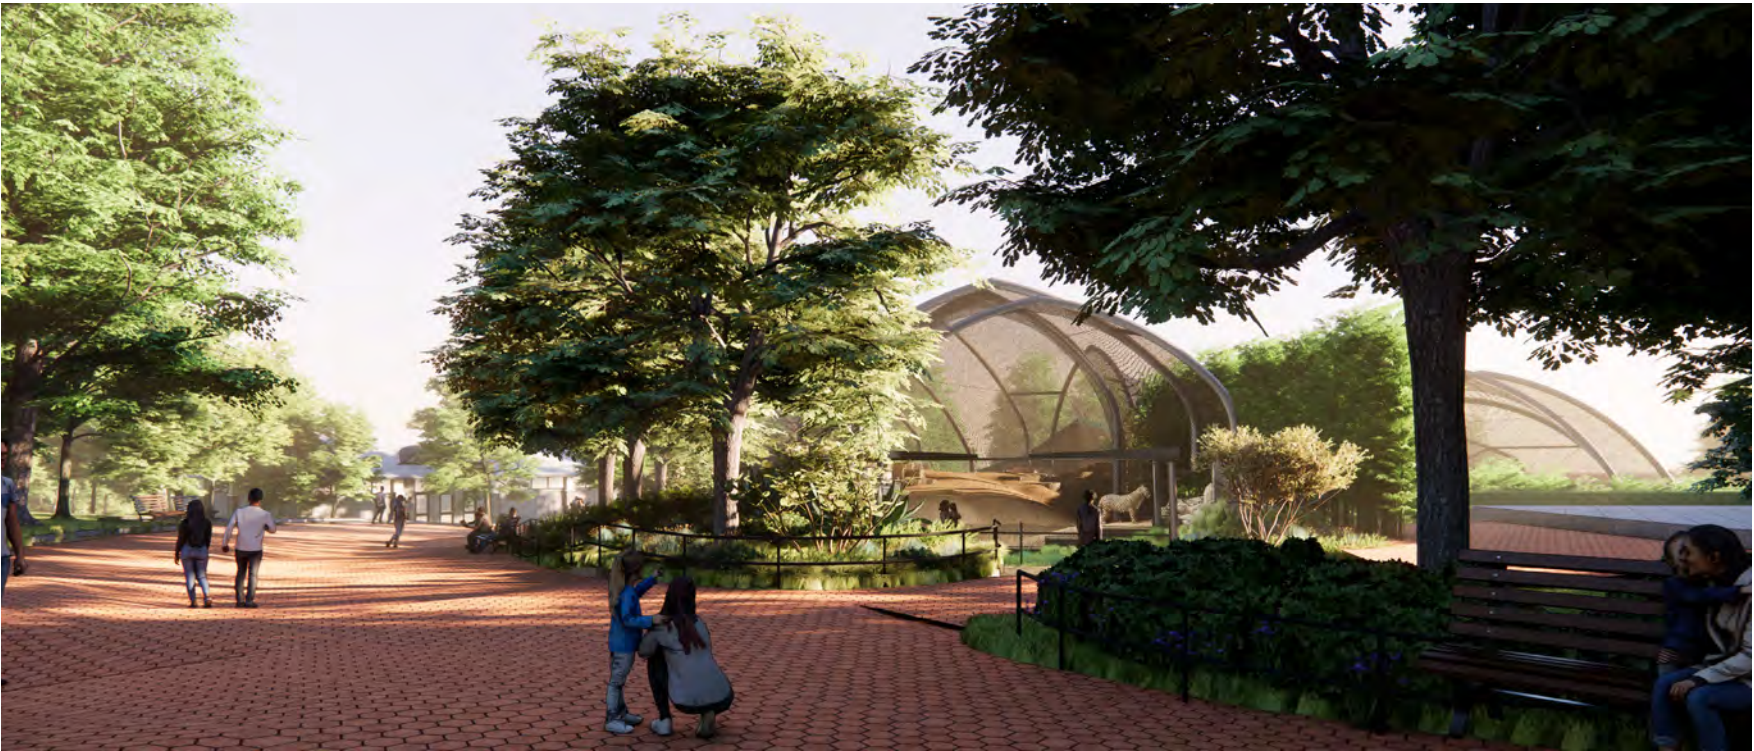
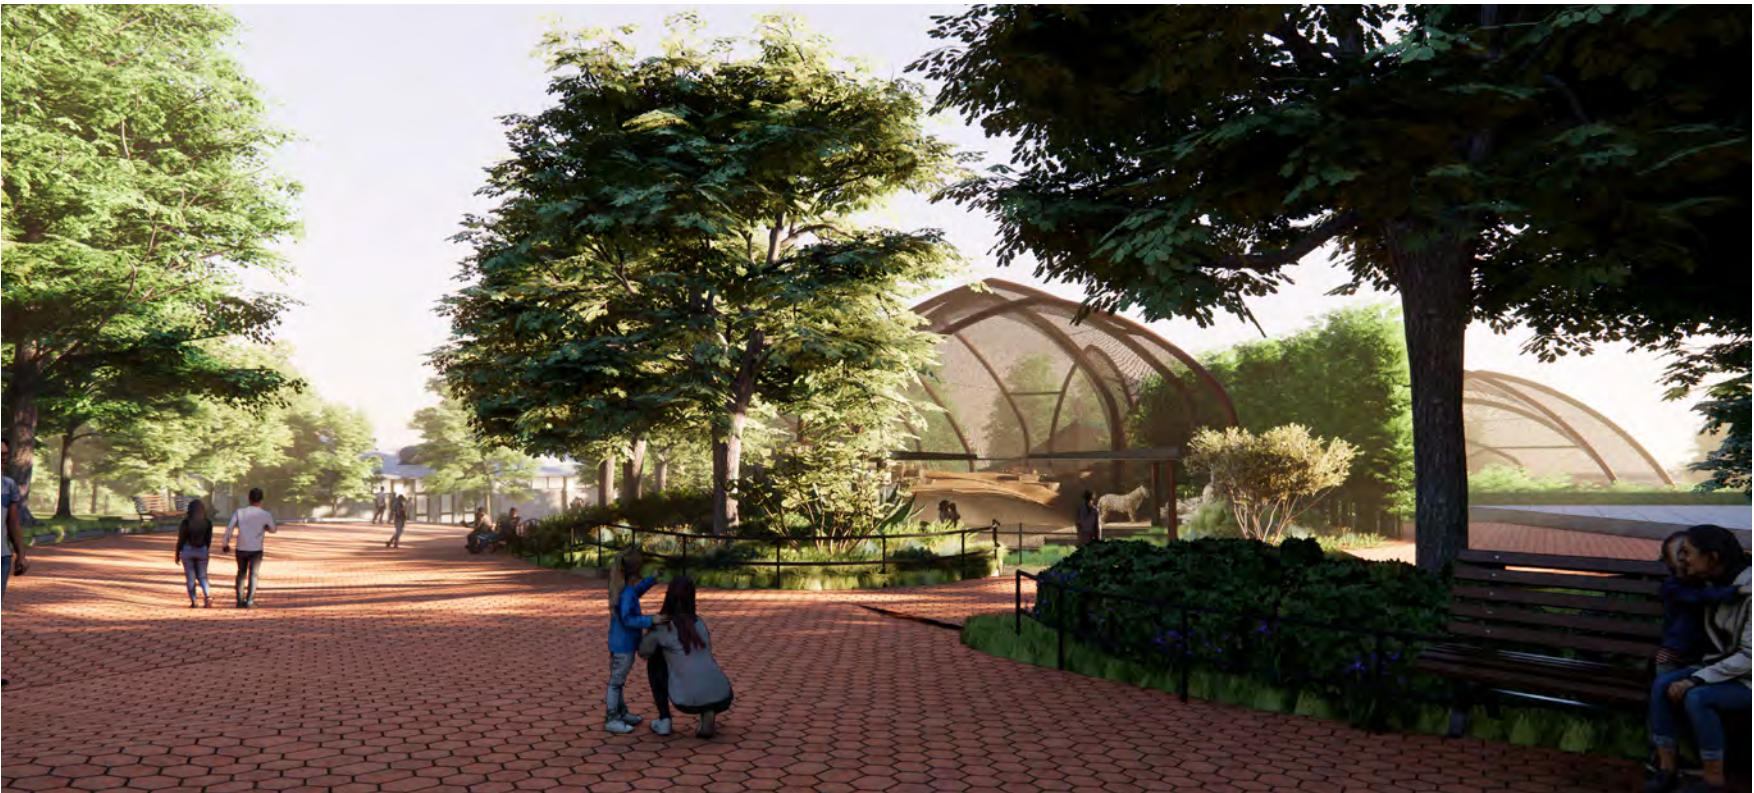
Figure 6.3.2.2: Enclosure Color Palette Refinement Studies

The design team recommends the enclosure arches be colored bronze to allow it to integrate with both the landscape and sky, the two backdrops the enclosure is visible against. The mesh color recommended is black oxidized as it disappears against landscape plantings and allows for clear viewing from visitor to animal.

Enclosure Color Study #1: Charcoal Grey Structure and Black Oxidized Mesh

Enclosure Color Study #2: Bronze Structure and Black Oxidized Mesh

- Arch Color: Charcoal Grey and Bronze
- Mesh Color: Black Oxidized Stainless Steel

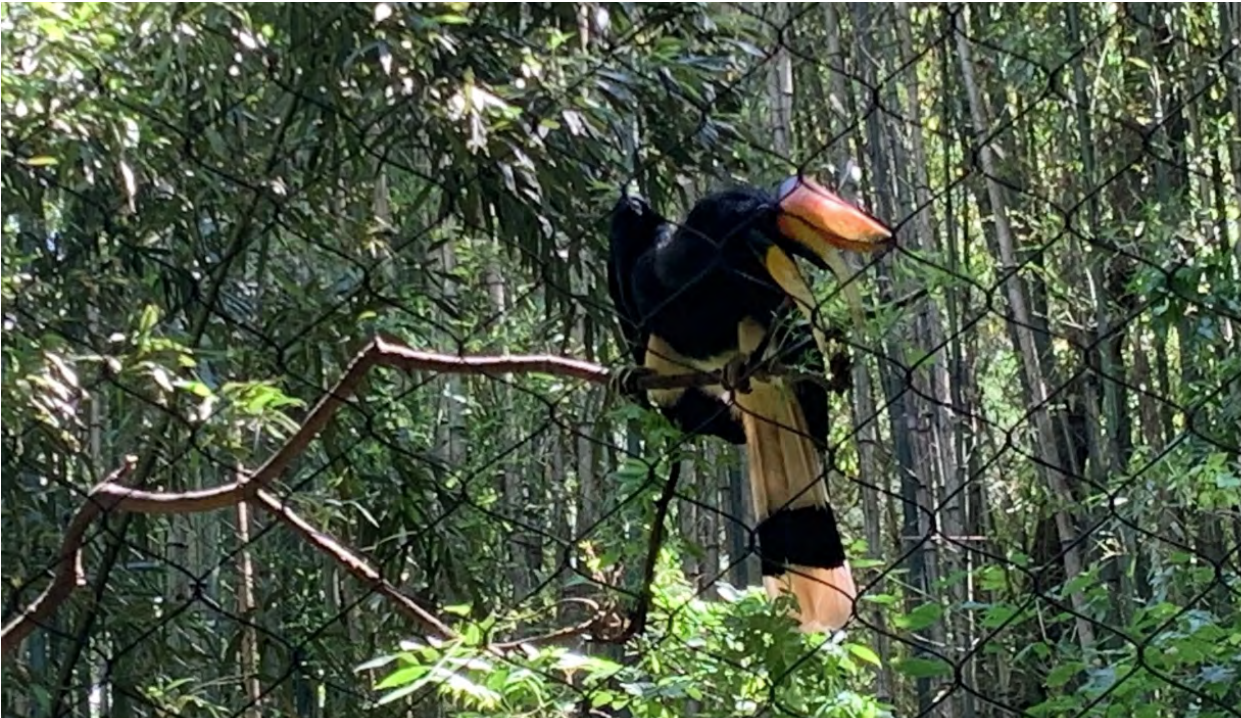
Figure 6.3.2.1: Stainless Steel Black Oxidized Finish Mesh

The enclosure mesh will be hand woven A316 stainless steel mesh. Mesh size is driven by the animal care program requirements and will be 2"x2"x1/8" to ensure the safety of both animal and human.

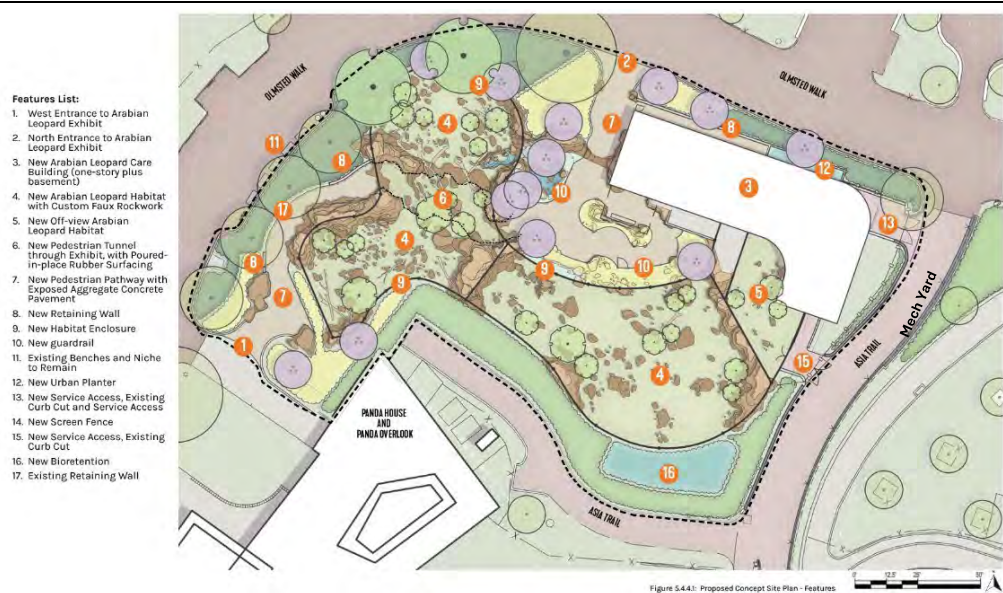
| Feature/Action | |
|---|---|
| <p><b>Site Plan</b> - Dashed black line frames extents of project site, white “L” shape shows footprint of Animal Care Building, and central figure outlined by solid black line illustrates the perimeter of the outdoor animal habitat.</p> | |

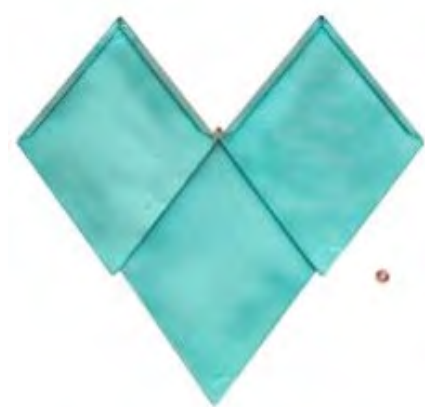
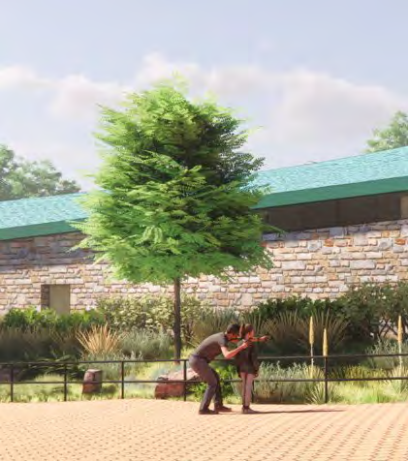
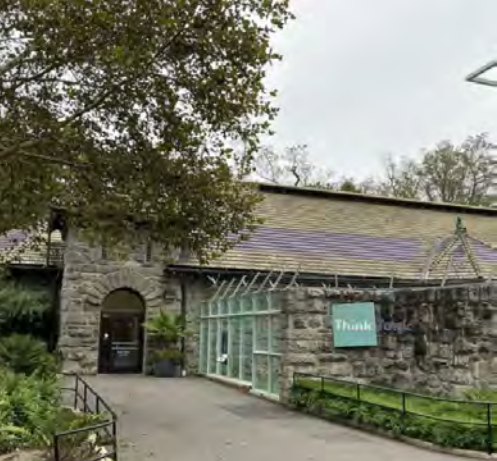
| Feature/Action | |
|---|---|
| <div></div> <p>Pre-Patinated Copper Diamond-Shaped Shingle</p> <p>Carderock – Varied Ashlar Coursing</p> <p>en-Colored Roof Precedent within Historic District: Think Tank</p> | |
| <p>The project complements the Zoo’s existing contributing buildings by utilizing consistent and/or compatible materials on the Care Building envelope. The envelope materials for the care building include Carderock cladding and a patinated copper roof in a diamond shingle pattern.</p> <p>Carderock is found throughout many of the contributing buildings, support buildings, and landscape features within the Historic District. At the nearby Elephant House, warm-toned, ashlar Carderock clads most of the building.</p> <p>Roof surfaces at the Zoo are composed of tiled or shingled roofs made of terracotta, slate, or wood. The Think Tank, a nearby contributing building, features green-colored terracotta tile. Several modern structures feature the use of vegetated green roofs to allow the structures to integrate into the topography. Many of the service buildings along Olmsted Walk are low in profile with prominent wood or slate shingled roof features, referencing natural colors and materials.</p> | <p>The vertical surface area of the animal care building will have a clear and close presence on Olmsted Walk.</p> <p>Carderock cladding in a varied ashlar pattern is proposed along the elevation fronting Olmsted Walk and Asia Trail for its consistency with other contributing buildings and historic materials within the District. Use of Carderock has precedent elsewhere in the Zoo and minimizes adverse effects from the Care Building.</p> <p>A pre-patinated, diamond-shaped copper shingle roof at the care building provides a visual connection to similarly colored roofs such as the Think Tank for consistency within the District.</p> <p>The incorporation of historically consistent materials at the care building minimizes the visual presence of the building as discussed in “Section 3: Animal Care Building Footprint and Massing.”</p> |

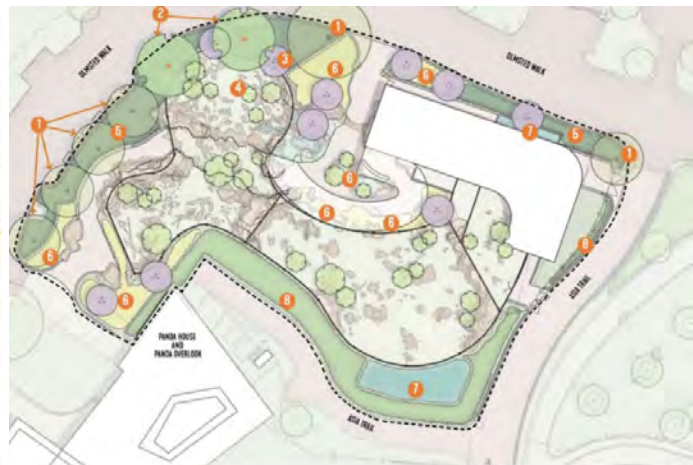
<p><b>Proposed Landscape Plan</b></p><p>1. Existing Tree to Remain</p><p>2. New Canopy Tree</p><p>3. New Understory Tree</p><p>4. New Habitat Tree</p><p>5. Olmsted Walk Planting Palette</p><p>6. Wadi and Oasis Planting Palettes</p><p>7. Bioretention Planting Palette</p><p>8. Asia Trail Planting Palette</p></div></div> <div><div>

| The landscape plan for the new habitat will prioritize the following: <ul style="list-style-type: none"><li>• Protection of existing trees along Olmsted Walk</li><li>• Addition of new trees, primarily along the edges and corners</li><li>• Introduction of berms along site edges adjacent to Olmsted Walk. The proposed berms will range in width from 12' – 24' and in height 2.5' – 4' and will include plantings, providing additional screening and height between Olmsted Walk and the new exhibit.</li><li>• Olmsted Planting Palette – Maintains conformance to existing plantings found along Olmsted Walk throughout the Historic District.</li><li>• Wadi/Oasis Planting Palette – Introduces plants thematically complementary of the Arabian Peninsula</li><li>• Asia Trail Planting Palette – Utilizes plantings found along Asia Trail to ensure the southeastern edge of the project site is consistent with other path edges and plantings along Asia Trail</li></ul> | The berming strategy seeks to integrate the exhibit and building design with the landscape to maintain the landscape character along Olmsted Walk. Landscape design maintains the existing character of Olmsted Walk and Asia Trail, avoiding adverse effect. |

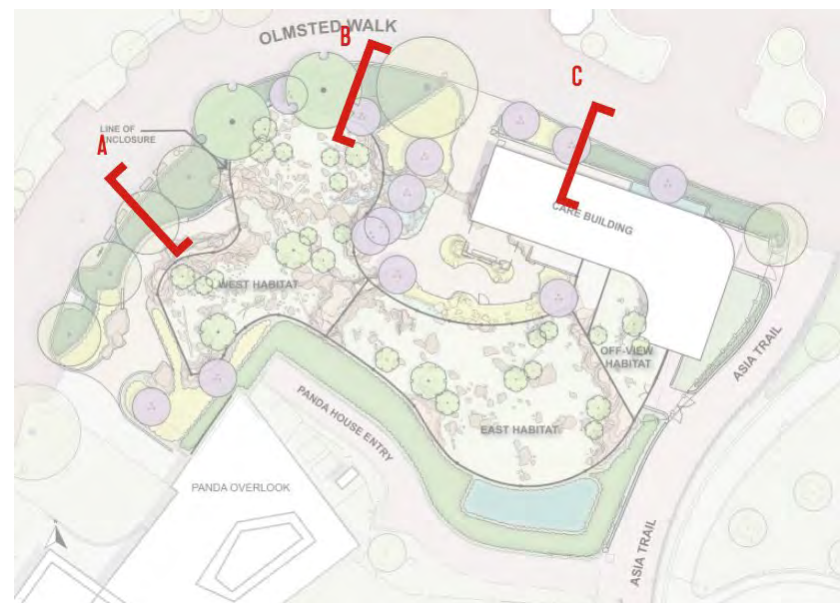
The proposed berms will range in width from 12’ – 24’ and in height 2.5’ – 4’ and will include plantings, providing additional screening and height between Olmsted Walk and the new exhibit. The existing viewing alcove off Olmsted Walk at the northwest corner of the project site will be removed and replaced with a berm, Olmsted walk plantings, and new canopy trees.

<p><b>Berm Locations</b></p></div><div>

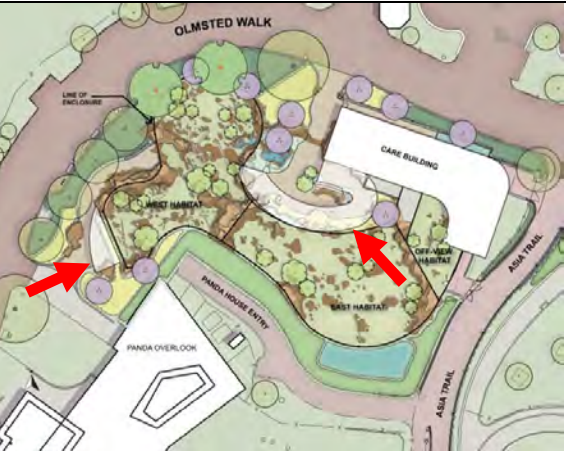
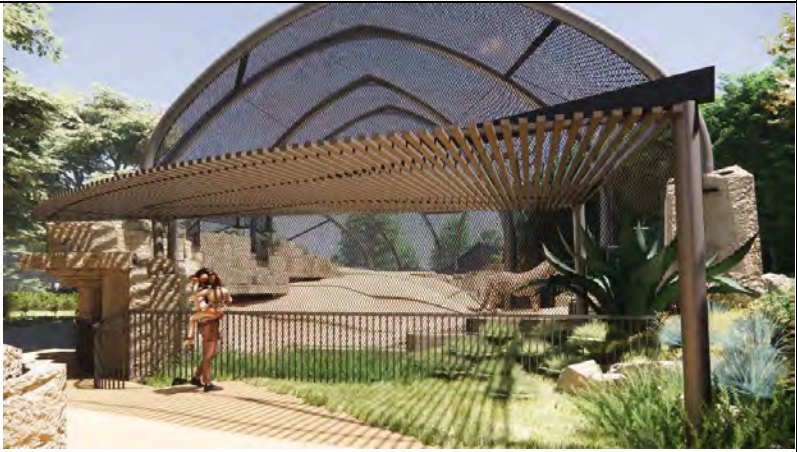
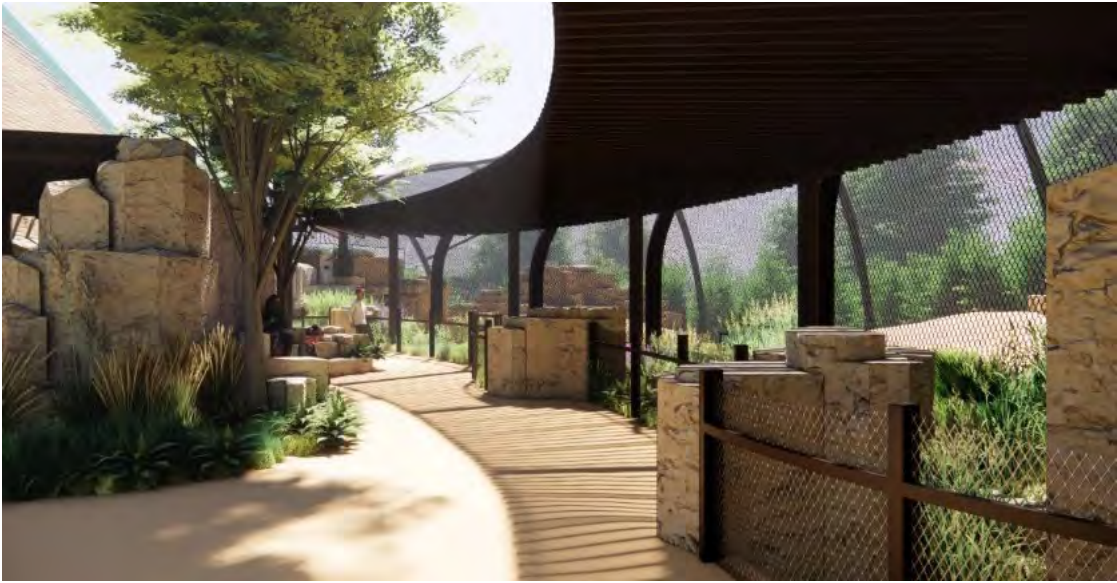
| Feature/Action | |
|---|---|
| <p><b>Proposed Shading Areas:</b> Shade structures shown as white shaded forms</p> <p>Shade Structure with Metal Slats</p> | |
| <p>Proposed shade structure with metal slats at central "Oasis" viewing plaza</p> | |
