Carnegie Library

Rehabilitation and Exterior Restoration

Concept Review Submission

National Capital Planning Commission

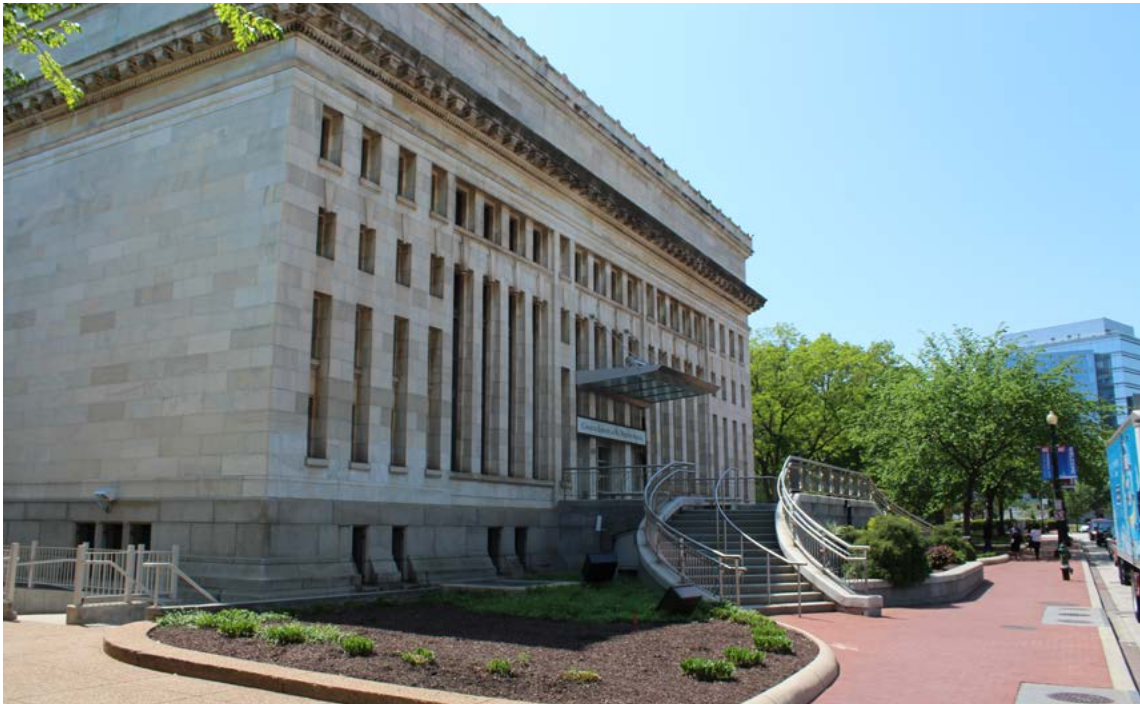
Figure 4: North elevation (including non-original stair and awning), facing southwest

The proposed project will rehabilitate and modernize the Carnegie Library building to become a retail and education facility. The building will be leased jointly by HSW (which will continue to operate its research library, exhibit galleries, and administrative offices there) and a retail tenant (which will operate a retail, events, and educational facility in the building). The project will include a full restoration of the building exterior, including the repair and cleaning of the exterior stone, repair and retrofit of the original wood windows, repair and retrofit of the original skylight frames, and repair of the copper roof cladding. On the north side, the non-original stair and awning will be removed and replaced with a new stair that improves access to the building. Windows on this elevation—modified during the UDC and HSW rehabilitation projects—will be replaced or retrofitted.
