## FINAL DESIGN SUBMISSION

# Arlington Memorial Bridge Rehabilitation

George Washington Memorial Parkway  
National Park Service  
U.S. Department of the Interior

NPS Project No. NP-GWMP 11(4), 11(7)  
QEA Project No. 31712800

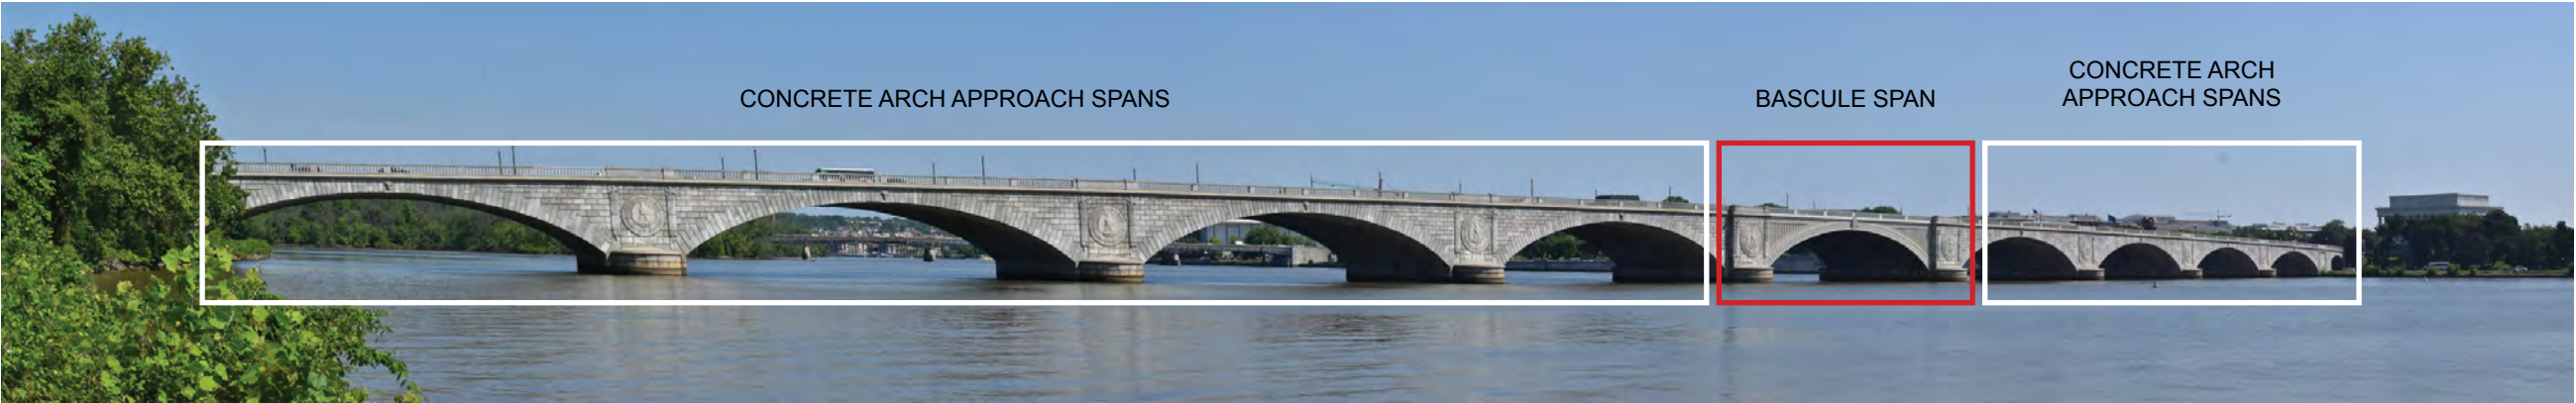
South Elevation looking North. Credit: Nathan Holth, courtesy HistoricBridges.org

The Arlington Memorial Bridge is 2,162 feet long and 94 feet wide and consists of ten reinforced concrete arch approach spans and a double leaf bascule span at the bridge's center. Eight of the ten approach spans convey the Potomac River under the bridge. Two smaller concrete arches span the GWMP, SW at each end of the bridge.

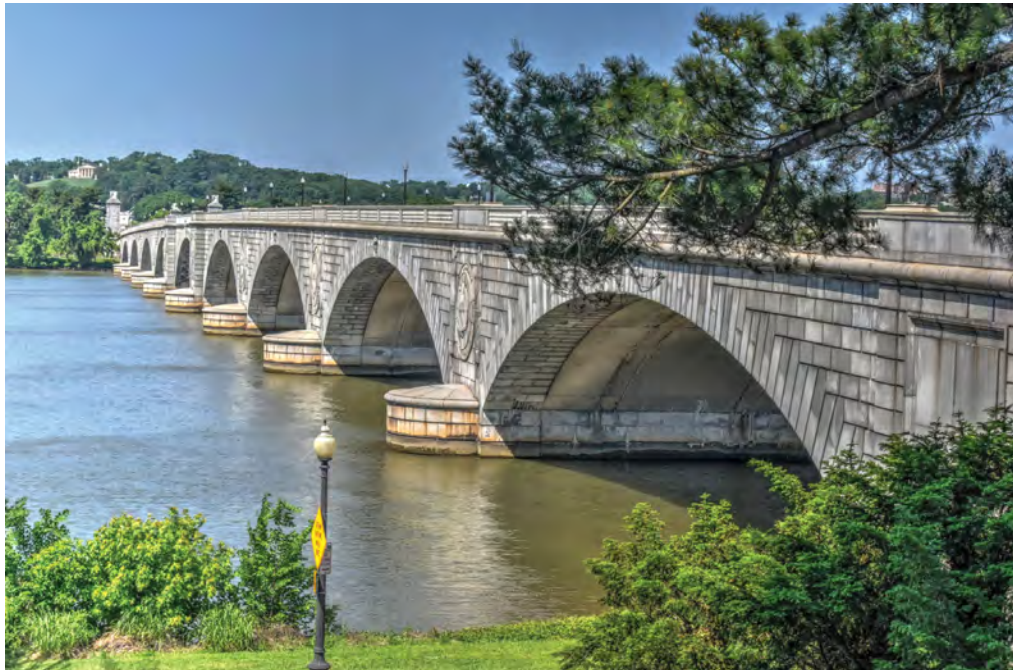
Granite facing on the concrete arch spans and cast-in-place concrete forming the underside of the approach span arches. Credit: Nathan Holth, courtesy HistoricBridges.org

- The **ashlar granite facing** on the exterior of the structure is in generally good condition. Granite masonry will be cleaned and repointed, with repair or replacement of cracked, broken or damaged blocks as required. Cleaning will include the performance of micro-abrasive cleaning on areas exhibiting heavy soiling, vegetation, foreign material, metallic and organic stains, efflorescence and exudation and paint/graffiti identified in the site survey. Special areas of masonry cleaning may be required for heavy staining. The gentlest method will be selected.

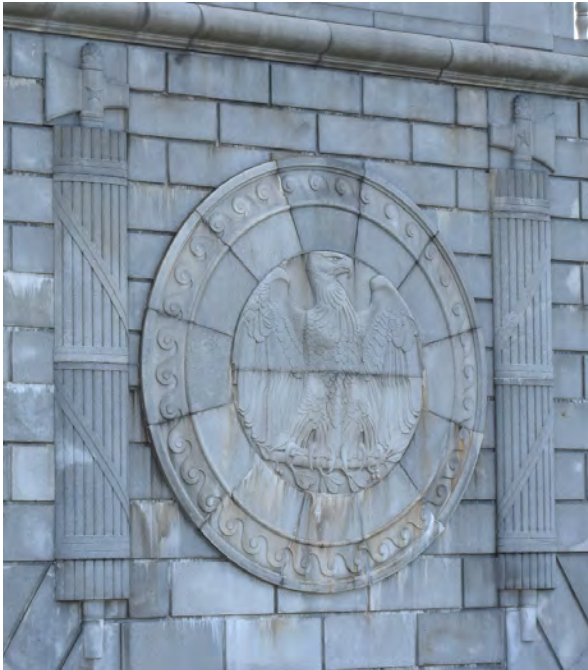
Carved granite eagle medallion & fasces  
Credit: Nathan Holth, courtesy HistoricBridges.org

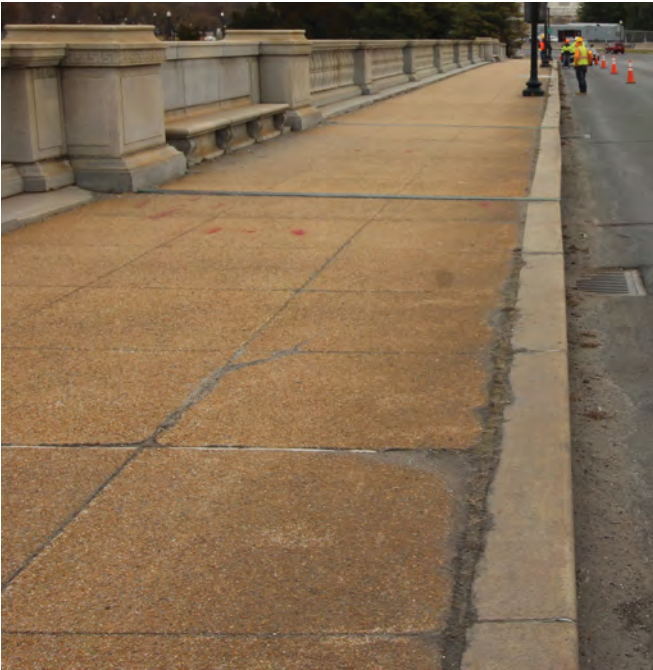
Exposed aggregate sidewalk and granite curbing  
Credit: Quinn Evans Architects

- The existing **exposed aggregate concrete sidewalk** will be replaced with an exposed aggregate concrete/polymer sidewalk to match in-kind the existing finish in texture, color and scored pattern.

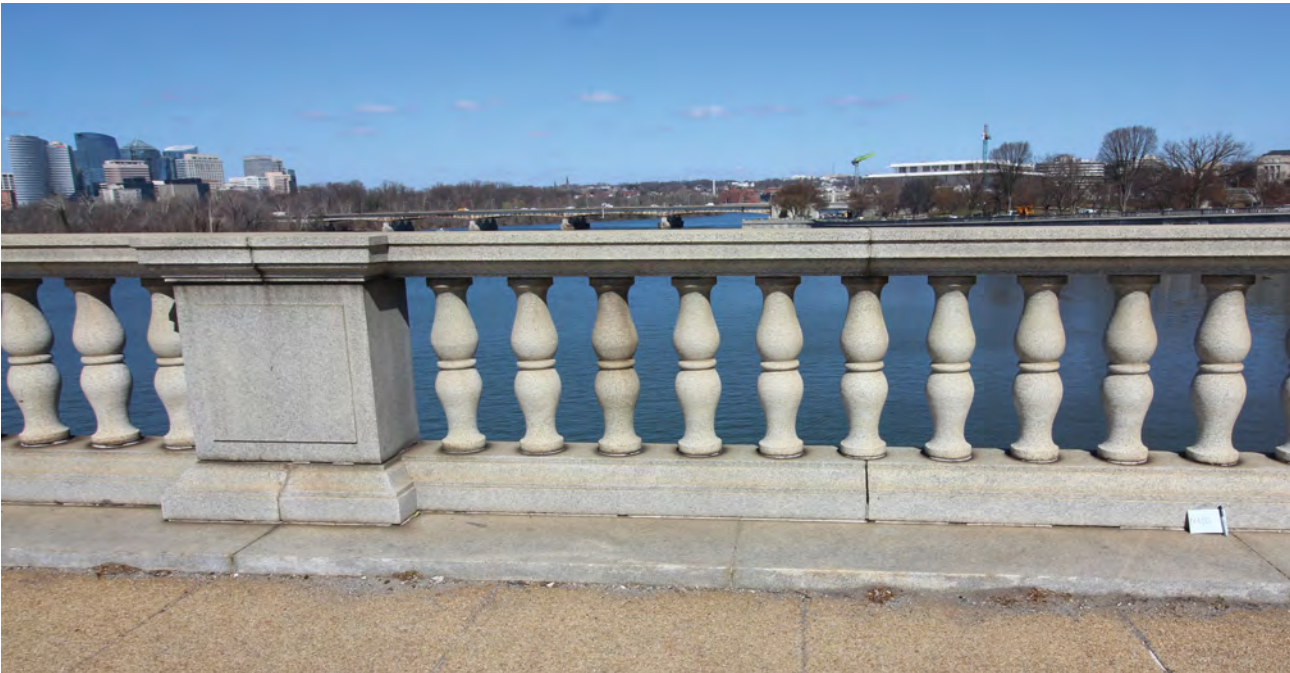
Granite balustrade. Credit: Quinn Evans Architects

- The existing **granite balustrade** which includes the railing, balustrade piers and granite bench seats, are part of the original construction and important architectural features of the bridge. Each granite element will be carefully labeled, removed, salvaged, and cleaned, with repair or replacement of broken or damaged blocks as required. Each element will be reset in the original positions as part of the new sidewalk construction.

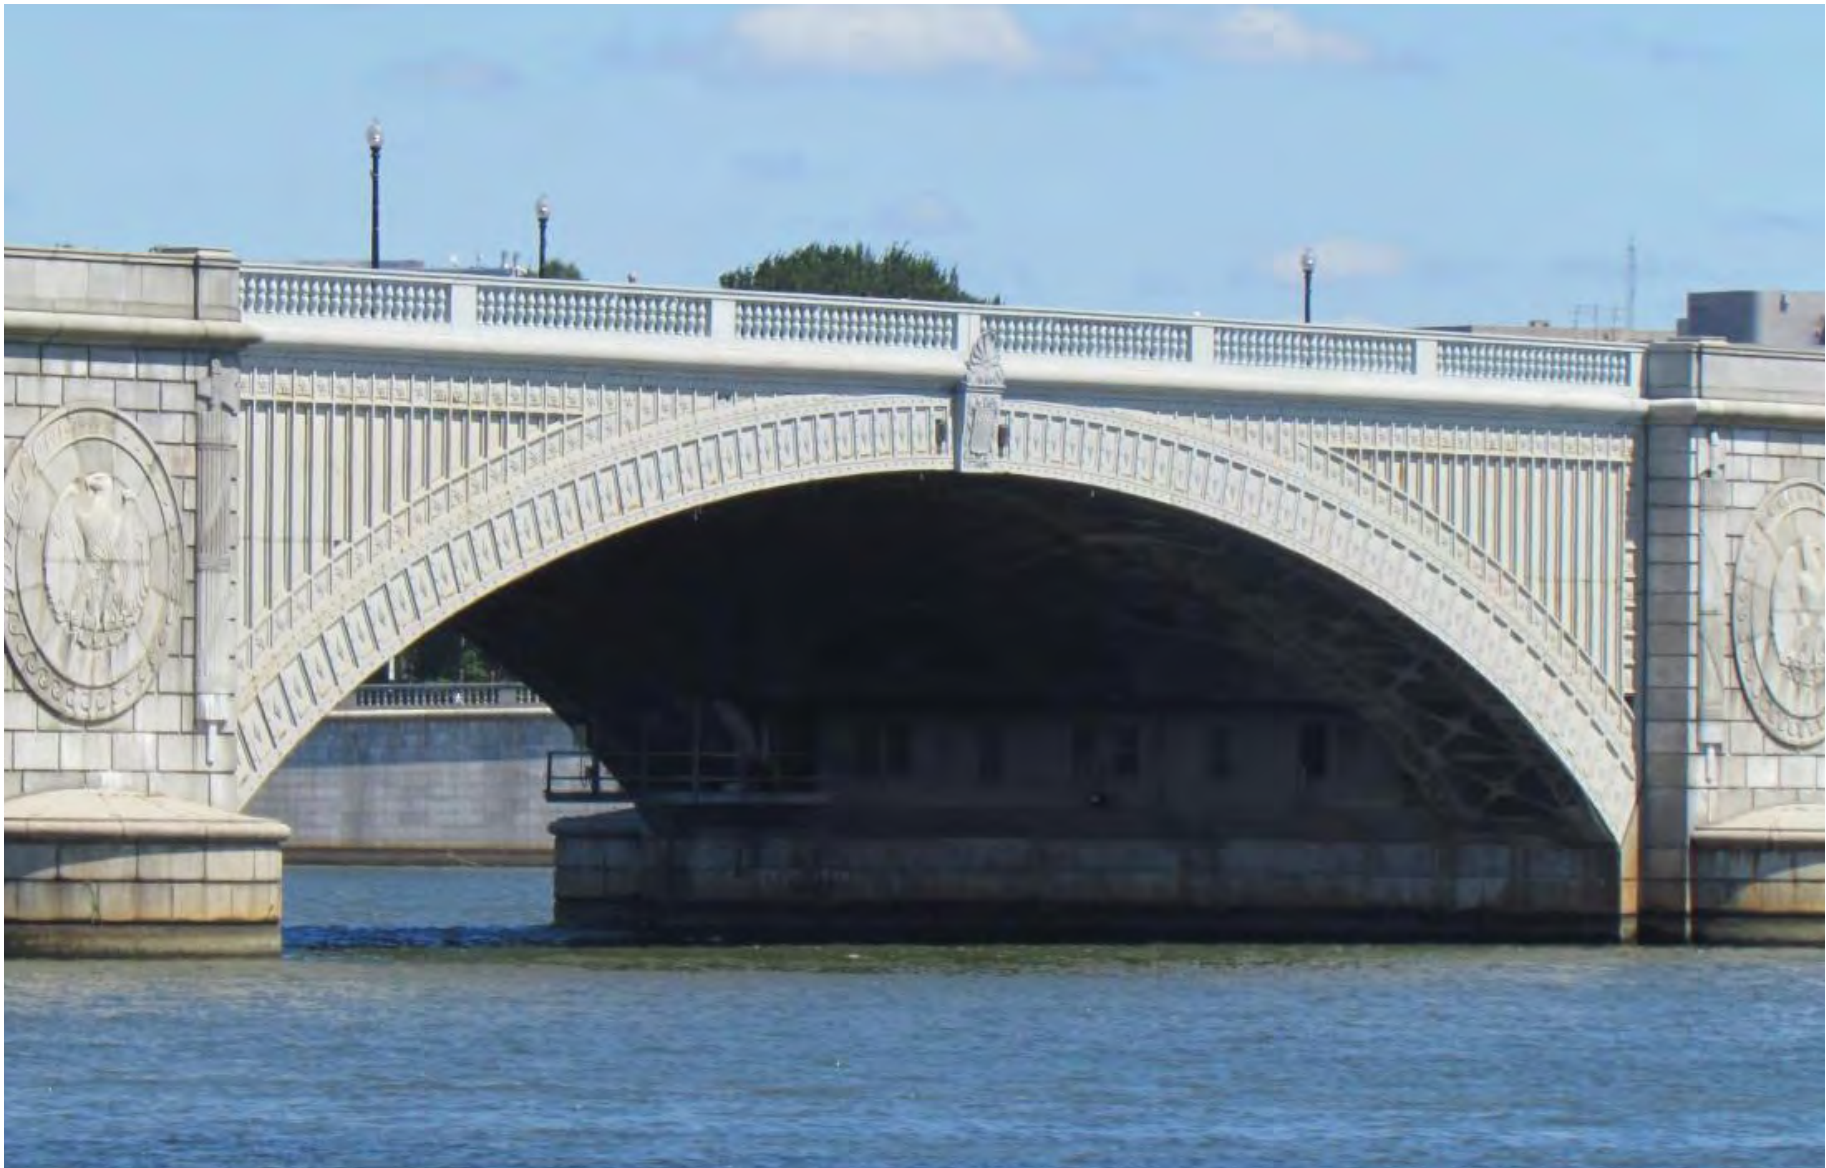
The bascule trusses on both sides are faced with ornamental steel fascia panels with decorative cast aluminum stars and buttons  
Credit: Nathan Holth, courtesy HistoricBridges.org

The existing fascia is comprised of a series of individual rust-proof panels that are bent, mitered, and welded together to form a uniform panel. The existing fascia panel is then attached to an existing fascia truss by a series of angle girders. It is these angles and the truss itself that give the fascia its strength and rigidity. Each span of the bascule includes one combined fascia truss and panel for a total of four on the bridge.

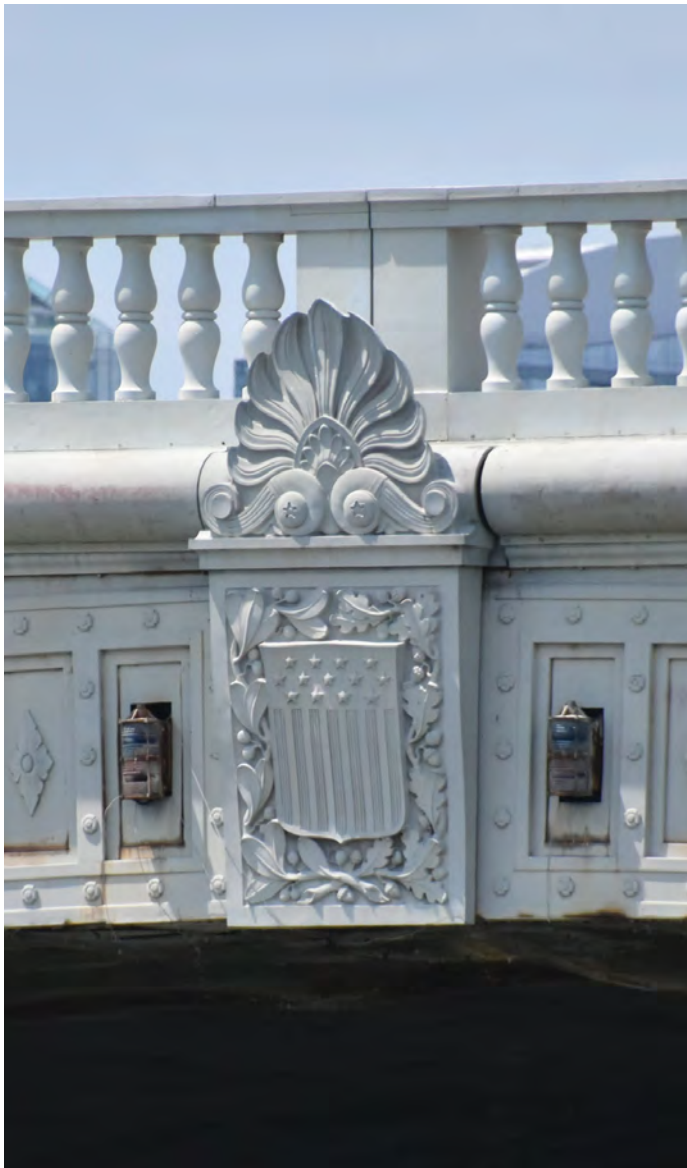
A cast aluminum cartouche sits at the center of the bascule span, flanked by red and green navigator lights  
Credit: Nathan Holth, courtesy HistoricBridges.org

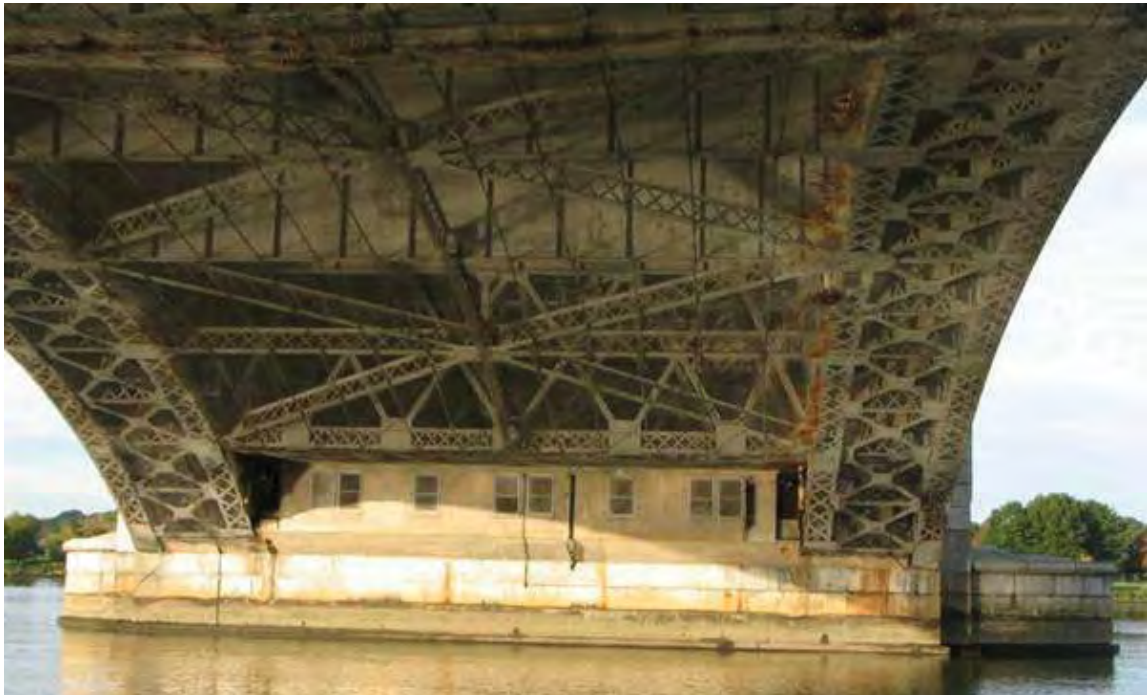
View of bascule span steel structure and east side of Abutment 3 including operating machinery room. Credit: Kiewit

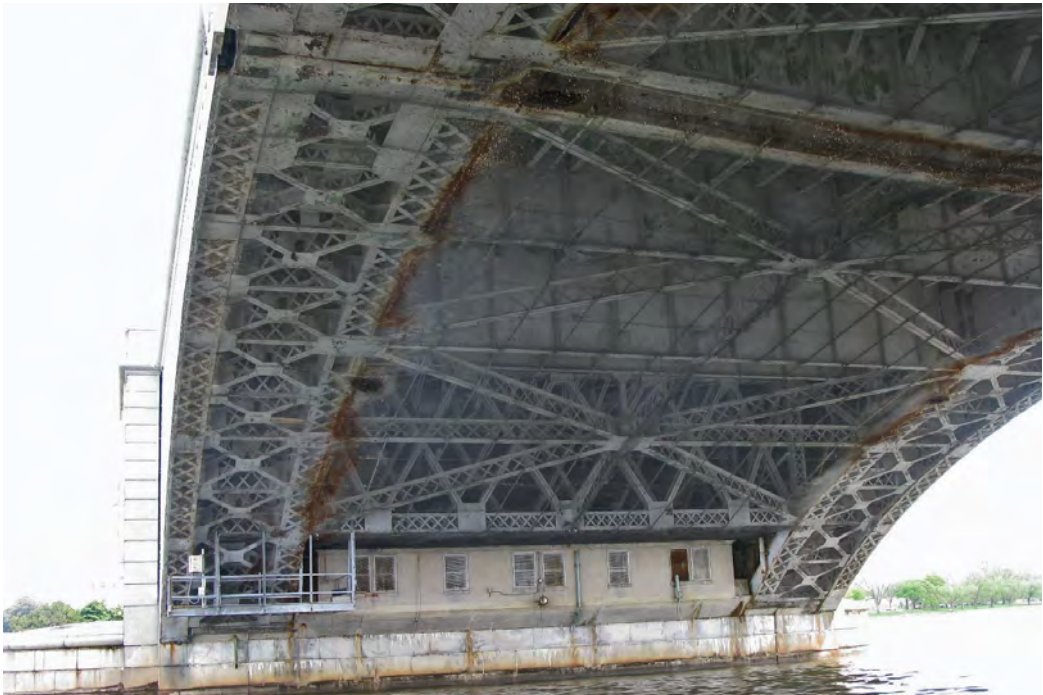
View of bascule span steel structure and west side of Abutment 2 including operating machinery room. Credit: Federal Highway Administration

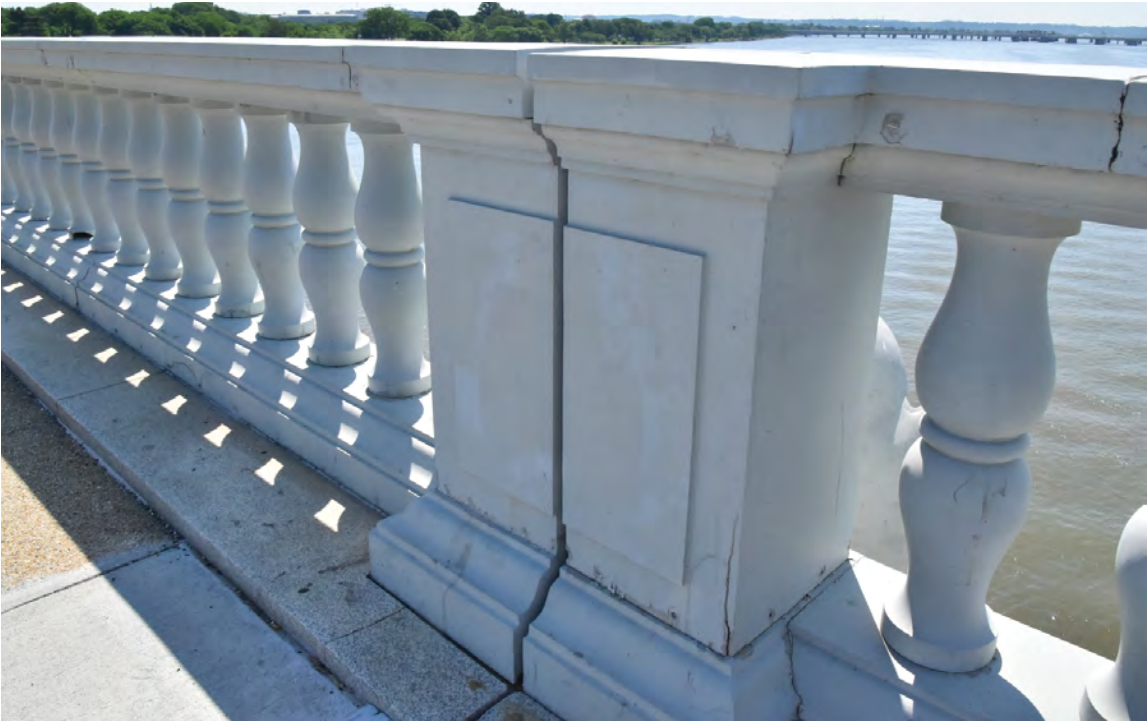
Aluminum balustrade. Credit: Quinn Evans Architects

- The existing **aluminum bridge railing** will be removed, repaired, and reinstalled, along with the existing light poles and granite curbs.
- The existing **exposed aggregate concrete sidewalk** will be replaced with an exposed aggregate concrete/polymer sidewalk to match in-kind the existing finish in texture, color and scored pattern.

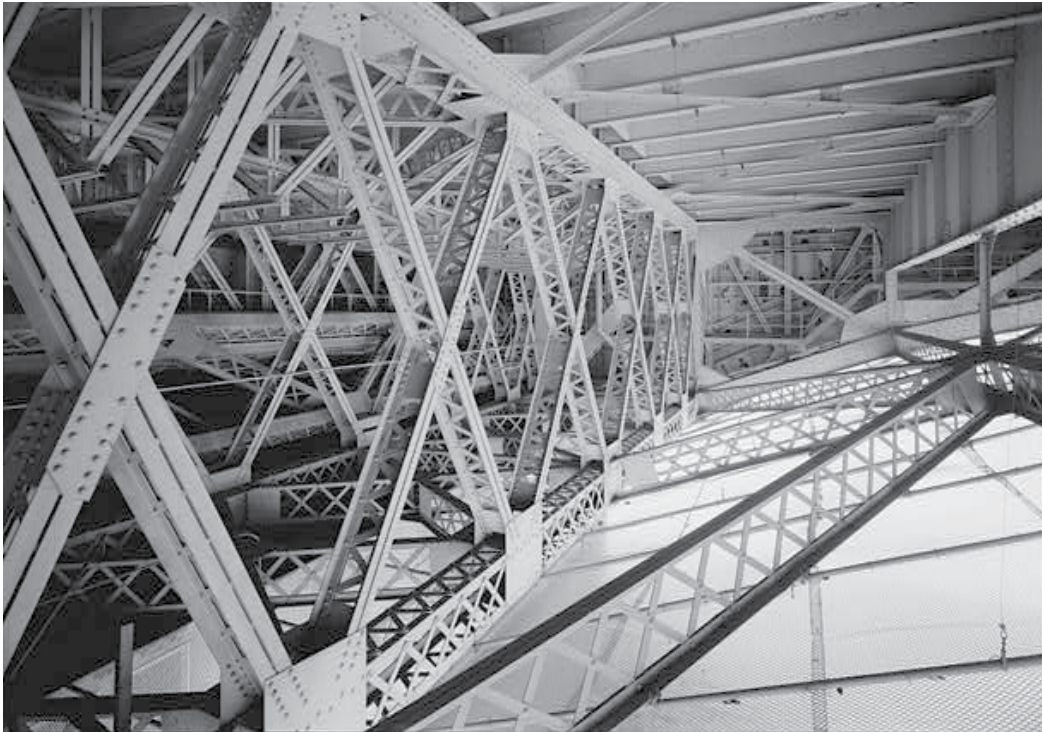
Transverse floor beams and bottom lateral bracing of the bascule span Credit: Library of Congress. Jet Lowe, Historic American Engineering Record, 1991.

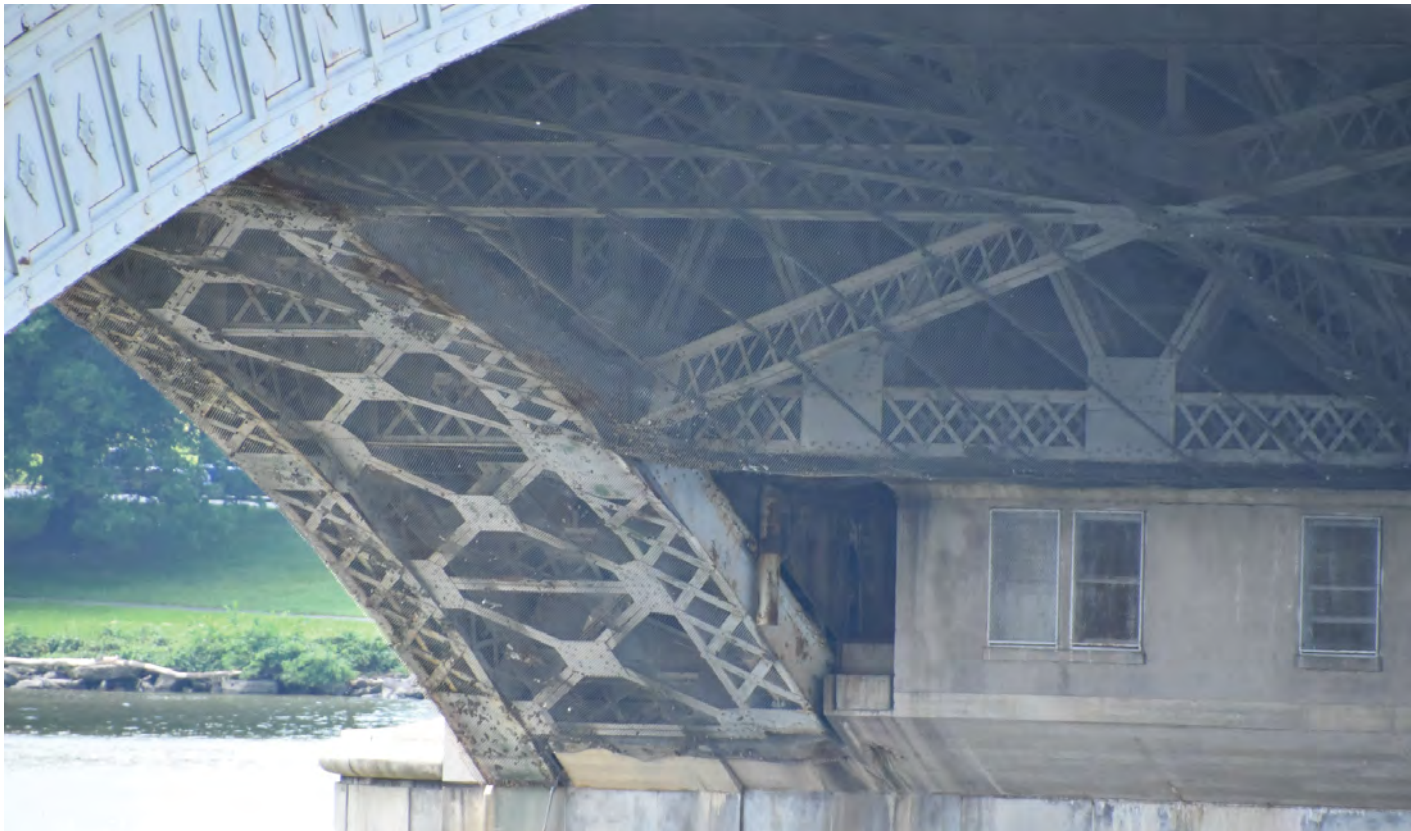
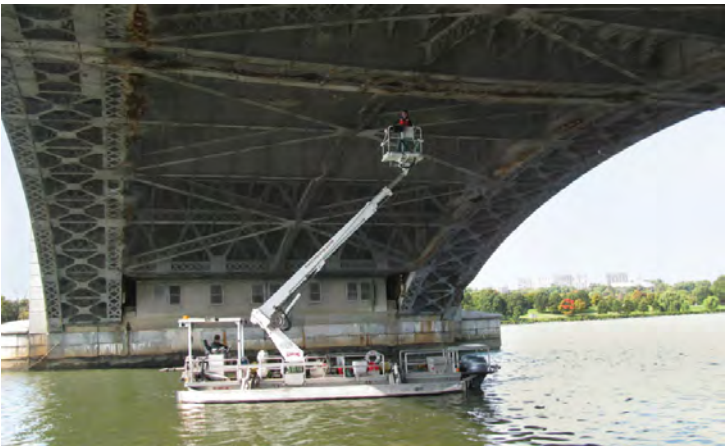
The existing bird nesting and dropping control system is installed at the entire underside of the bascule span along the underside of the existing trusses. The mesh density is 1" x 1" at a 45 degree angle hung using metal pipes. Existing bridge inspection methods involve removal of the bird netting to inspect the bridge elements from a boat lift.

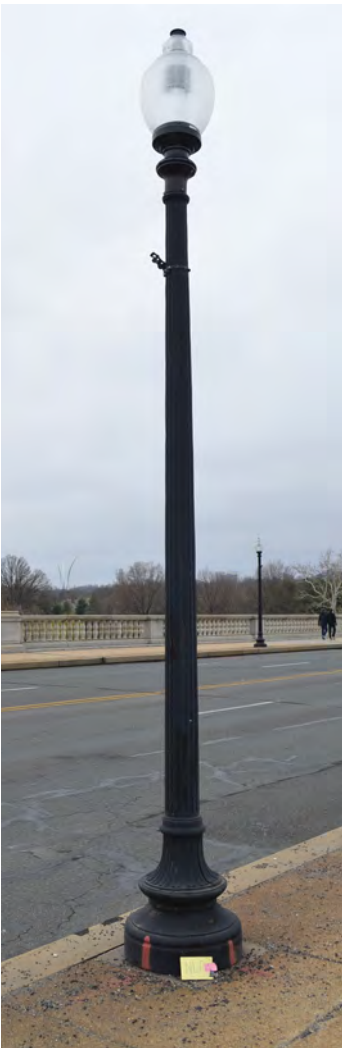
Cast iron lamp post

The forty 15'-high lamp posts are replicas of the original ones, which were a standard used throughout the city of Washington, designed by Francis D. Millet.

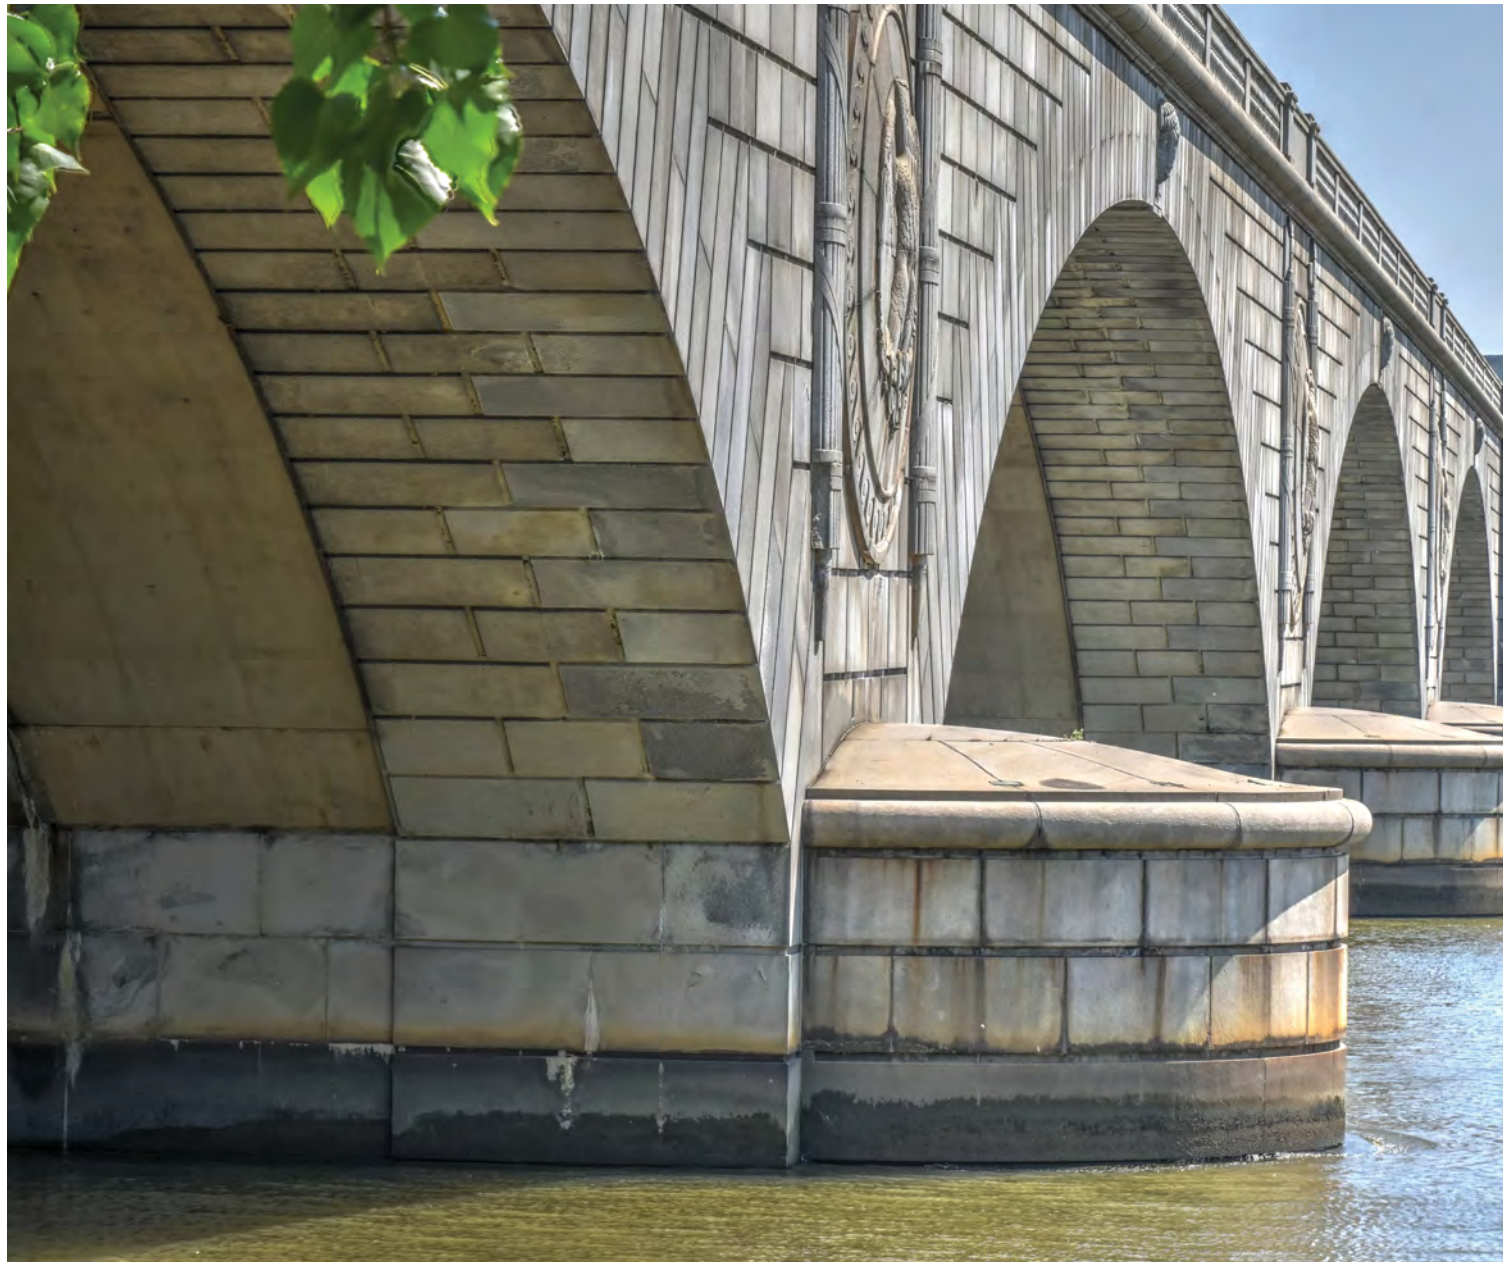
The scope of the concrete arch approach spans includes the following structural repairs:

- The ten reinforced concrete arch spans require varying levels of **structural repair**. The work needed to rehabilitate the concrete arch spans includes filling cracks with epoxy, patching concrete spalling with concrete repair compound, and replacing the concrete edge beams.

- Several **concrete bridge piers** have cracking and scouring surrounding the piers that require repair below water. In order for structural repairs to occur, cofferdams will be installed to dewater the area around the bridge piers. This allows concrete repairs to be completed in a dry working environment. Cracks in the bridge piers/abutments will be filled using a material suitable for underwater applications. Undermined footing areas will be filled with grout.

- The bridge's **expansion joints** will be replaced to allow for expansion and contraction that results from changes in temperature and to minimize water intrusion at each joint.

- **Bridge bearings** will be replaced. The bridge bearings support the bridge superstructure, transfer loads from the superstructure to the substructure, and provide the ability for the superstructure to move and rotate.

- The existing **concrete bridge deck** will be removed and replaced with a full depth precast concrete deck panel system designed to minimize water intrusion. An overlay will be installed on top of the deck that will serve as the road surface.

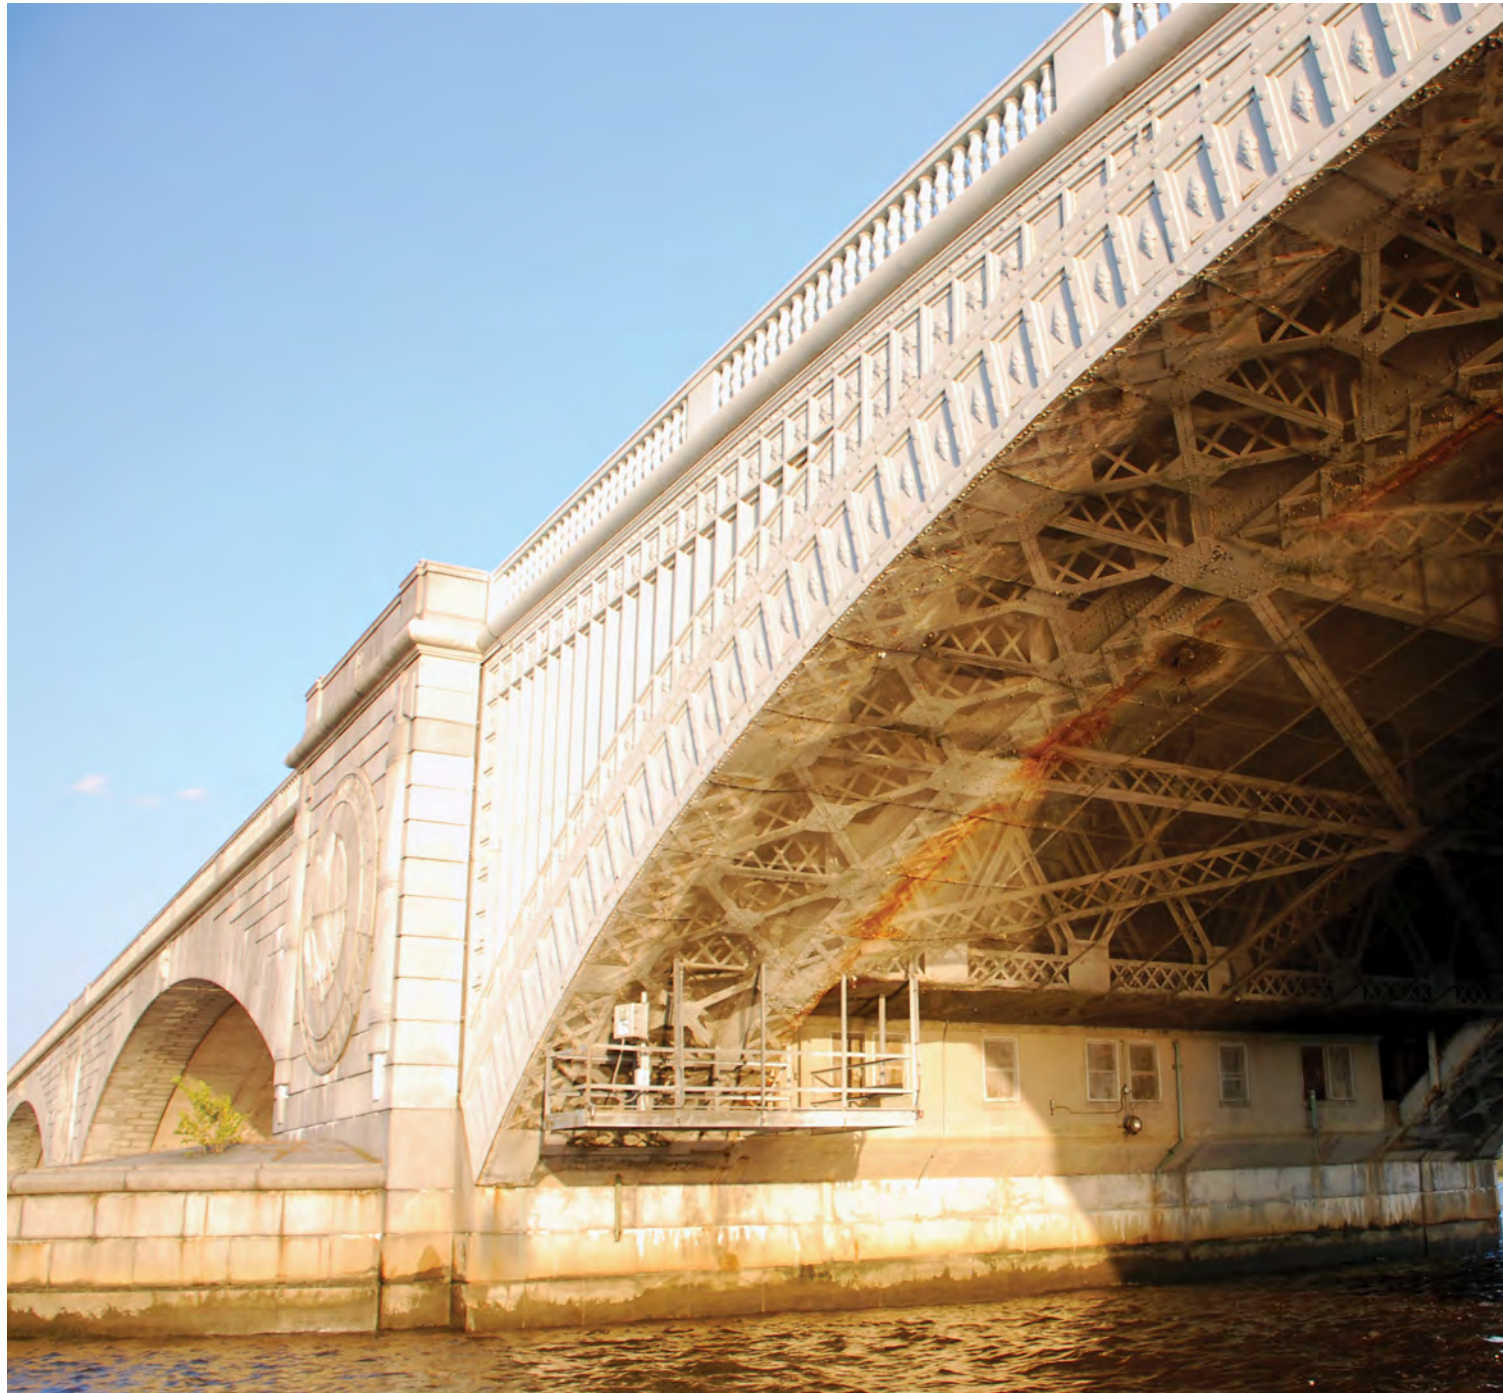
The scope of the bascule span includes the following:

- **Replacement of the existing bascule span** with a new fixed span comprised of variable depth steel girders and K-frame diaphragm members. The width of the bottom flange of the girders will be 28". The underside of the replacement structure will be arched to mimic the current bascule span arch; however, the bridge will no longer have the appearance of truss construction.

- The **overlay** that will replace the existing asphalt road surface will be the only element on the top of the replacement span that would not replicate the original bascule span due to the difference in color between the existing black asphalt surface and the traditional gray color of concrete.

The Federal Highway Administration estimates that the variable depth steel girder replacement span will have a design life of 75 years. During this time, maintenance activities would be required including repainting the structural steel approximately every 25 years, installing new expansion joints and bearings approximately every 20 years, and installing a new overlay approximately 25 years into the life of the structure. Other than scheduled routine inspections of the structure, no additional work would be expected.

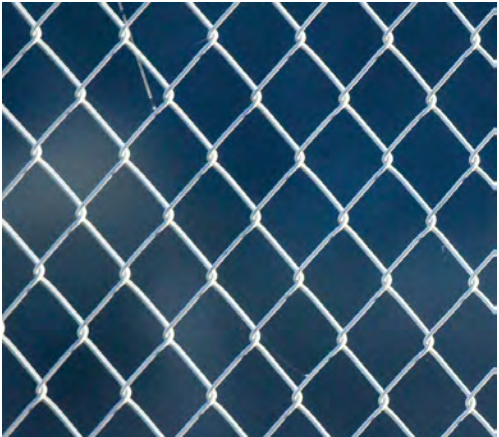
1" X 1" mesh

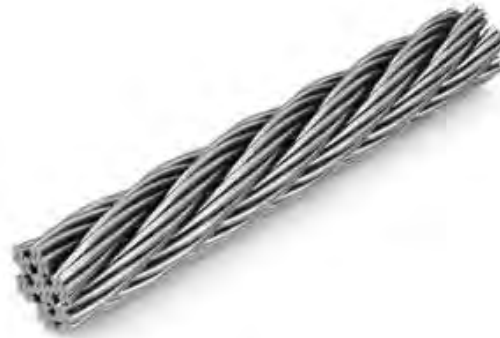
3/4" diameter cable
