U.S. National Arboretum Administration Building Roof Replacement

Approval of Preliminary and Final Site Development Plans

United States Department of Agriculture

Project Summary

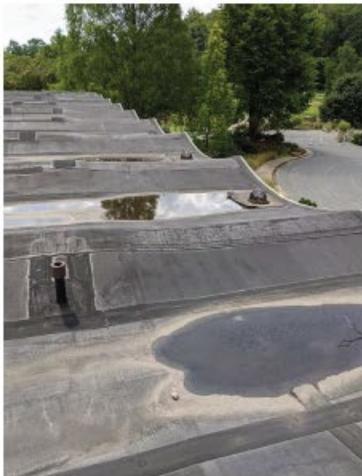
TYPICAL CONDITION WITH PONDING AND CURLING OF MEMBRANE

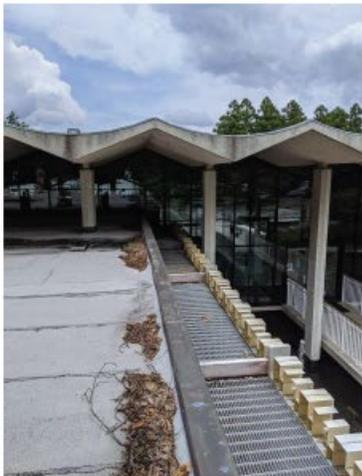
EXISTING COPING CONDITION AND FLAT ROOFING SEAMS

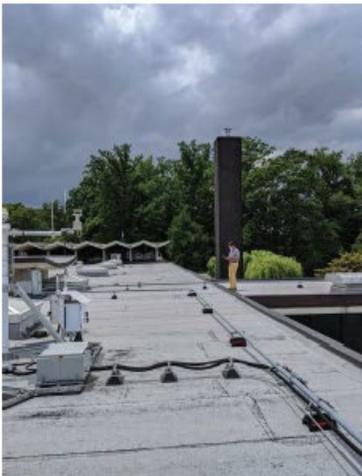
EQUIPMENT ON ROOF OF THE OFFICE WING

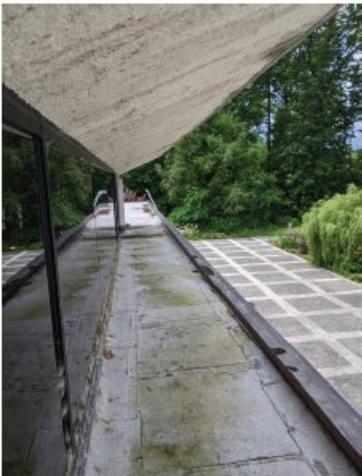
NORTH SIDE OF THE OFFICE WING ROOF UNDER OVERHANG OF LOBBY WING ROOF

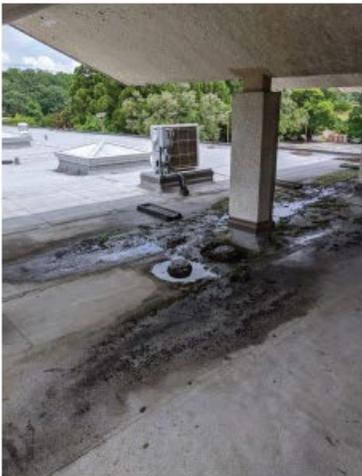
PONDING AND BIOLOGICAL GROWTH ON ROOF OF THE OFFICE WING

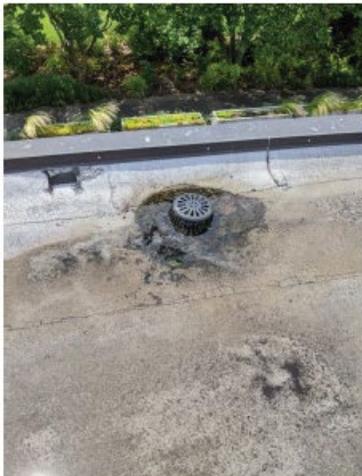
ROOF DRAIN CLOGGED AT ROOF OF THE HERBARIUM WING

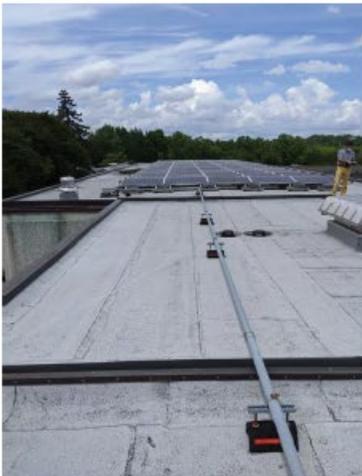
EXISTING SOLAR PANEL ARRAY

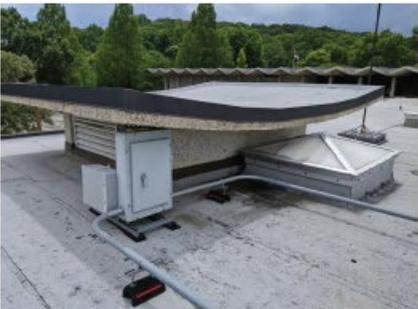
ELEVATOR PENTHOUSE ROOF

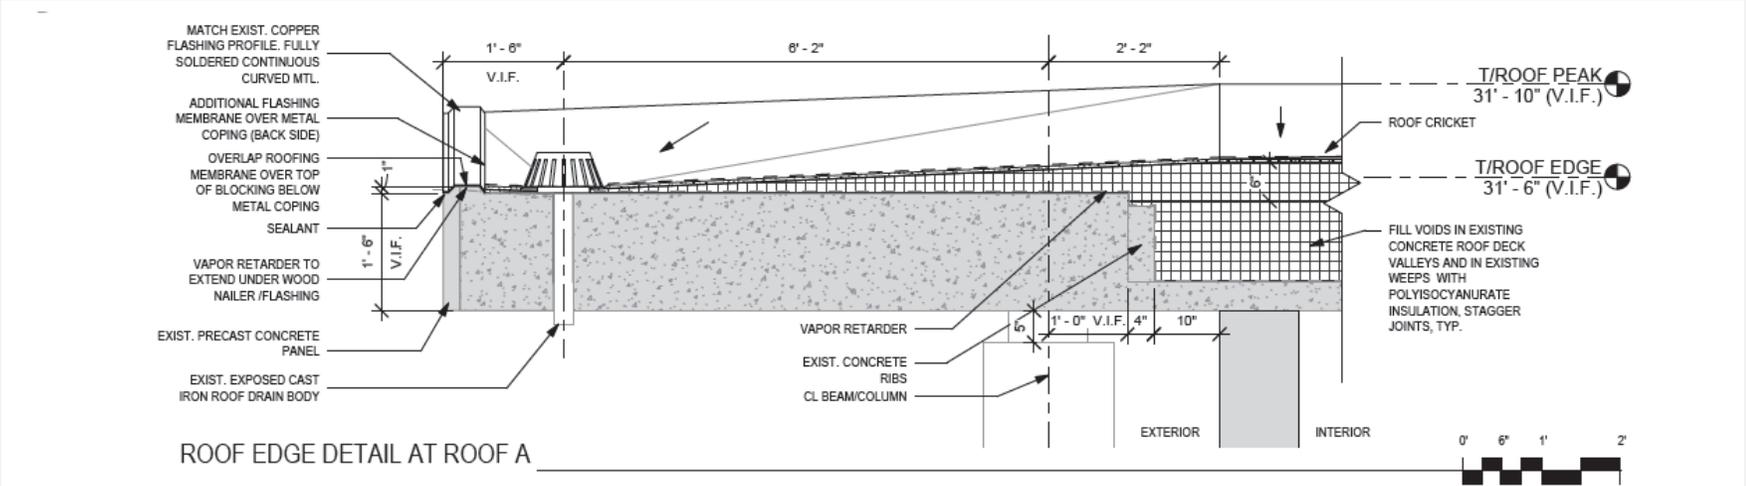
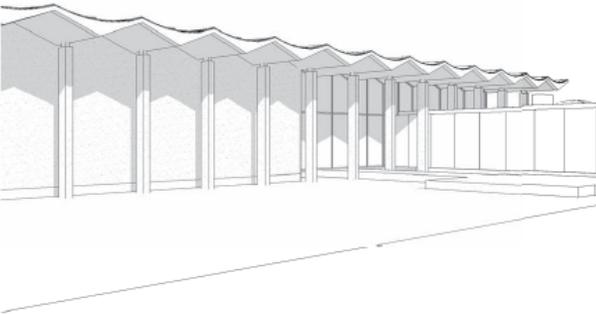
5 - ROOF A - PROPOSED VIEW LOOKING NORTHWEST
 ADDED INSULATION IS NOT SEEN FROM GROUND PLANE AND REPLACEMENT ROOFING SYSTEM MATCHES EXISTING EDGE PROFILE

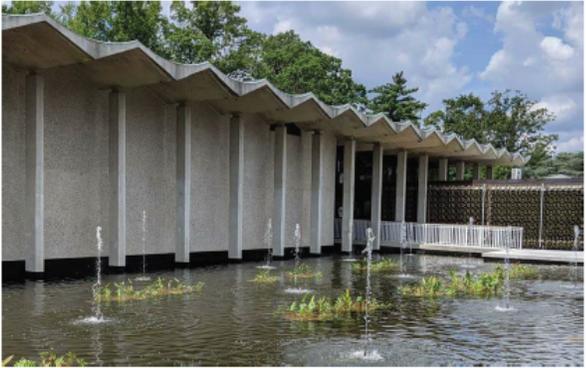
6 - ROOF A - EXISTING EAST SIDE

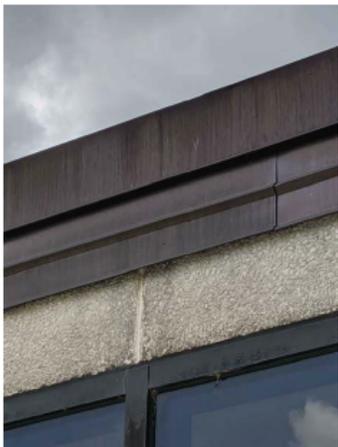
9 - ROOF B - EXISTING COPING PROFILE

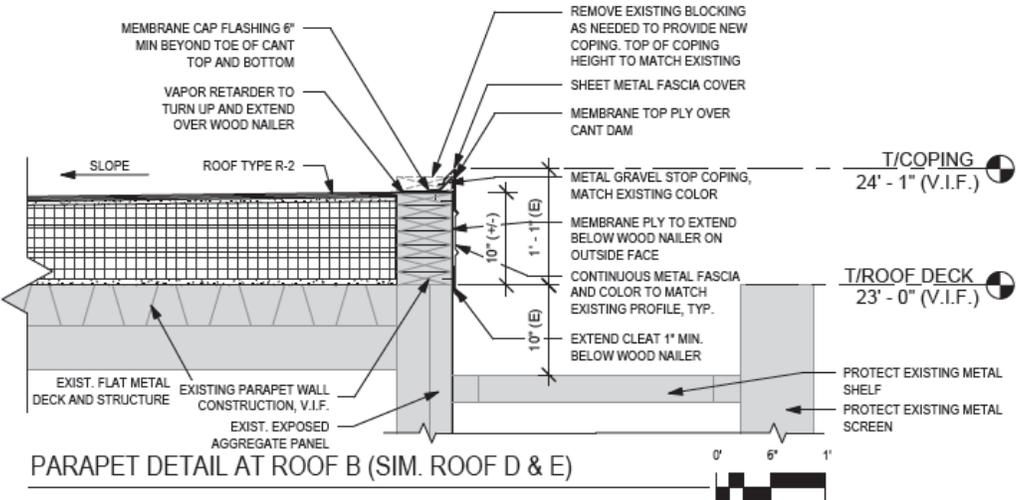
PARAPET DETAIL AT ROOF B (SIM. ROOF D & E)

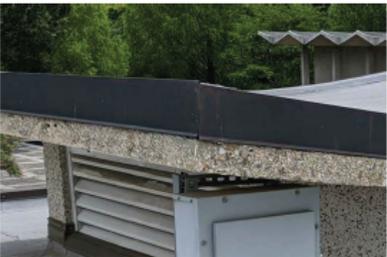
10 - ROOF C - EXISTING COPING PROFILE

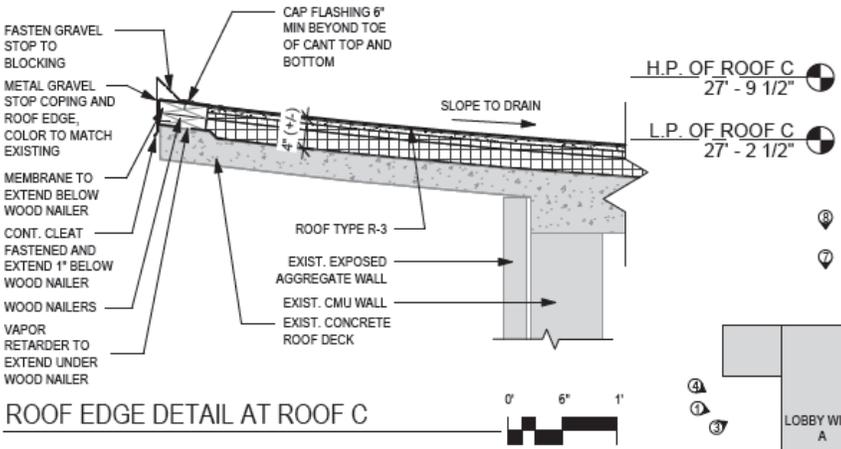
ROOF EDGE DETAIL AT ROOF C

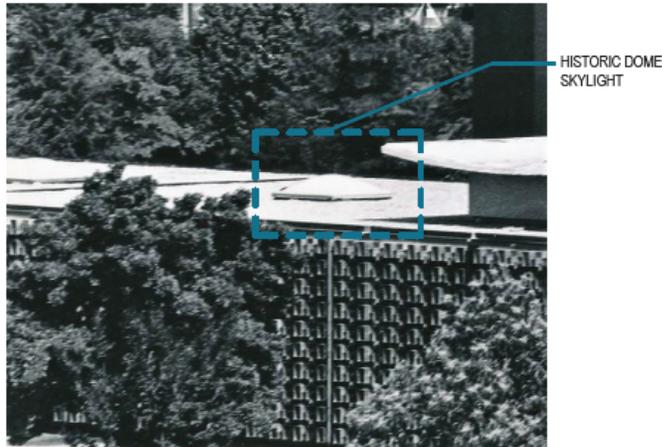
11 - ROOF B - HISTORIC SKYLIGHT PROFILE

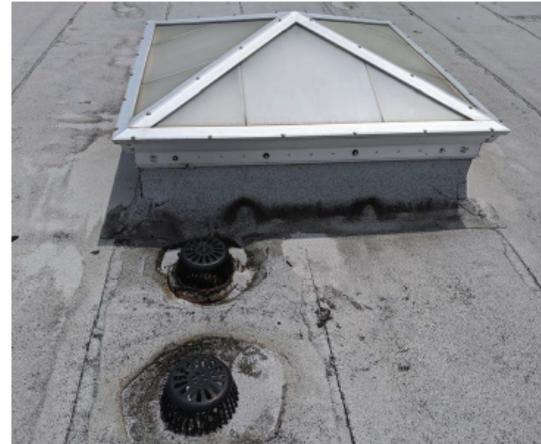
12 - ROOF B - EXISTING SKYLIGHT PROFILE

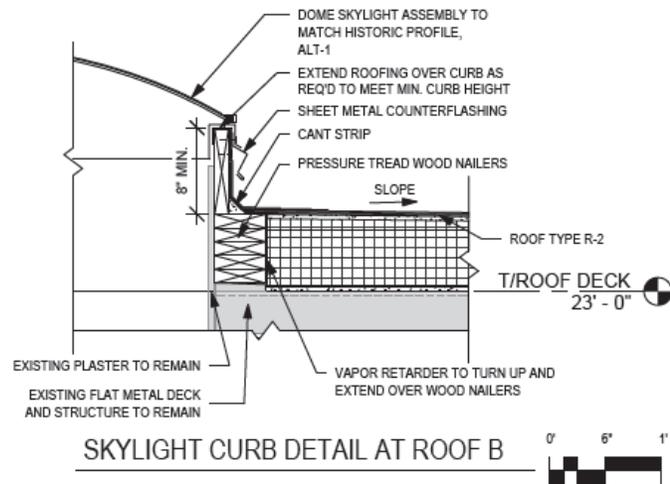
SKYLIGHT CURB DETAIL AT ROOF B

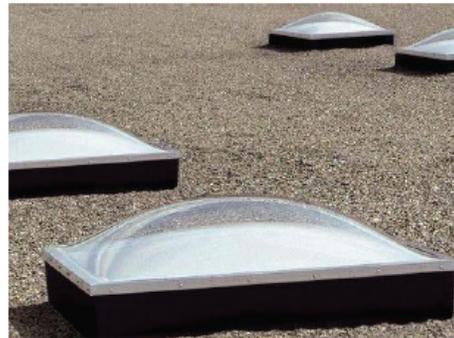
PROPOSED DOME SKYLIGHT
