Fort McNair Building 17 Renovation

100 C Street, SW, Washington DC

Approval of Preliminary Building Plans

United States Department of Defense

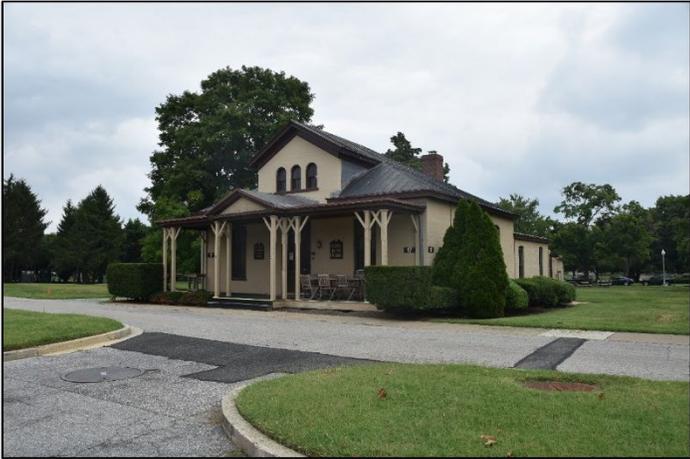
Figure 1: Building 17, west (front) elevation, facing east-northeast.

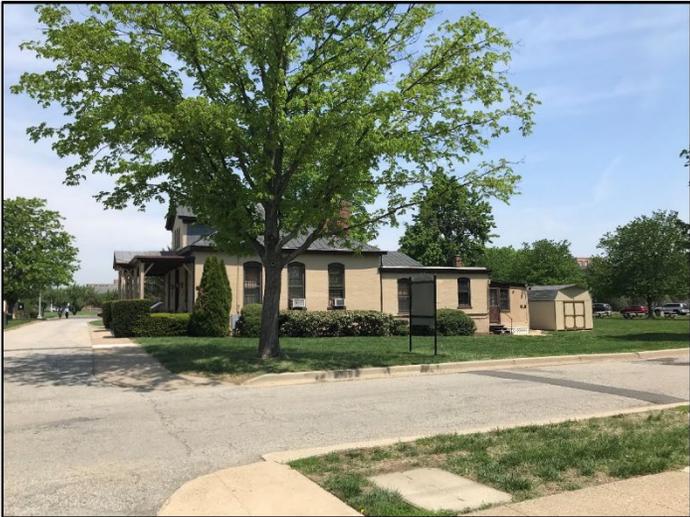
Figure 2: Building 17, general view looking northeast.

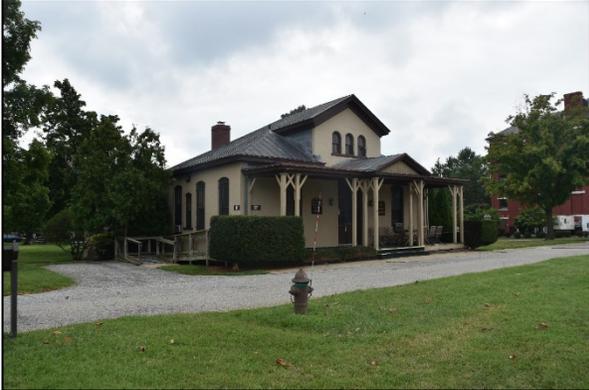
Figure 3: Building 17, west (front) elevation, facing east-southeast.

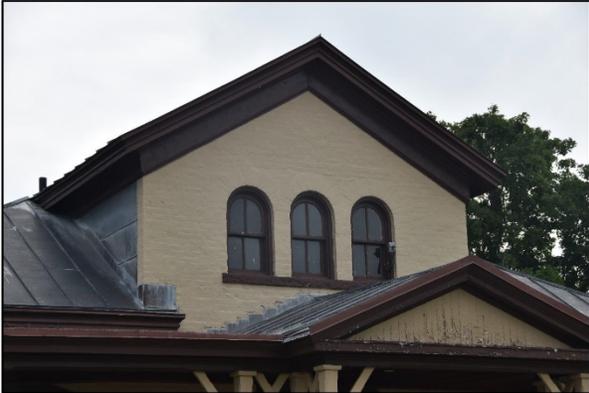
Figure 4: Building 17, detail of west (front) dormer, facing east-southeast.

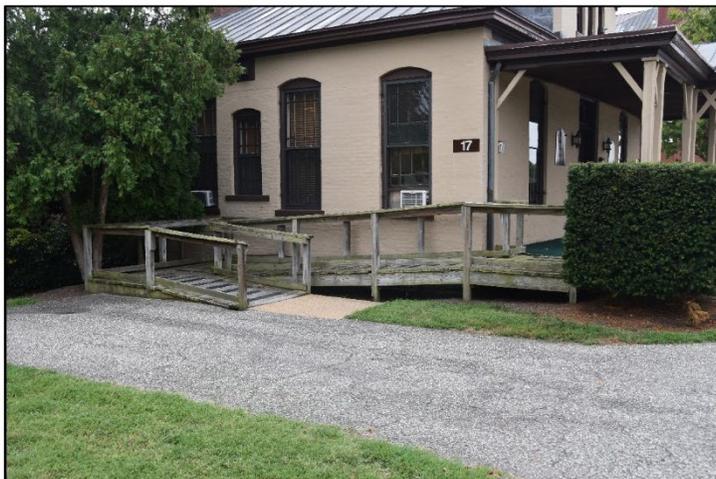
Figure 5: Building 17, detail of northwest corner and the current wood ramp, facing southeast.

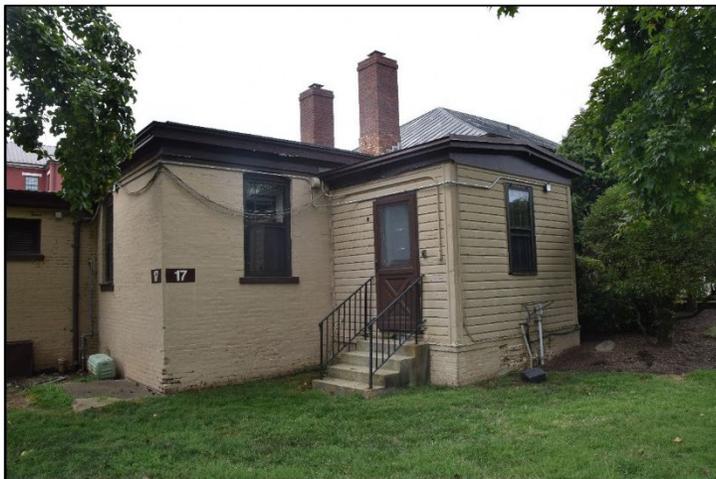
Figure 6: Building 17, north (rear) corner, showing frame addition (former communications space), facing southwest.

The Department of Defense, Department of the Army, has submitted preliminary building plans for proposed renovations of Building 17 at Fort McNair in Washington, DC. The exterior scope of work includes removal of the non-original, wood-framed addition on the north rear side of the building; removal of the non-original, wood-framed addition on the southeast (rear) corner of the building; and the removal/in-kind replacement of the non-historic, frame ramp on the north end of the porch. Where additions have resulted in the conversion of window openings into door openings, the original window openings will be restored, as appropriate, using salvaged bricks. If missing or damaged beyond repair, new windows will be provided that match the existing historic units. All historic brick chimneys will be retained and examined for any needed repairs. The exterior of the building will be cleaned with a low-pressure water spray, and the painted brick and wood trim scraped, repaired, and repainted, as necessary. Two new masonry additions will be constructed on the northeast and southeast (rear) corners, adjoining the centrally located brick mechanical room. The mechanical room will revert to its original use as restrooms. The additions will be respectful of the massing, proportions, and details of the original building and will be slightly offset to differentiate them from the original building. Door openings, accessed by concrete steps, will be located on the east (rear) elevations of both new additions.

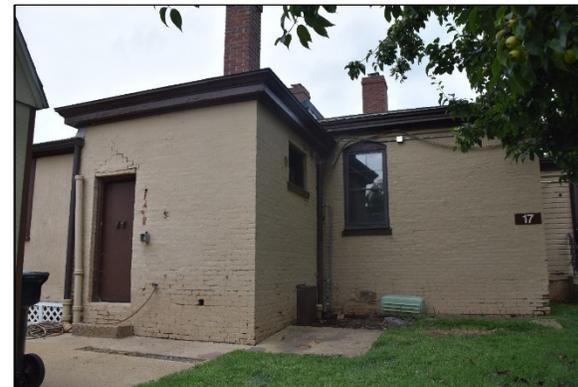
Figure 7: Building 17, northeast rear corner, showing the original center rear wing (former toilet room) (left) and the location of one of the proposed new additions (right), facing west.

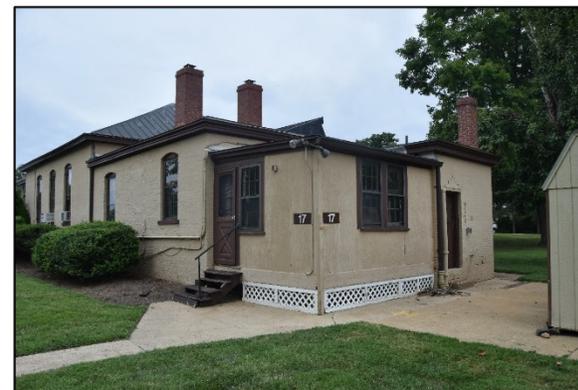
Figure 8: Building 17, southeast (rear) corner, showing the non-historic frame addition to be removed and replaced with one of the proposed new additions, facing northwest. Note the chimney on the center rear wing.
