NAVFAC WNY B76 RENOVATION BRIEF

BUILDING 76, WASHINGTON NAVY YARD

- Full facility renovation for National Museum of the United States Navy (NMUSN) support facility (admin & support spaces for artifact processing, conservation, and museum support (workshops, etc.)

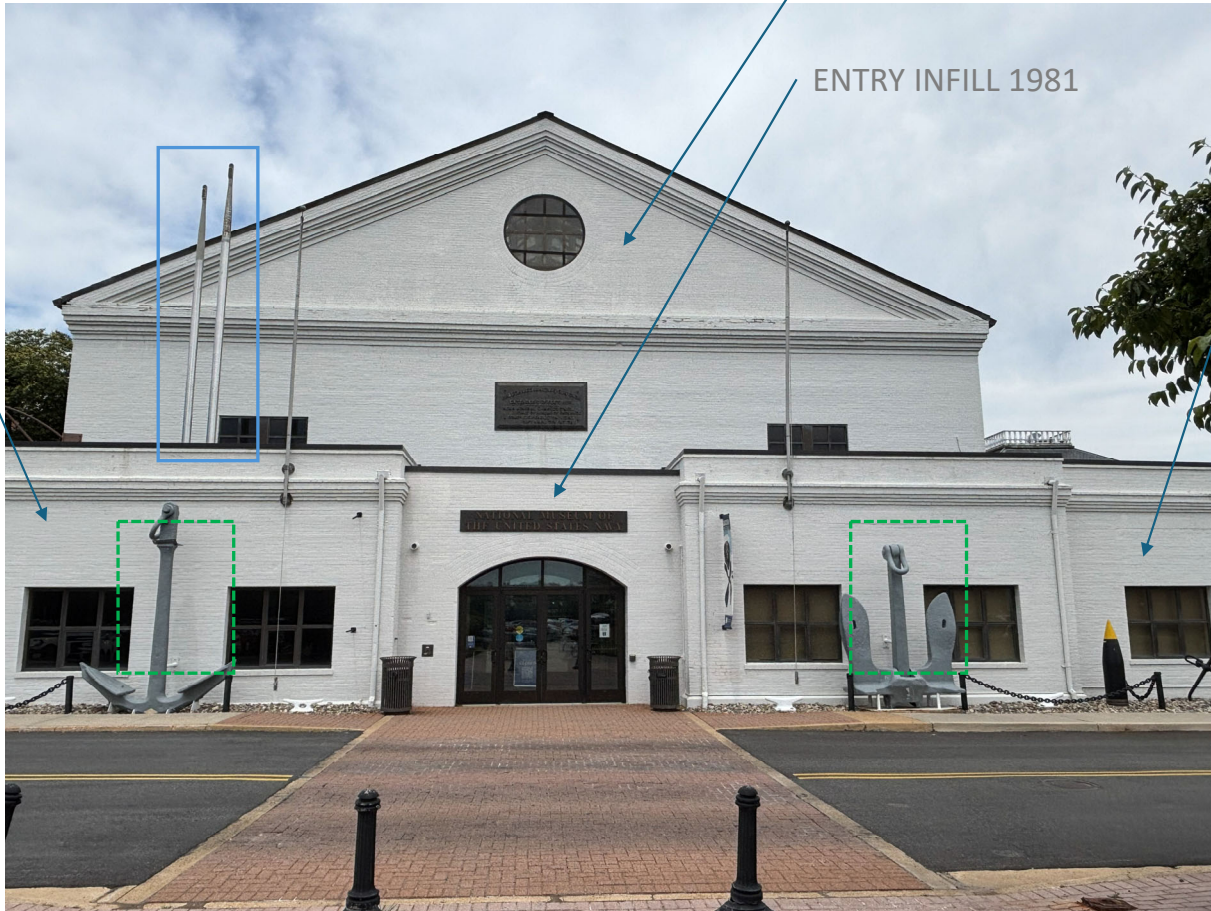
ORIGINAL 1889

ENTRY INFILL 1981

EAST ADDITION 1917

- REPLACE OPENINGS (AT MAIN BLDG.)
- REPAIR, REPOINT BRICK
- REPLACE ROOFS & DRAINAGE
- REMOVE PERISCOPES
- REMOVE PAINT

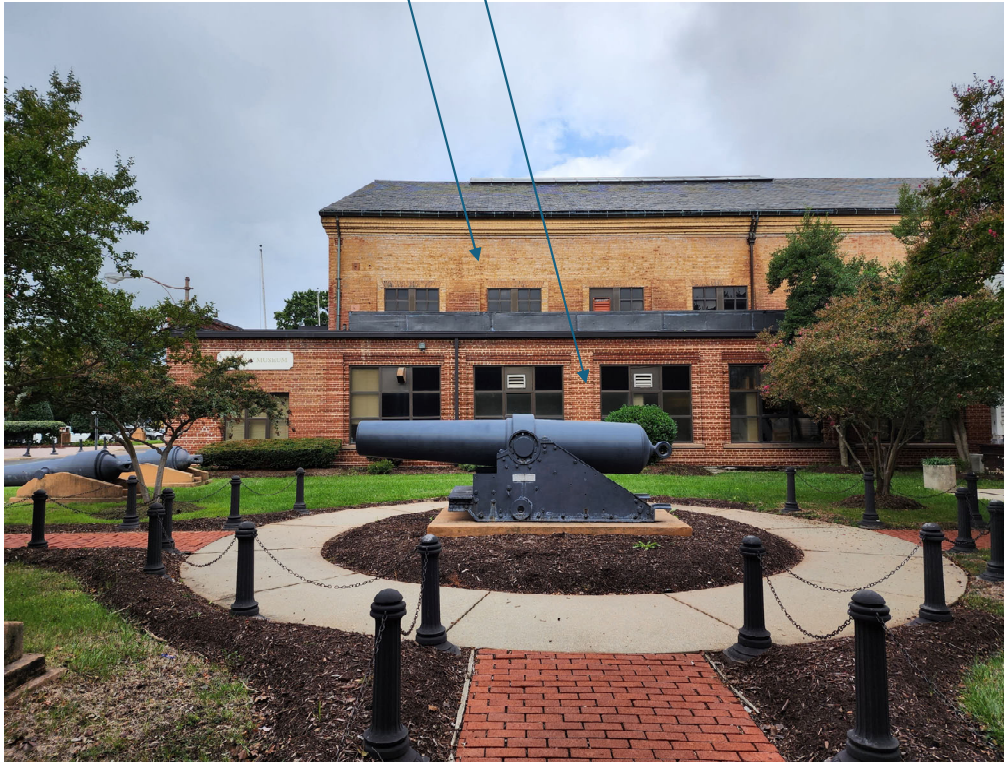
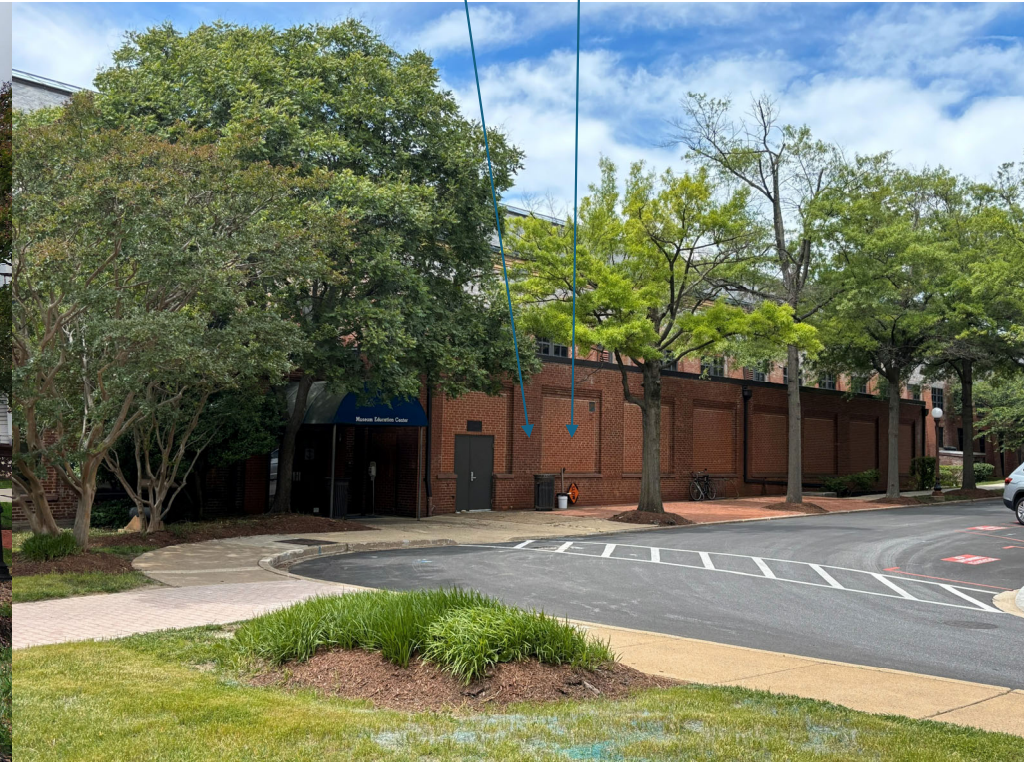
EAST – SOUTH END

ORIGINAL 1889

ADDITION 1917

ADDITION BELIEVED TO BE 1940s

WINDOWS INFILLED

- REPLACE OPENINGS TO MATCH ORIGINAL

- REPAIR, REPOINT BRICK

- REPLACE ROOFS & DRAINAGE

- MAINTAIN INFILL AREAS

- REMOVE AWNING

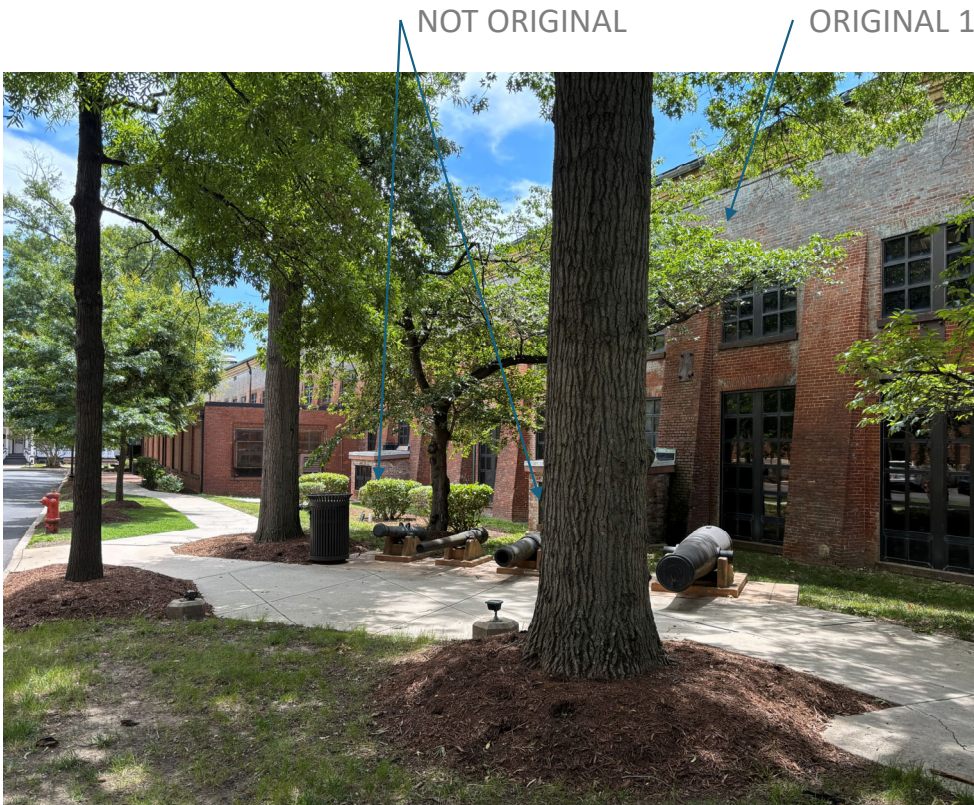
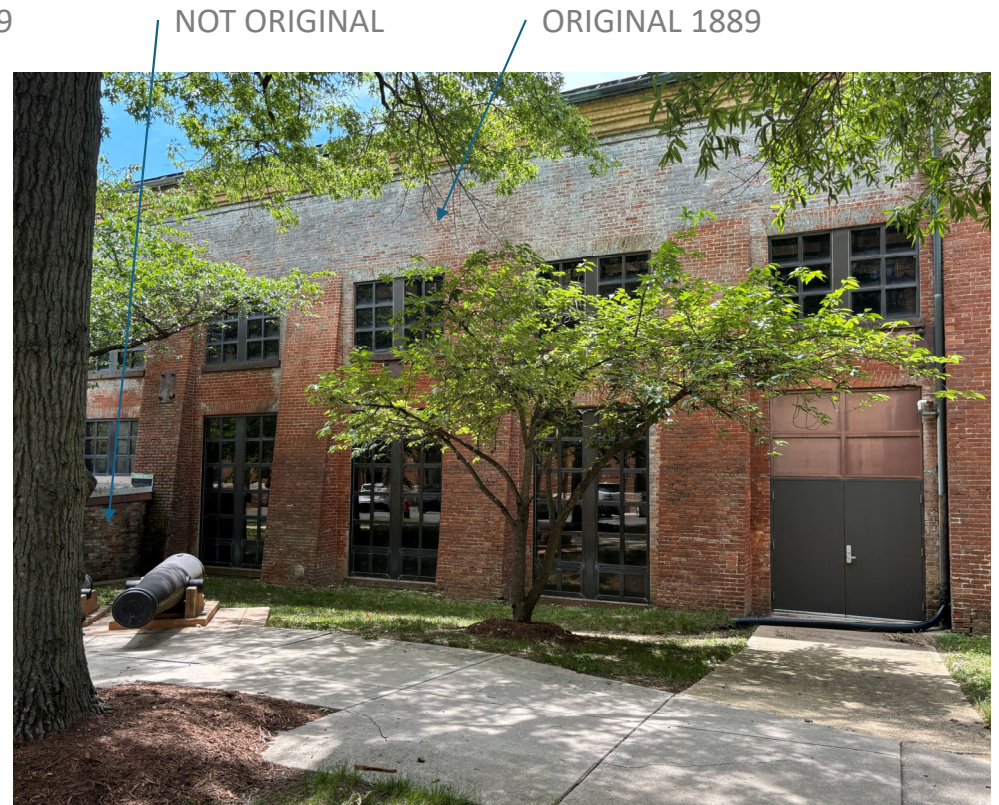
EAST – NORTH END

- REPLACE OPENINGS TO MATCH ORIGINAL

- REPAIR, REPOINT BRICK

- REPLACE ROOFS & DRAINAGE

- MAINTAIN INFILL AREAS

- DEMOLISH LEAN-TOS

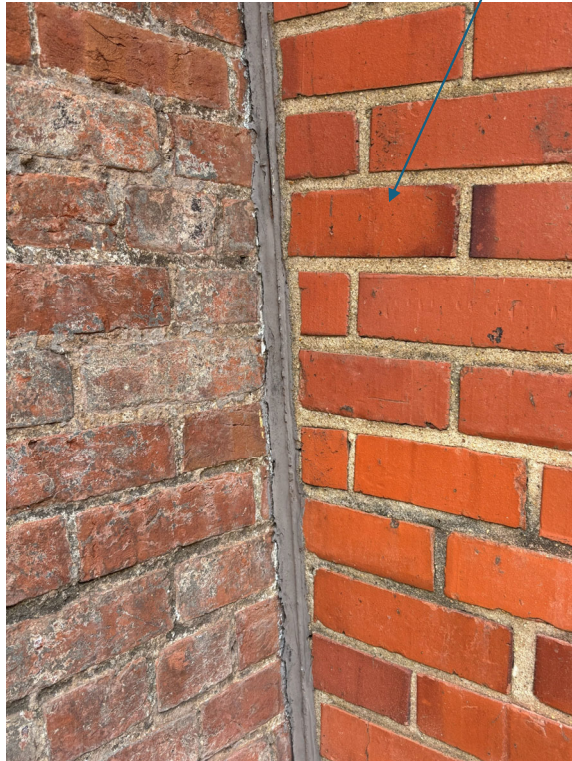
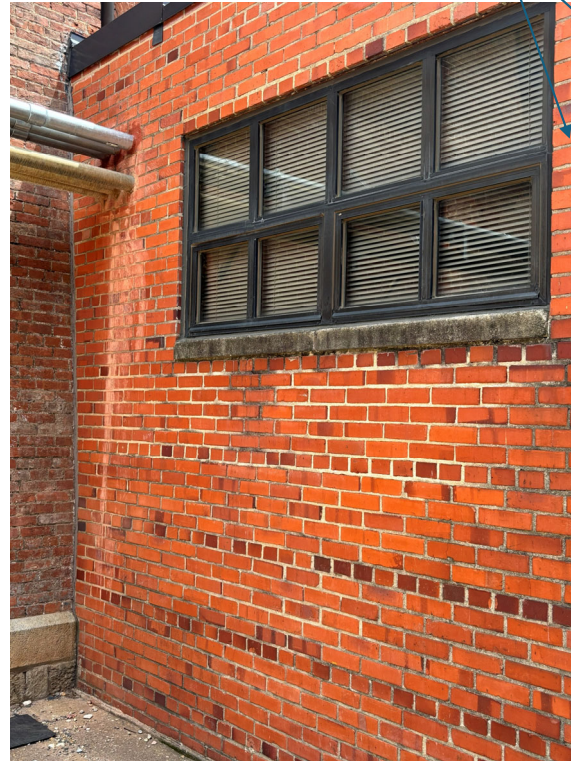
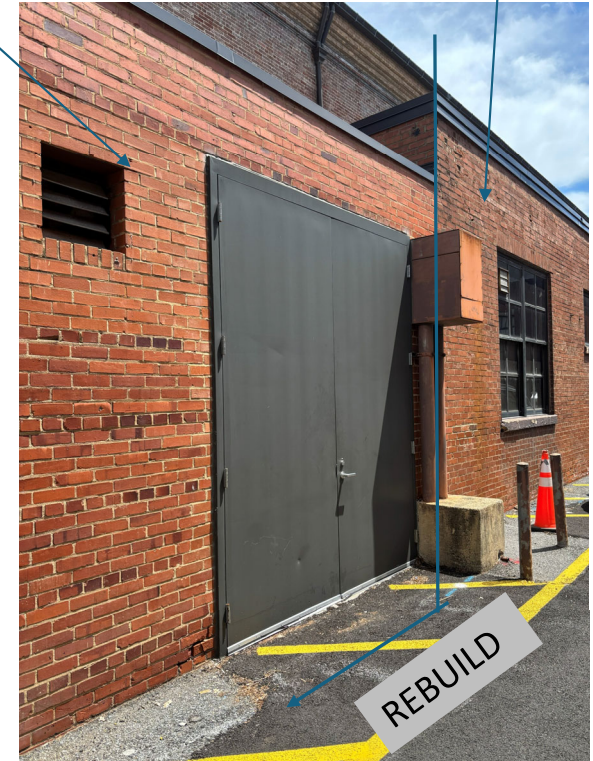
WEST – MID BUMPOUT

ADDITION BELIEVED TO BE BUILT OR REBUILT AFTER ADJACENT ADDITION

ADDITION BELIEVED TO BE 1917 – 1942

- REBUILD ADDITION (HEIGHT DOES NOT MEET REQUIREMENTS FOR MISSION)

- REPLACE OPENINGS

- REPAIR, REPOINT BRICK

- REPLACE ROOFS & DRAINAGE

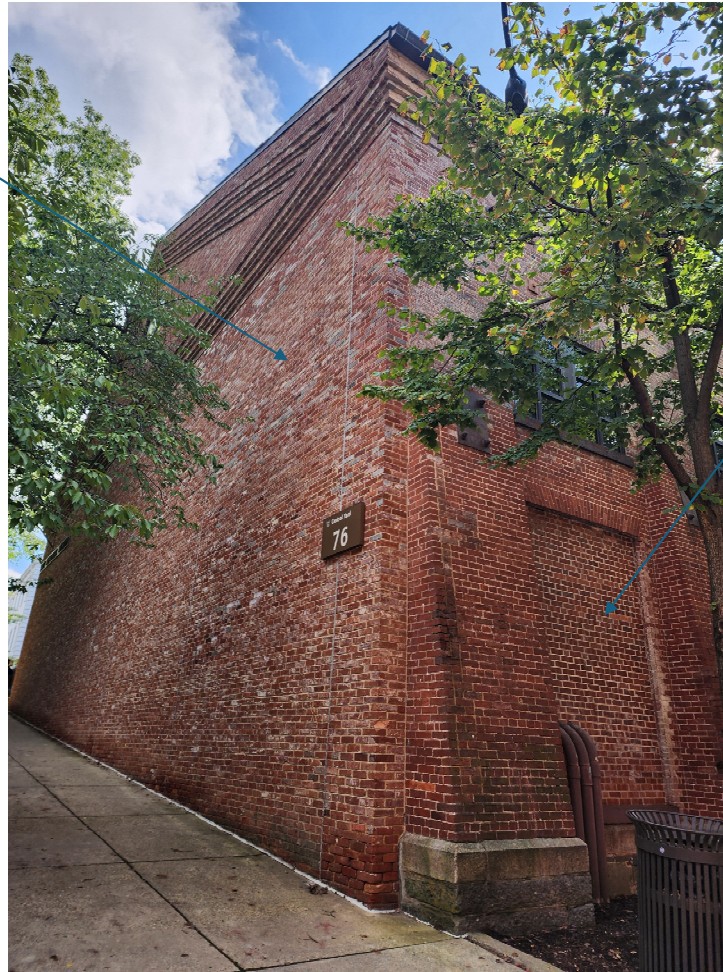
NORTH

REBUILT 1977

BUILDING 41
DEMOLISHED

- REPLACE BRICK EJS
- REPLACE ROOFS & DRAINAGE
- MAINTAIN INFILL AREAS

WINDOW
INFILL

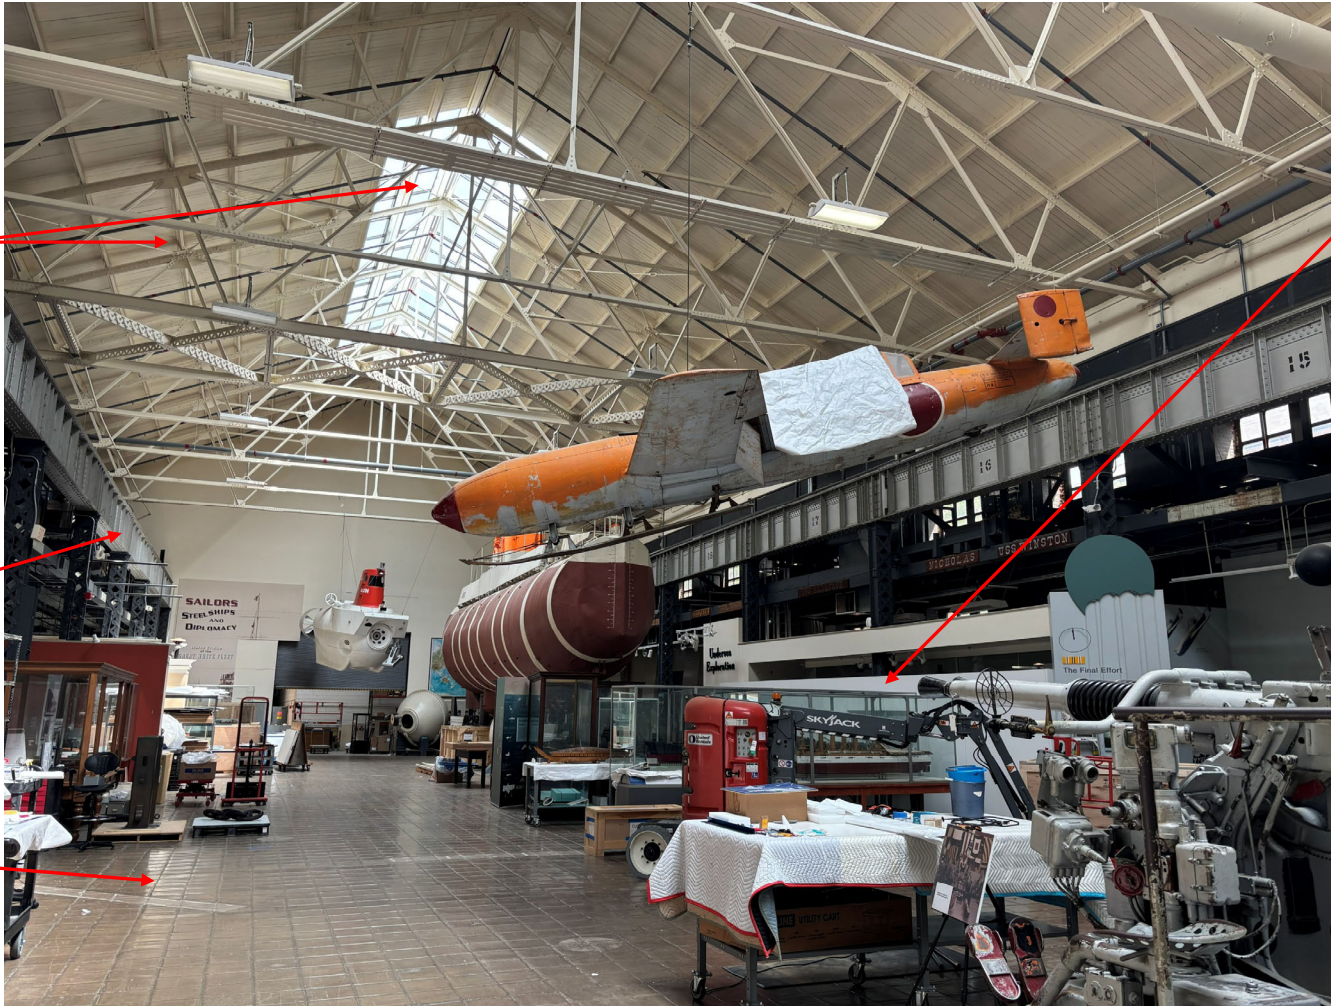
Maintain bridge crane structure

Demo floor & replace w/ sealed conc for program (carts / FLs)

All artifacts relocated prior to renovation
