Revitalize Beaver Otter Raven Habitat

NCPC Preliminary and Final Submission

OPDC Project # 2433103
QE Project # 52404680

SMITHSONIAN'S NATIONAL ZOO
& CONSERVATION BIOLOGY INSTITUTE

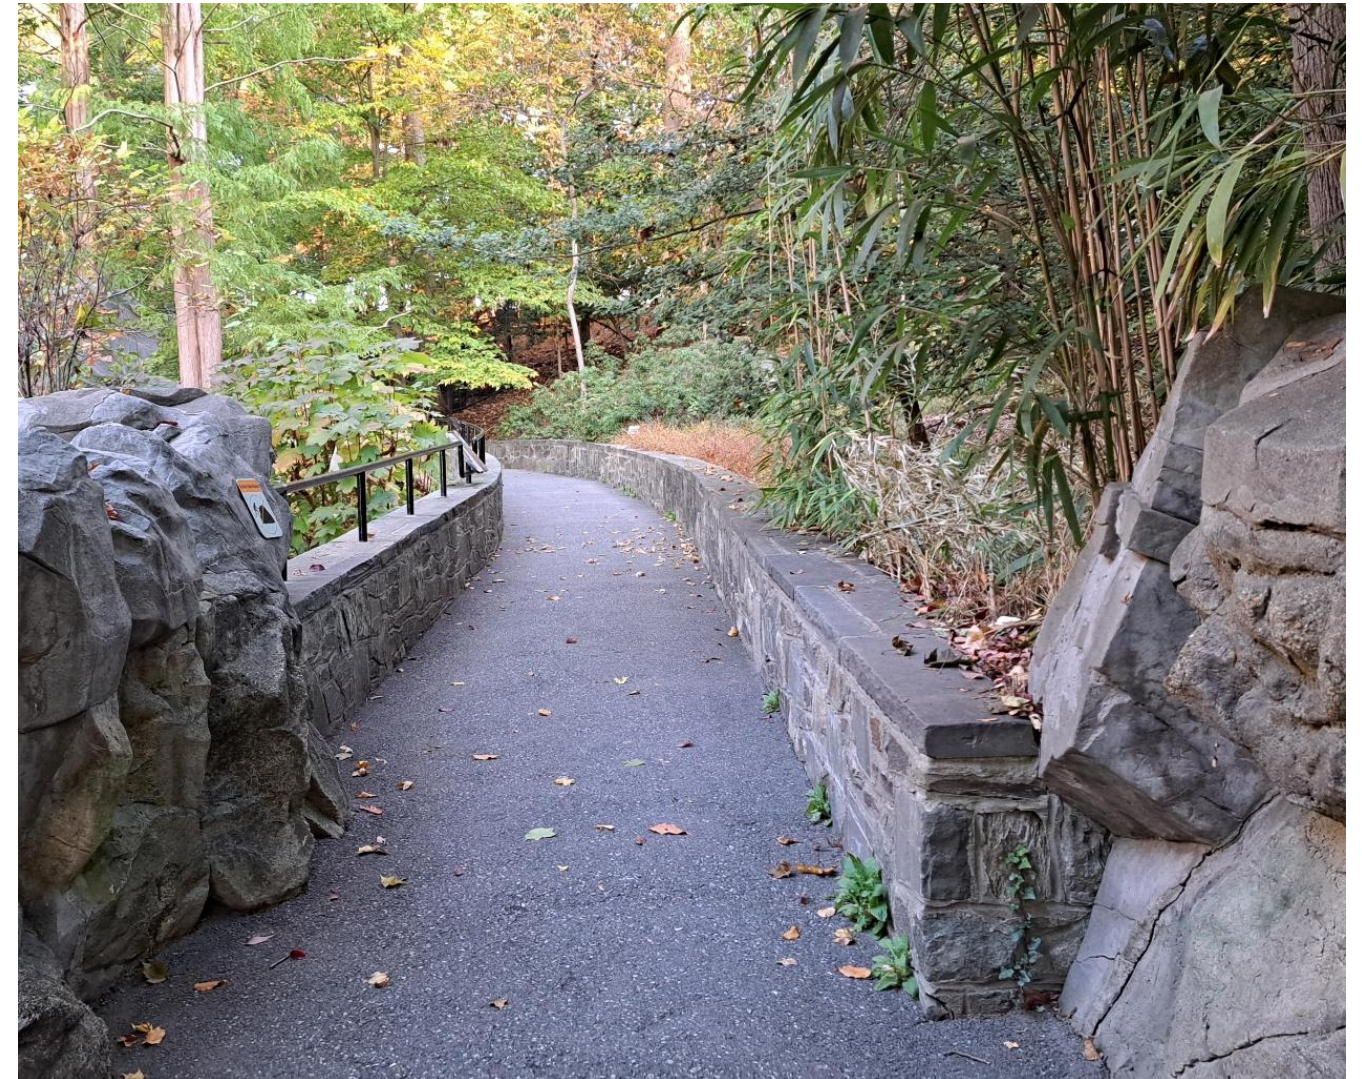
Existing faux rock and site wall along Beaver habitat visitor path.

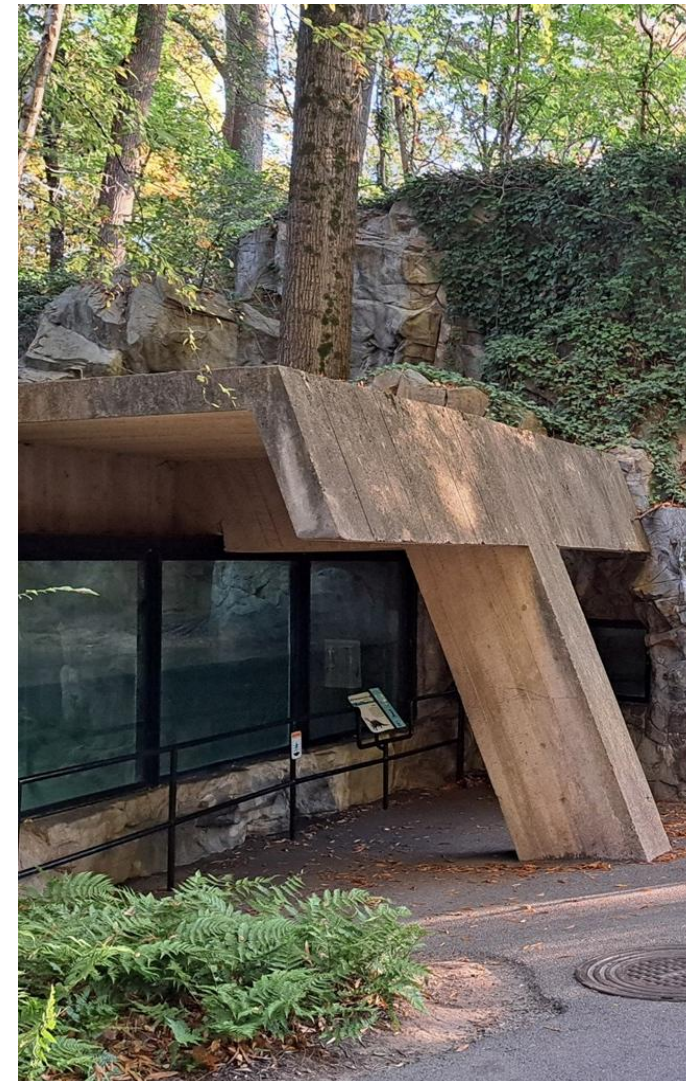
Existing Otter viewing canopy and faux rockwork.

The existing concrete Otter viewing canopy will remain, while the original window glazing will be replaced to improve visibility and performance. New barrier walls clad with veneer stone and fiber cement vertical panels will ensure continuity of animal containment. A new training window will invite visitors to engage with the animal keepers as they feed and use activities to care for the otters.

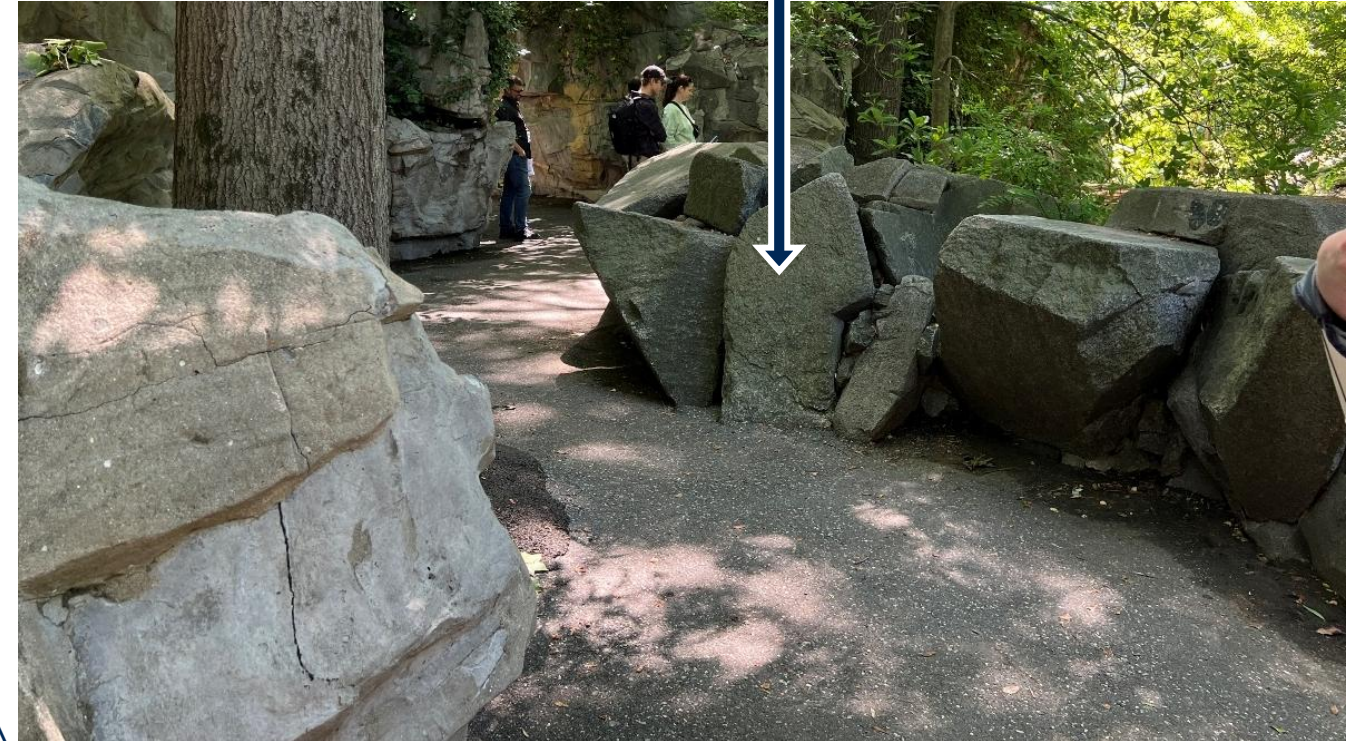
A

NATURAL CARDEROCK BOULDERS

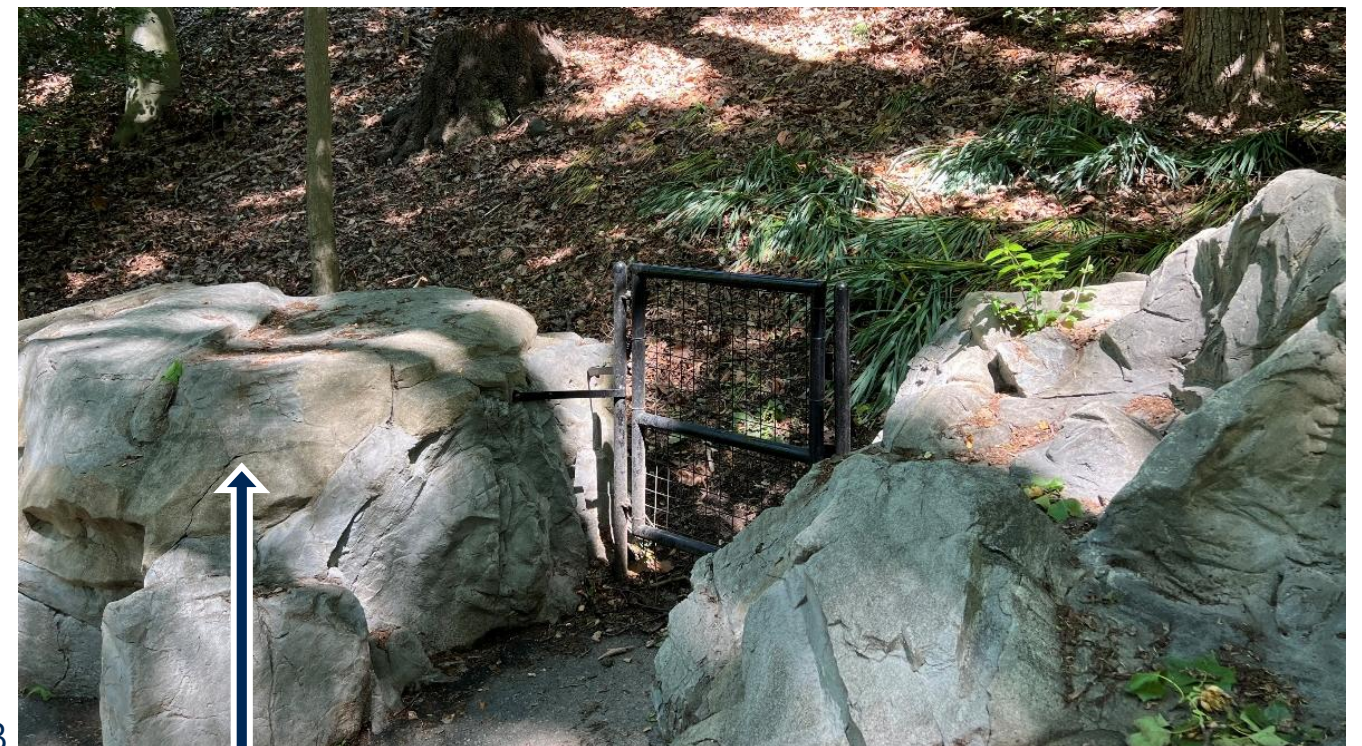
B

ARTIFICIAL ROCKWORK

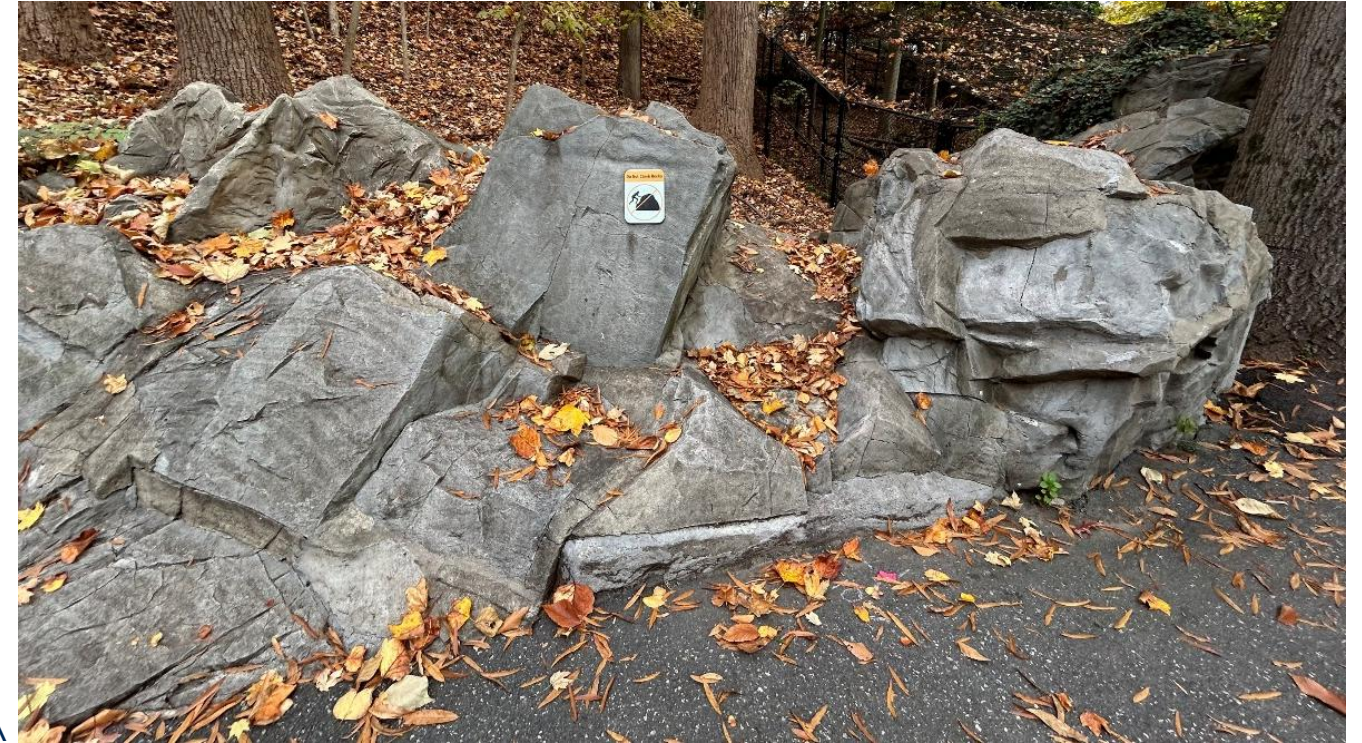
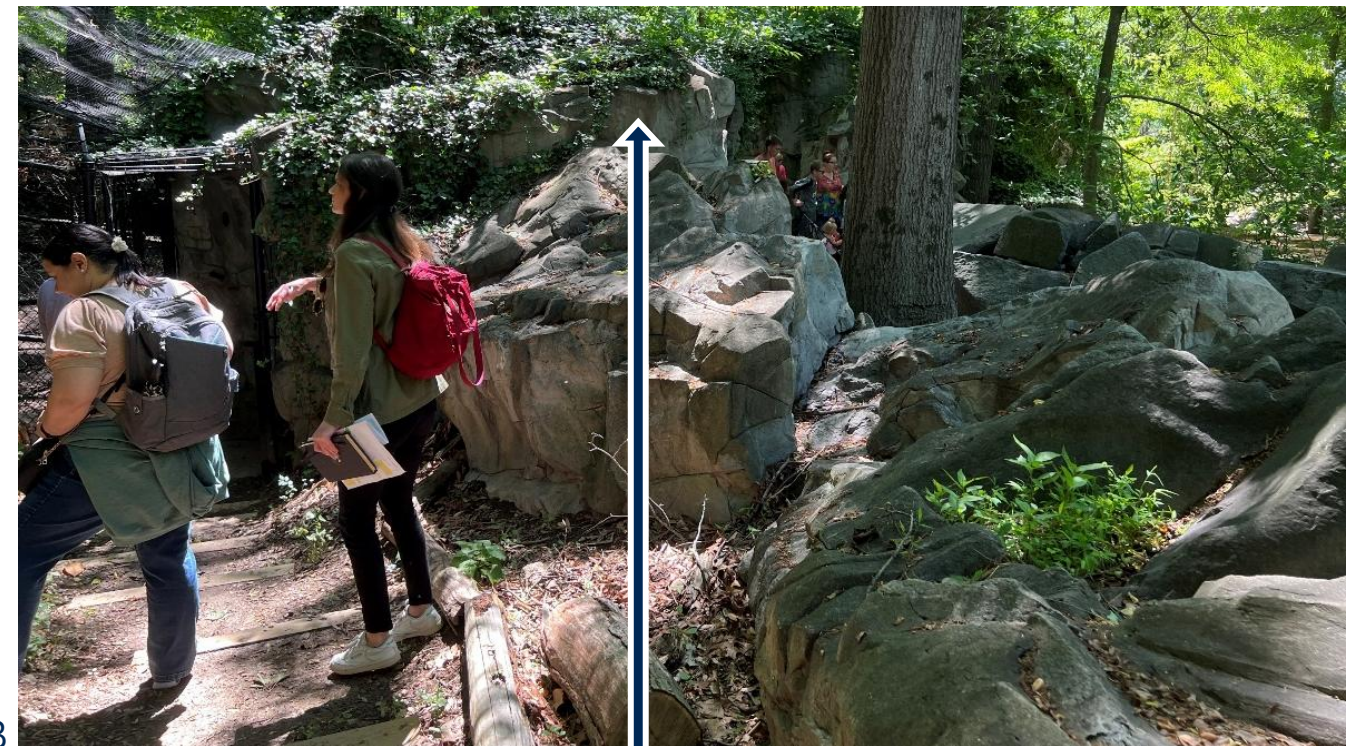
RAVEN BUILDING ENCASED IN ARTIFICIAL ROCKWORK

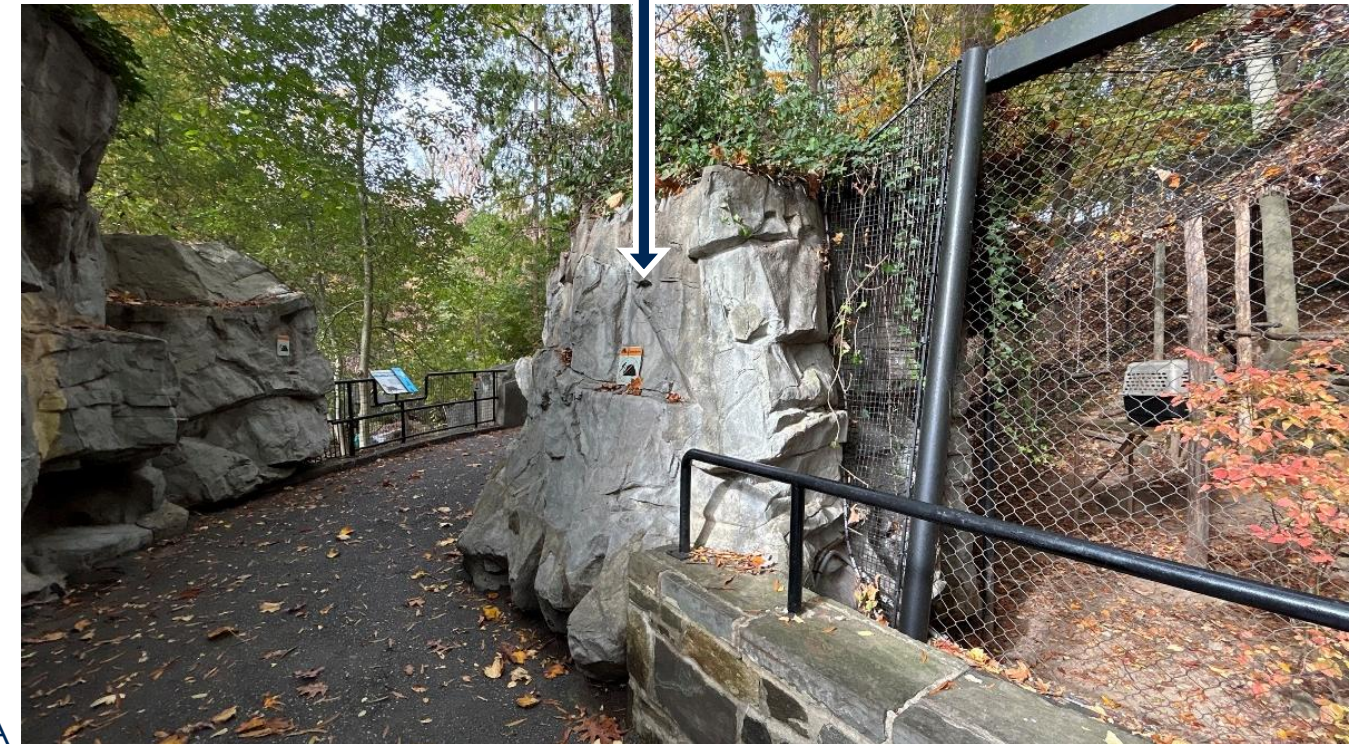
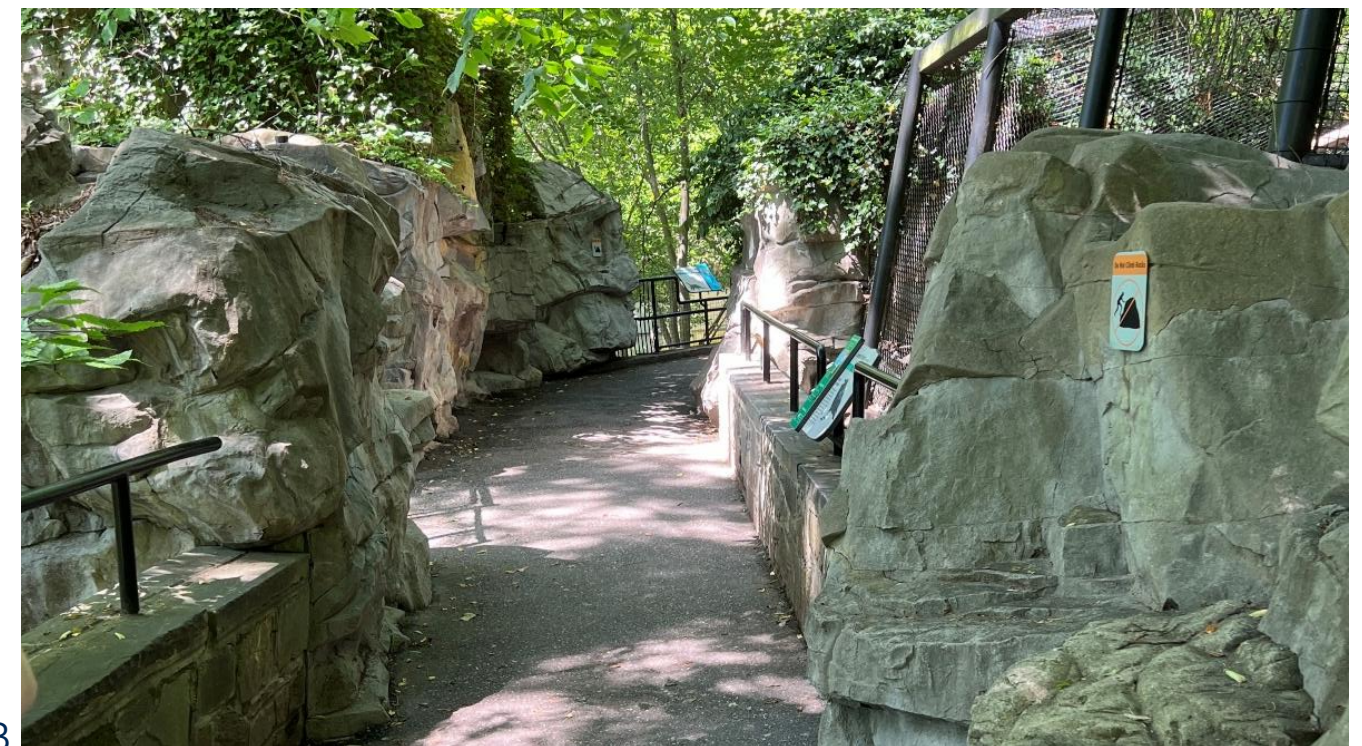
RAVEN BUILDING

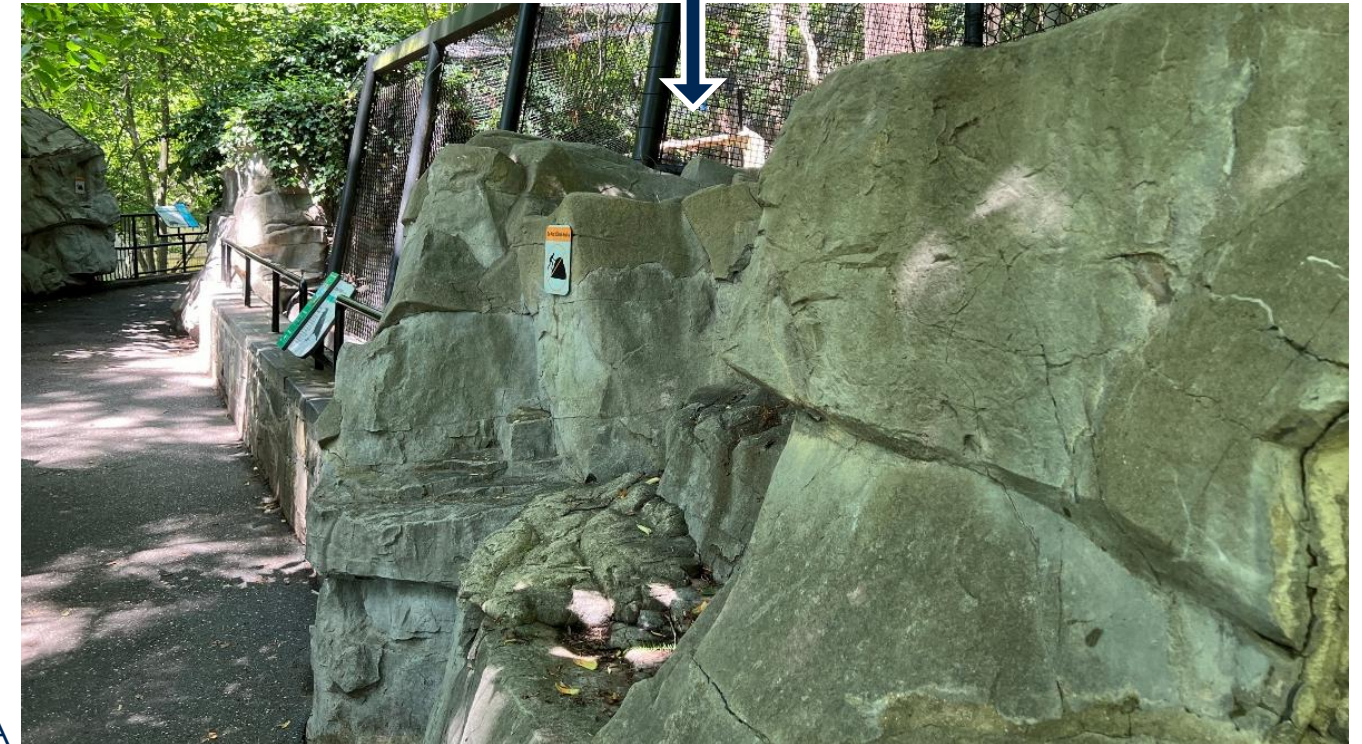
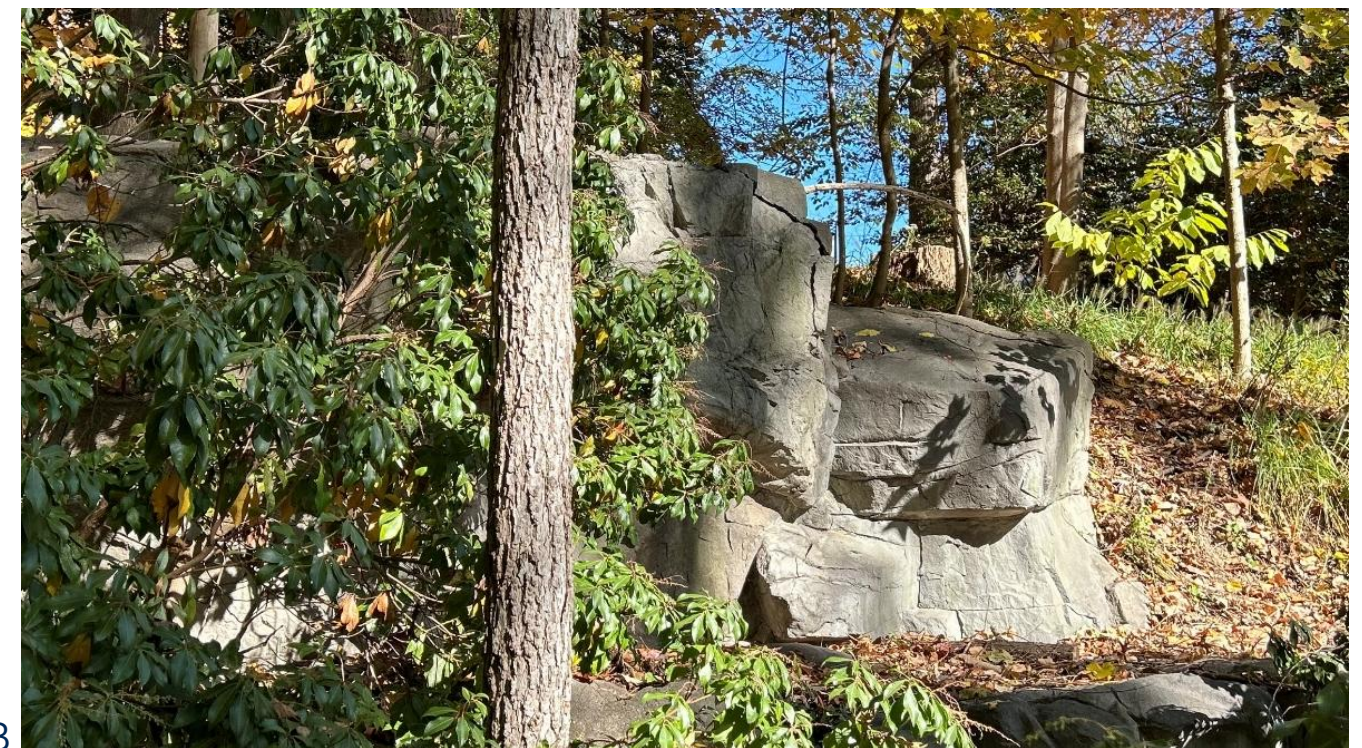
RAVEN HABITAT ENCLOSURE

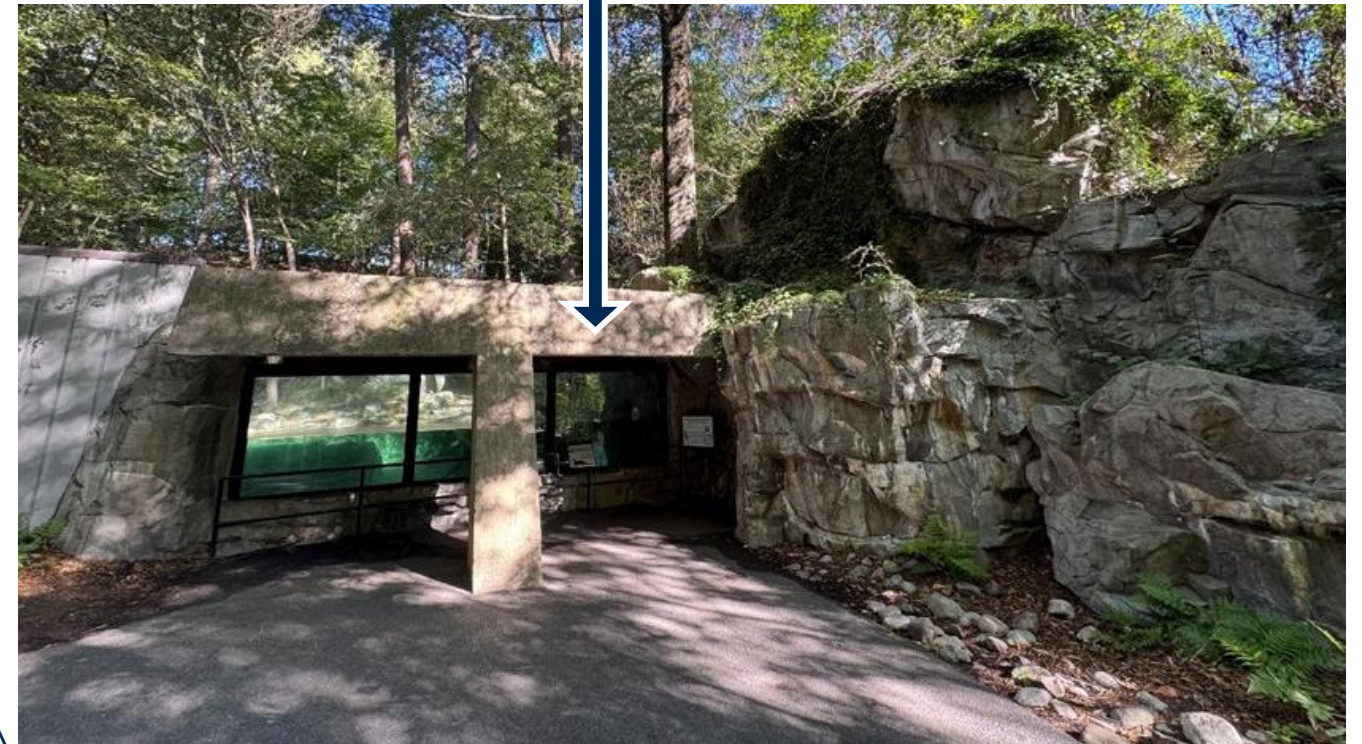
A

COVERED OTTER HABITAT VIEWING AREA

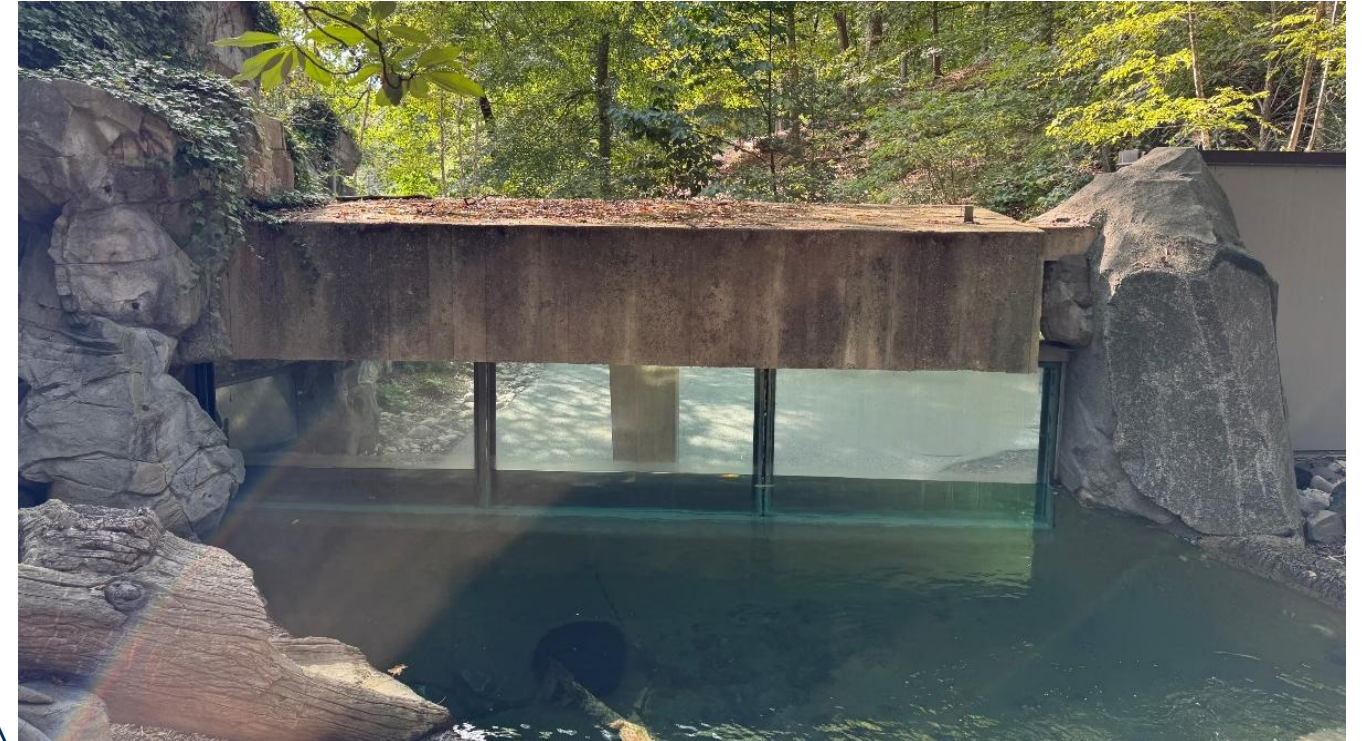
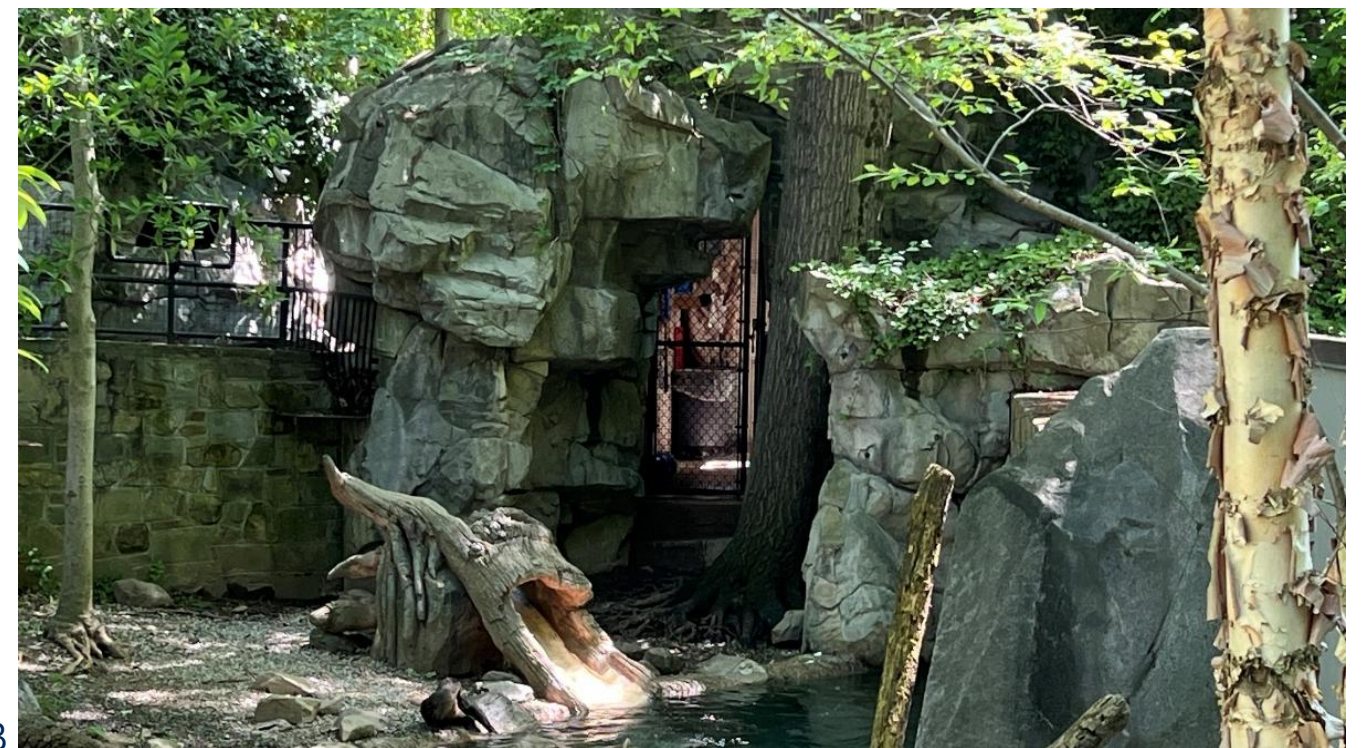
American Trail: Views of rockwork from the Otter habitat

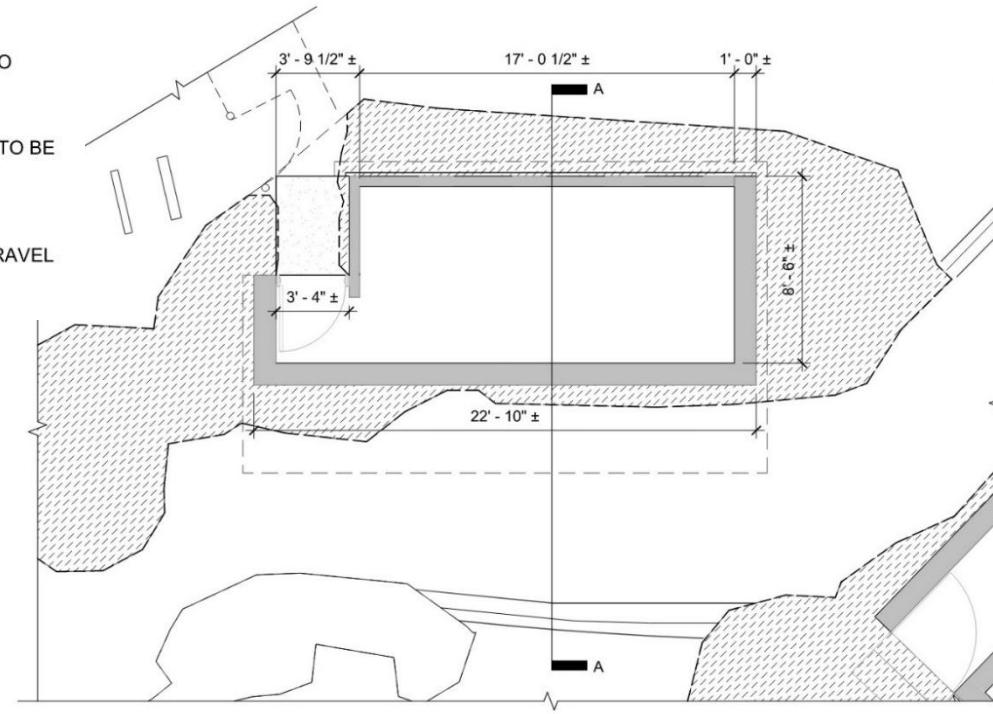
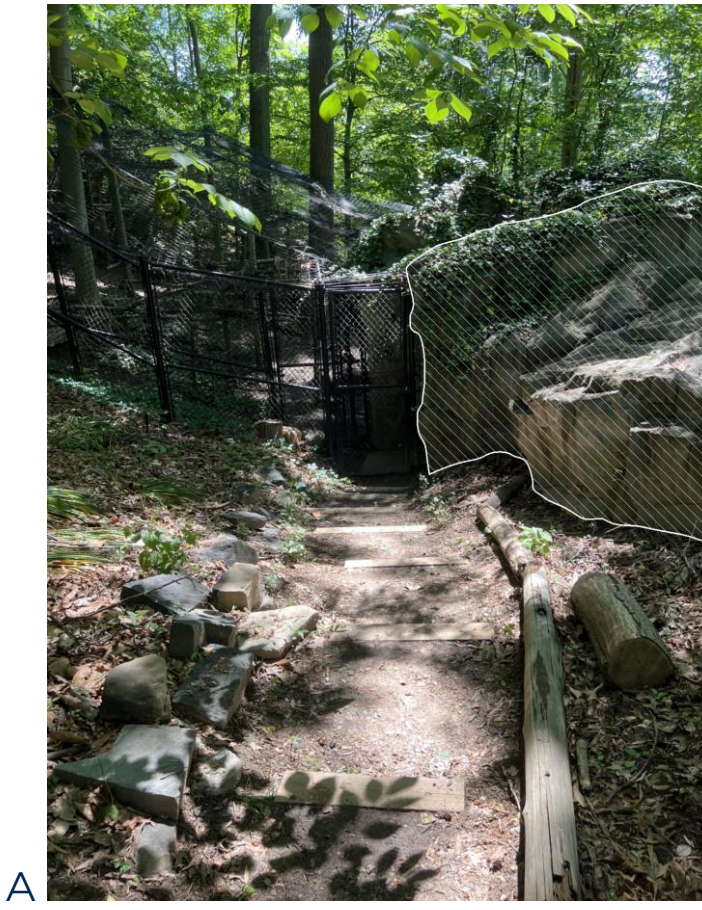
RAVEN SUPPORT – DEMO PLAN & SECTION

Cast-in-place concrete building exposed after rockwork removal.

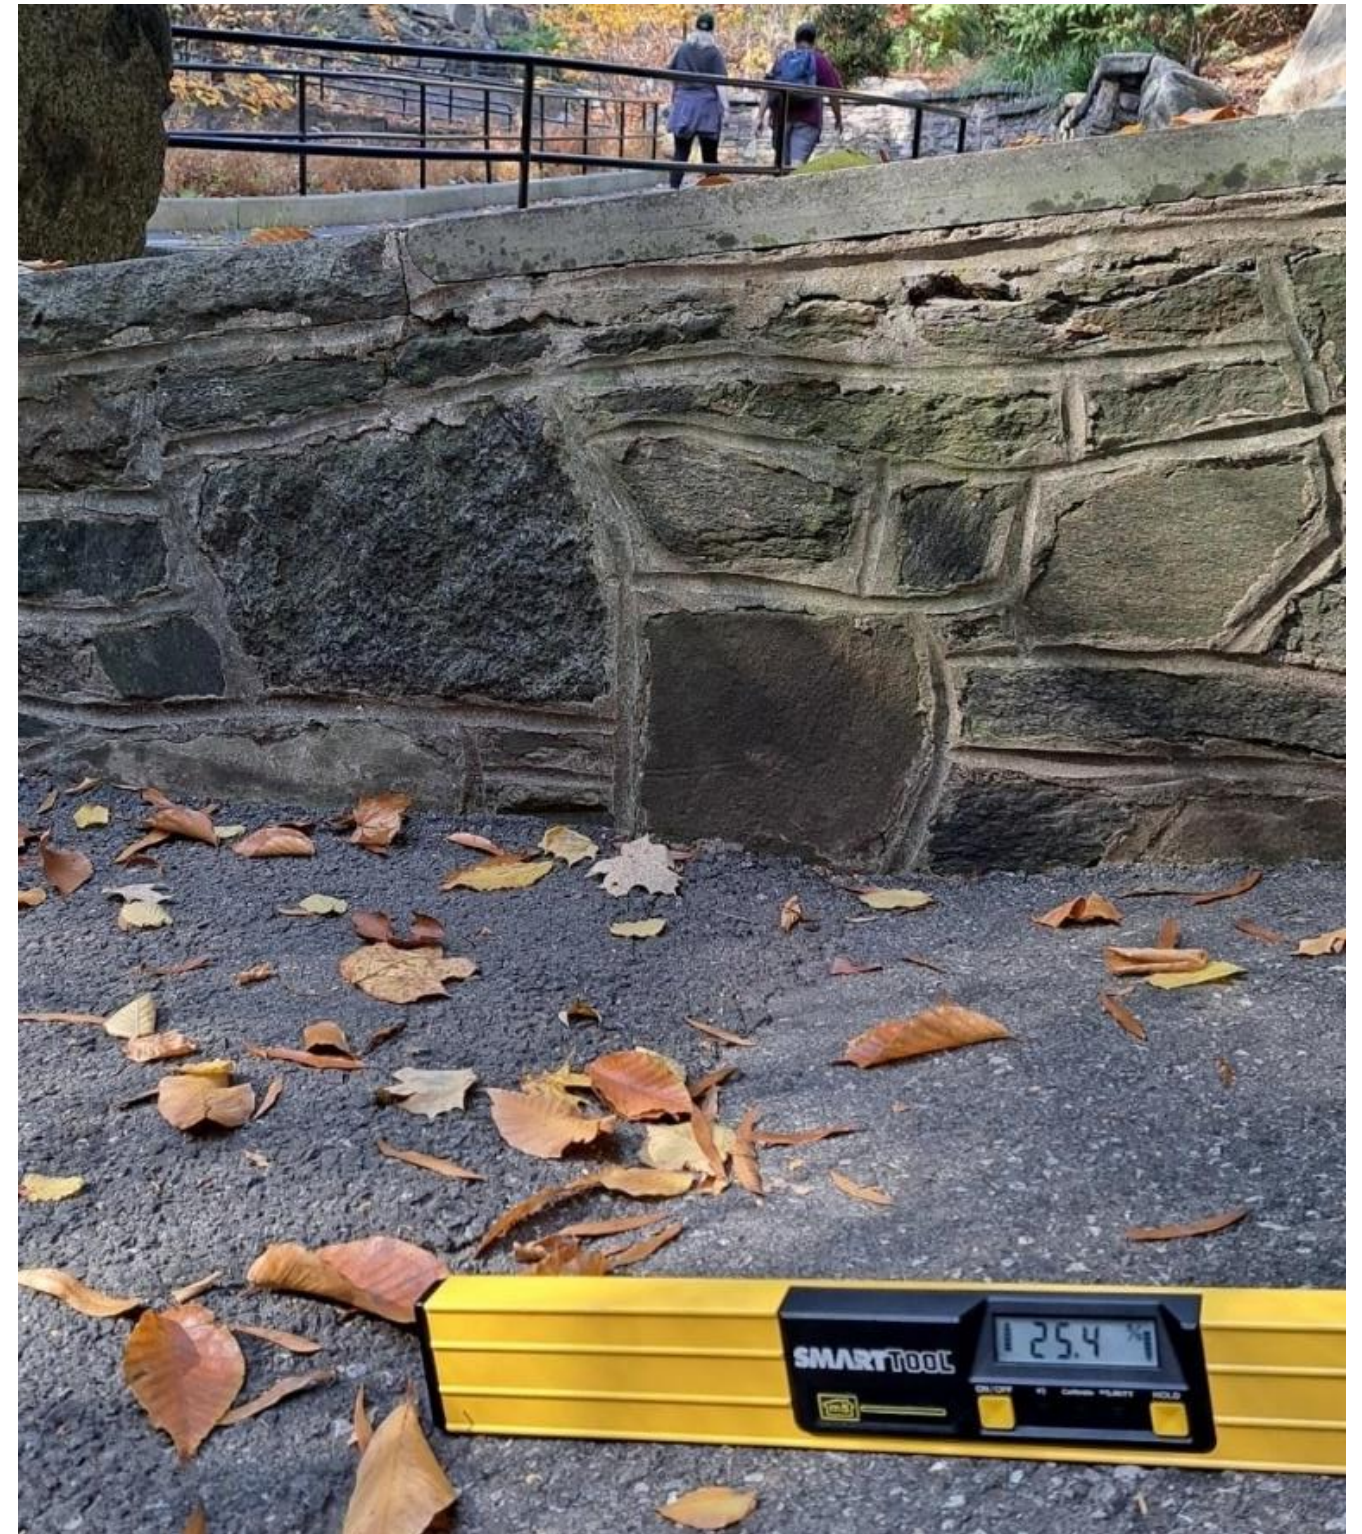
Demonstration of area of upper path with a steep slope of approximately 25%.

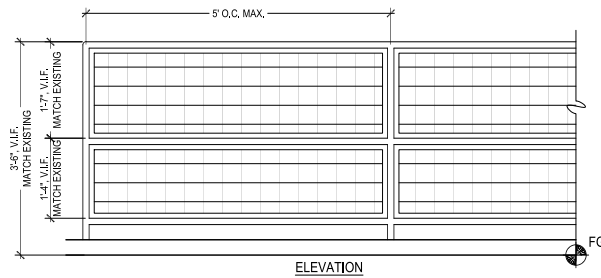
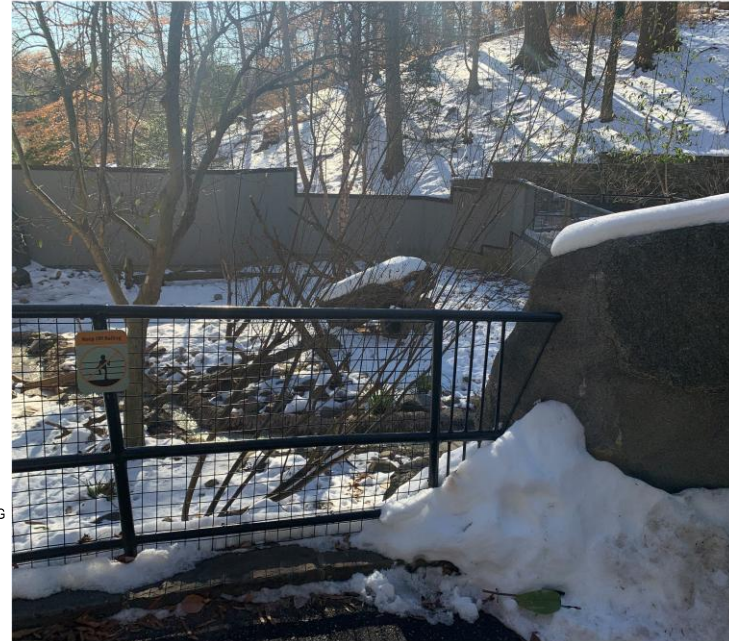
SITE WALL WITH RAILING TYPE 1

The proposed rail infill in the non-public zone will match existing tube and mesh rail.

REFERENCE IMAGE FOR PROPOSED RAILING TYPE 1: Existing stone clad retaining wall with steel mesh netting guardrail at Otter

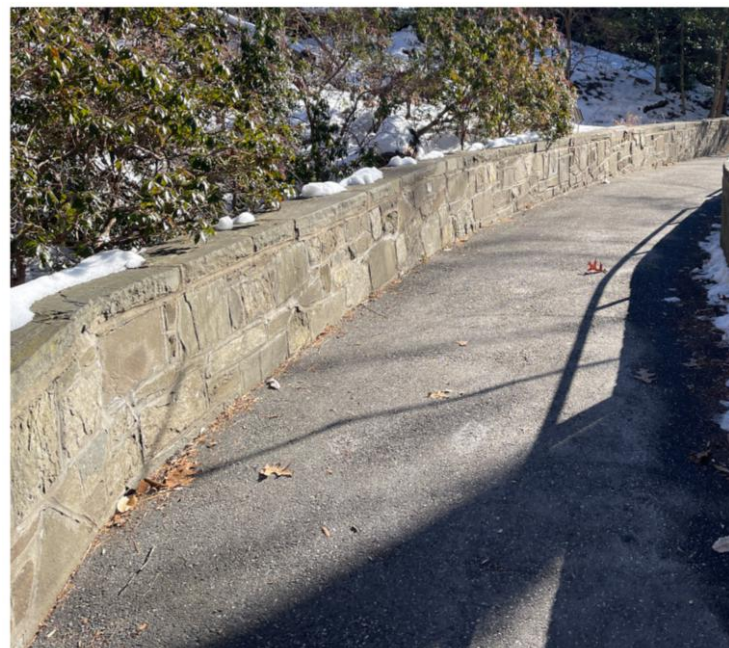
SITE WALL

The proposed retaining walls will be designed to match existing stone clad walls on site. Top of wall elevations will vary depending on animal containment and visitor barrier requirements.

REFERENCE IMAGE FOR PROPOSED SITE WALL: Existing stone clad retaining wall

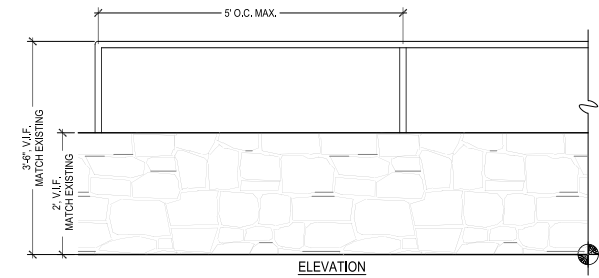
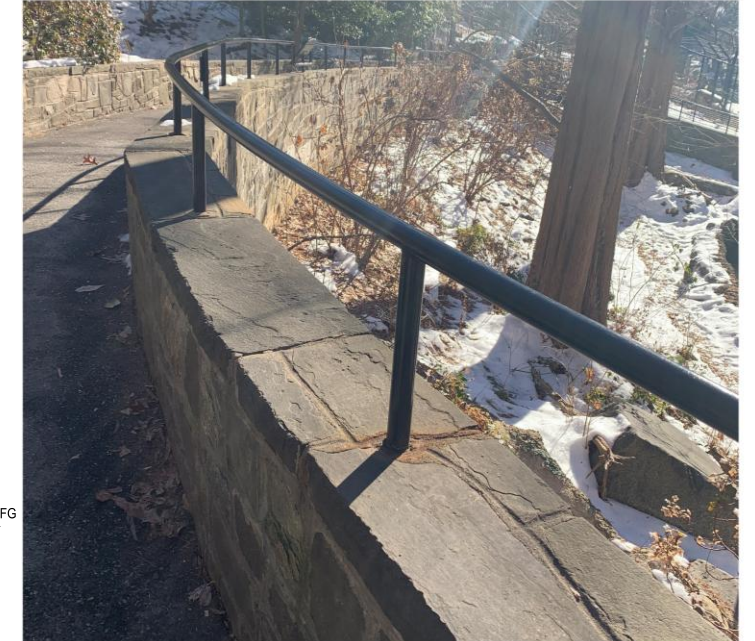
SITE WALL WITH RAILING TYPE 2

The proposed rail infill in the non-public zone will match the existing stone clad walls and steel tube rails.

REFERENCE IMAGE FOR PROPOSED RAILING TYPE 2: Existing stone clad retaining wall with steel tube handrail at beaver

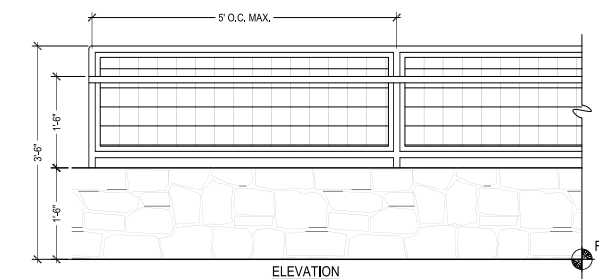
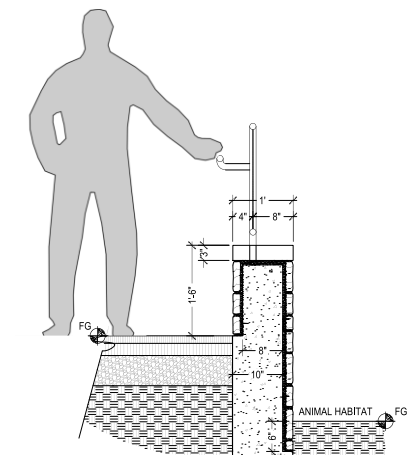
SITE WALL WITH RAILING TYPE 3

The proposed visitor rail at Beaver introduces a new design that meets animal containment requirements while drawing from the site's existing rail vocabulary. Welded wire mesh panels are set between painted black steel posts, to preserve visibility while discouraging visitor trespass. An integrated handrail enhances usability and comfort, exceeding ADA baseline provisions for sloped walkways.

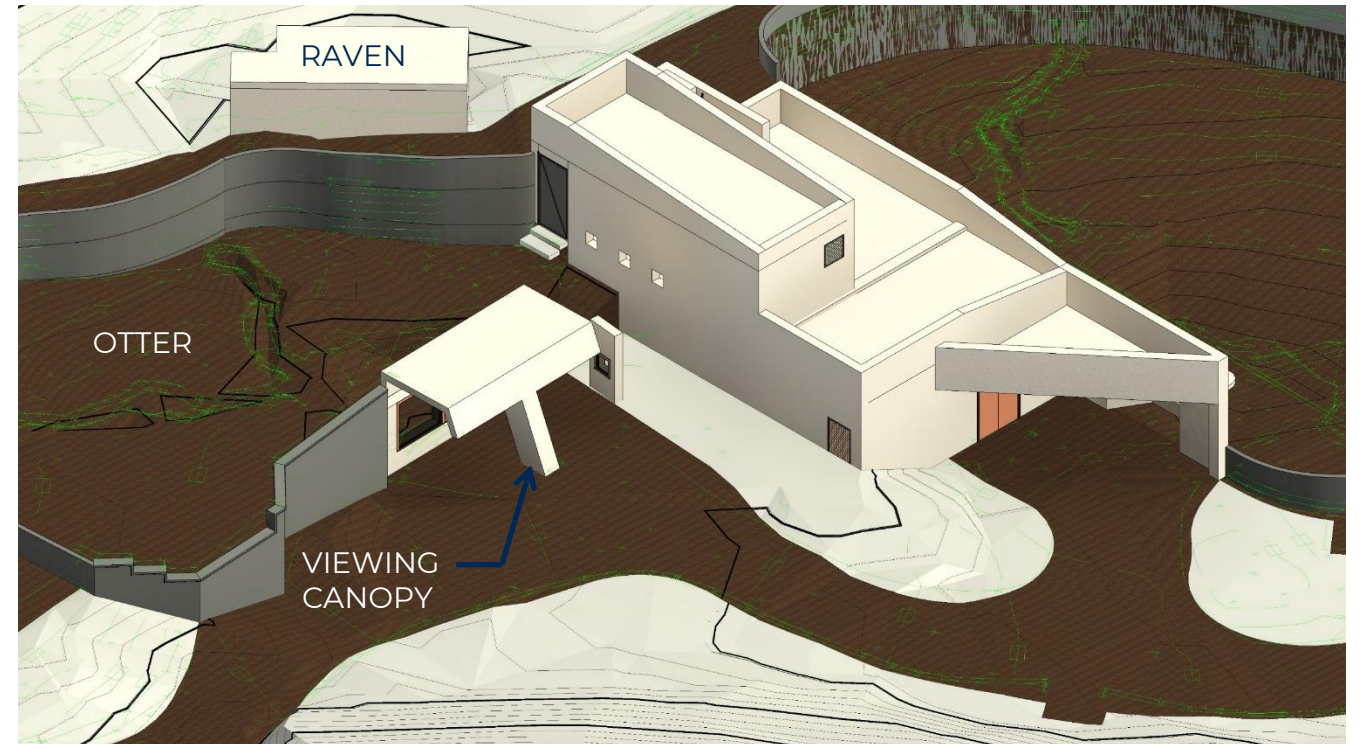
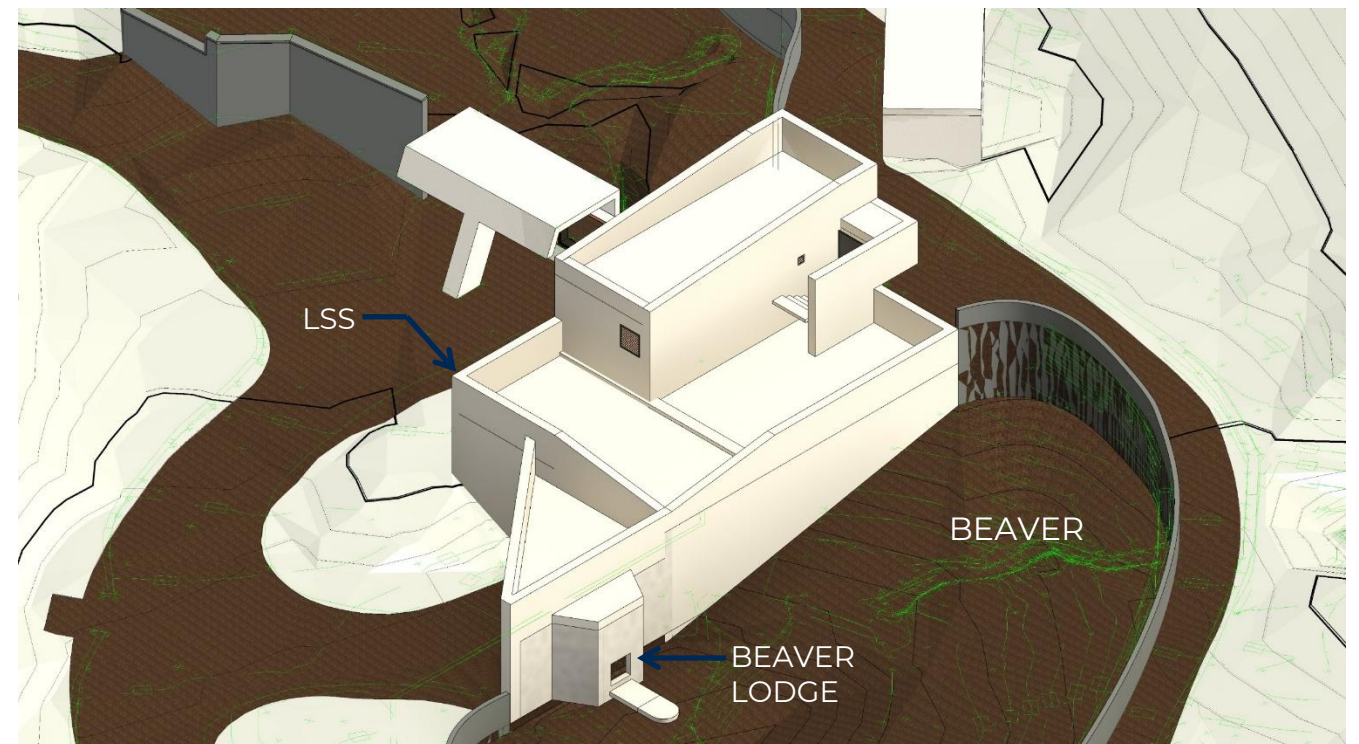
Due to the need to remove all failing faux-rock from the site, an architectural approach for cladding the exposed building is required. *(The 3D model views to the right showcase the existing LSS building once the rockwork has been removed.)* Initial scope refinement studies explored three options with varying levels of intervention.
