Revitalize Beaver Otter Raven Habitat

NCPC Preliminary and Final Submission

OPDC Project # 2433103
QE Project # 52404680

SMITHSONIAN'S NATIONAL ZOO
& CONSERVATION BIOLOGY INSTITUTE

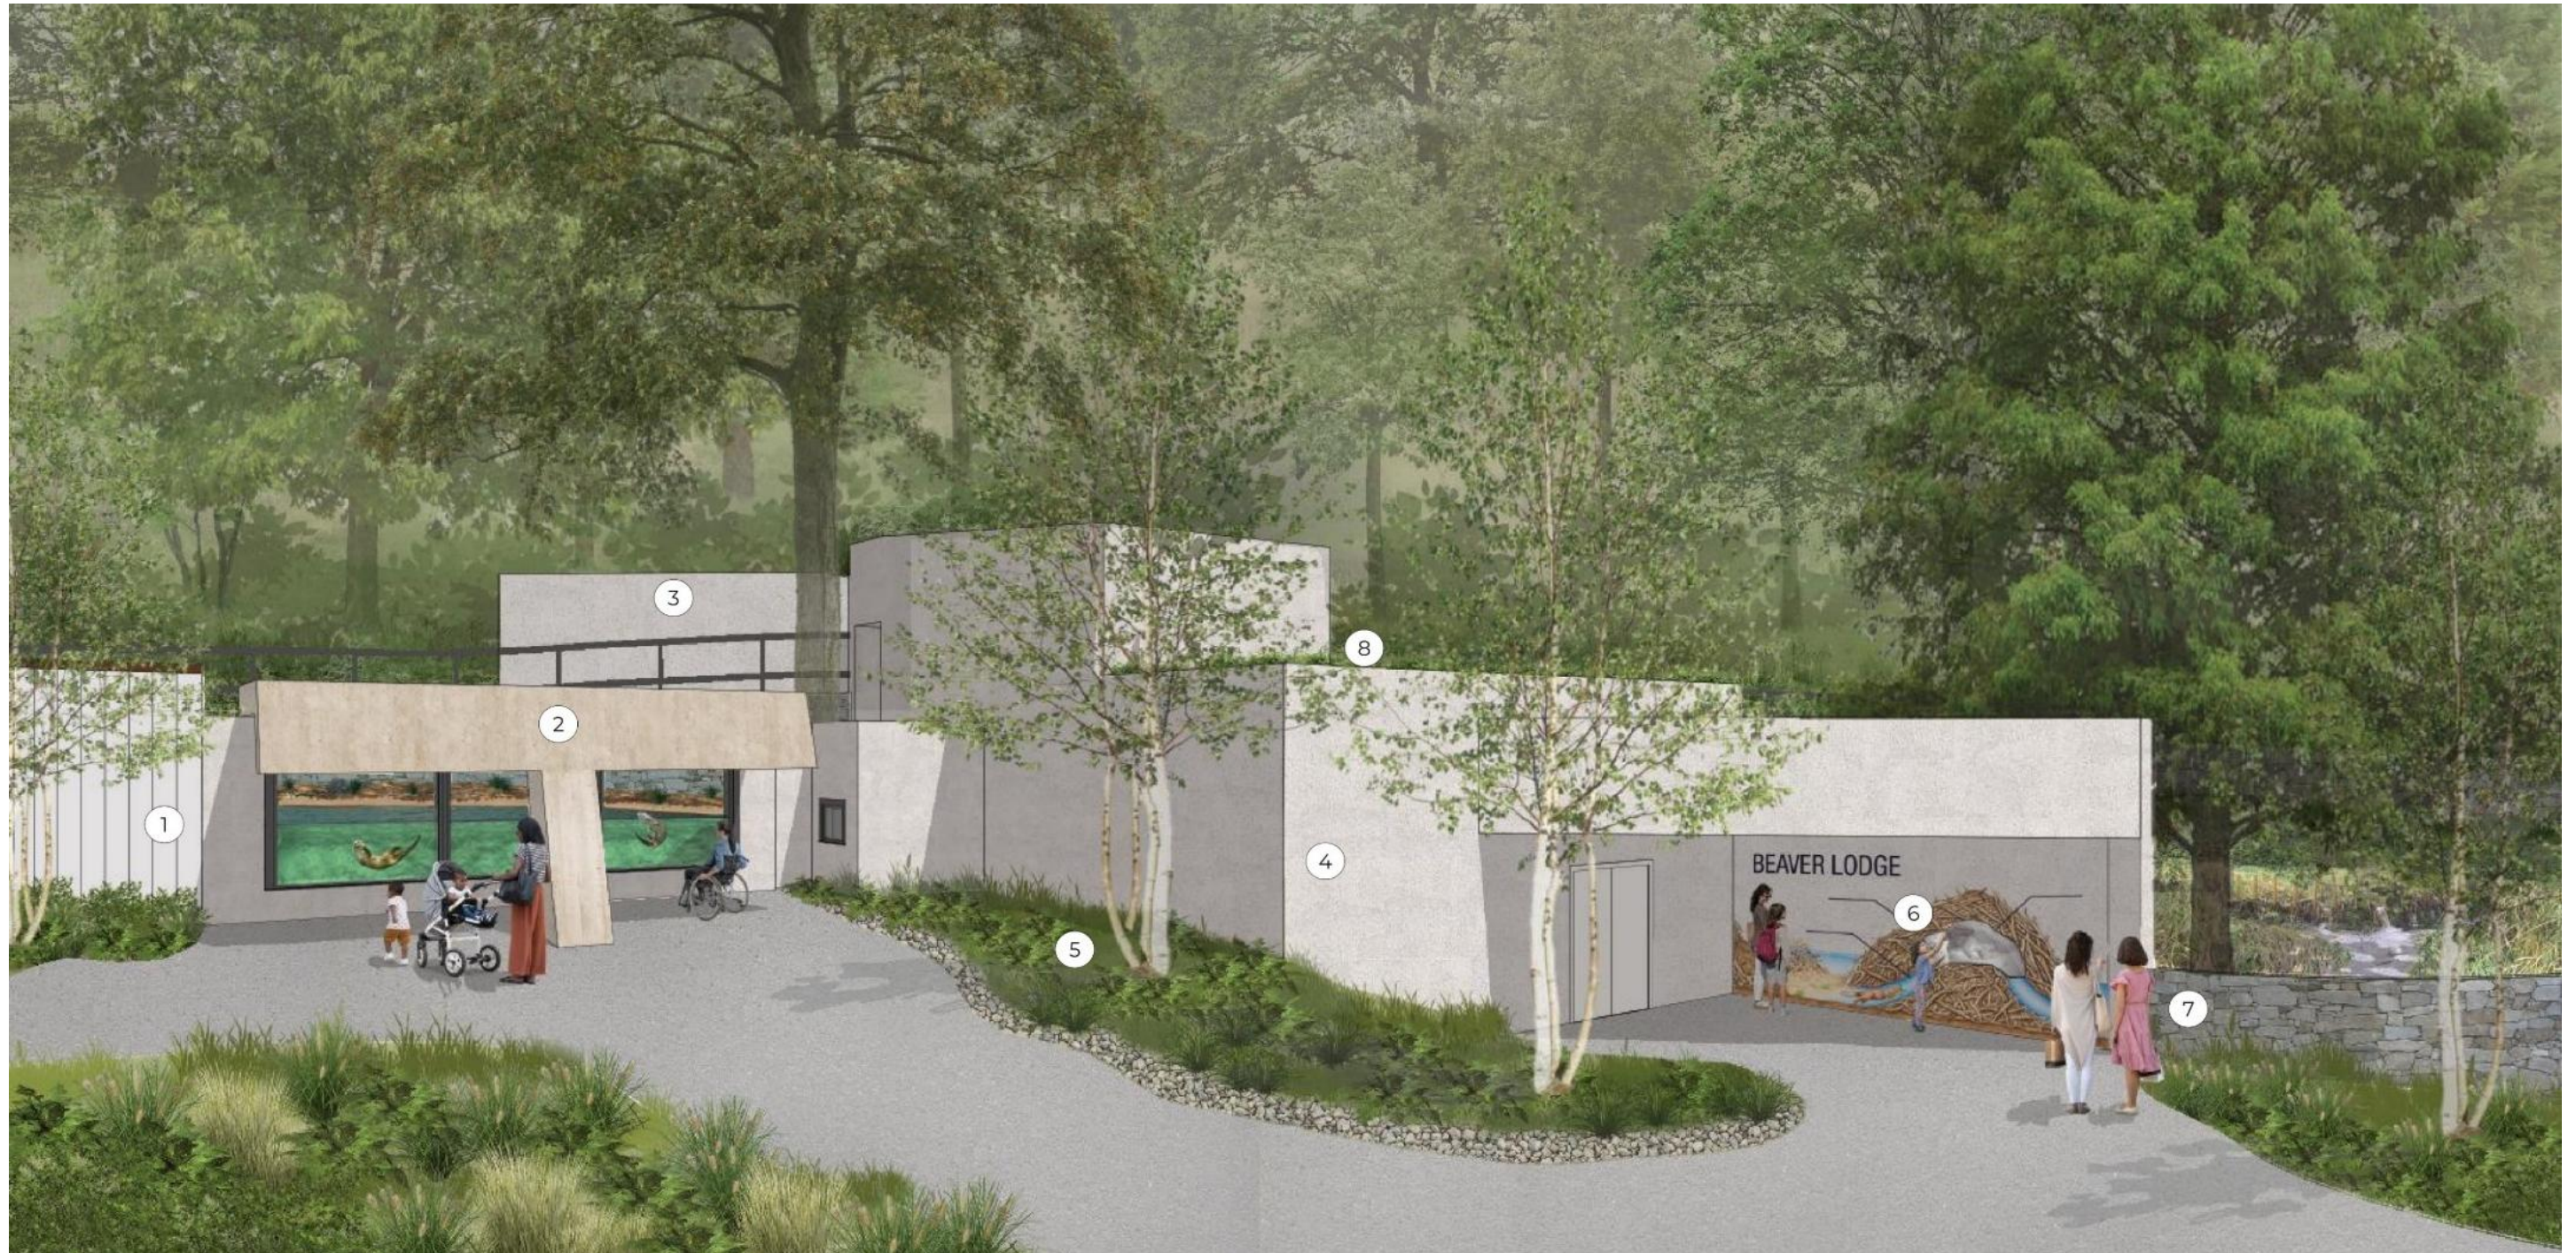
Initial Studies – Cladding Concept Zero

1. REPLACE DAMAGED FIBER CEMENT BOARD

2. EXISTING CONCRETE CANOPY TO REMAIN

Concept Zero minimized work to essential repairs, applying a parged concrete finish over rough surfaces to create a smooth, finished look. Concept One introduced new architectural cladding for the existing structures, including a stone wainscot, fiber cement panels, and salvaged wood over the canopies. Concept Two resulted in the most transformative intervention, demolishing the concrete viewing canopy and the overhang above the entrance, replacing them with new canopy structures. The images that follow provide a closer look at these early design options.

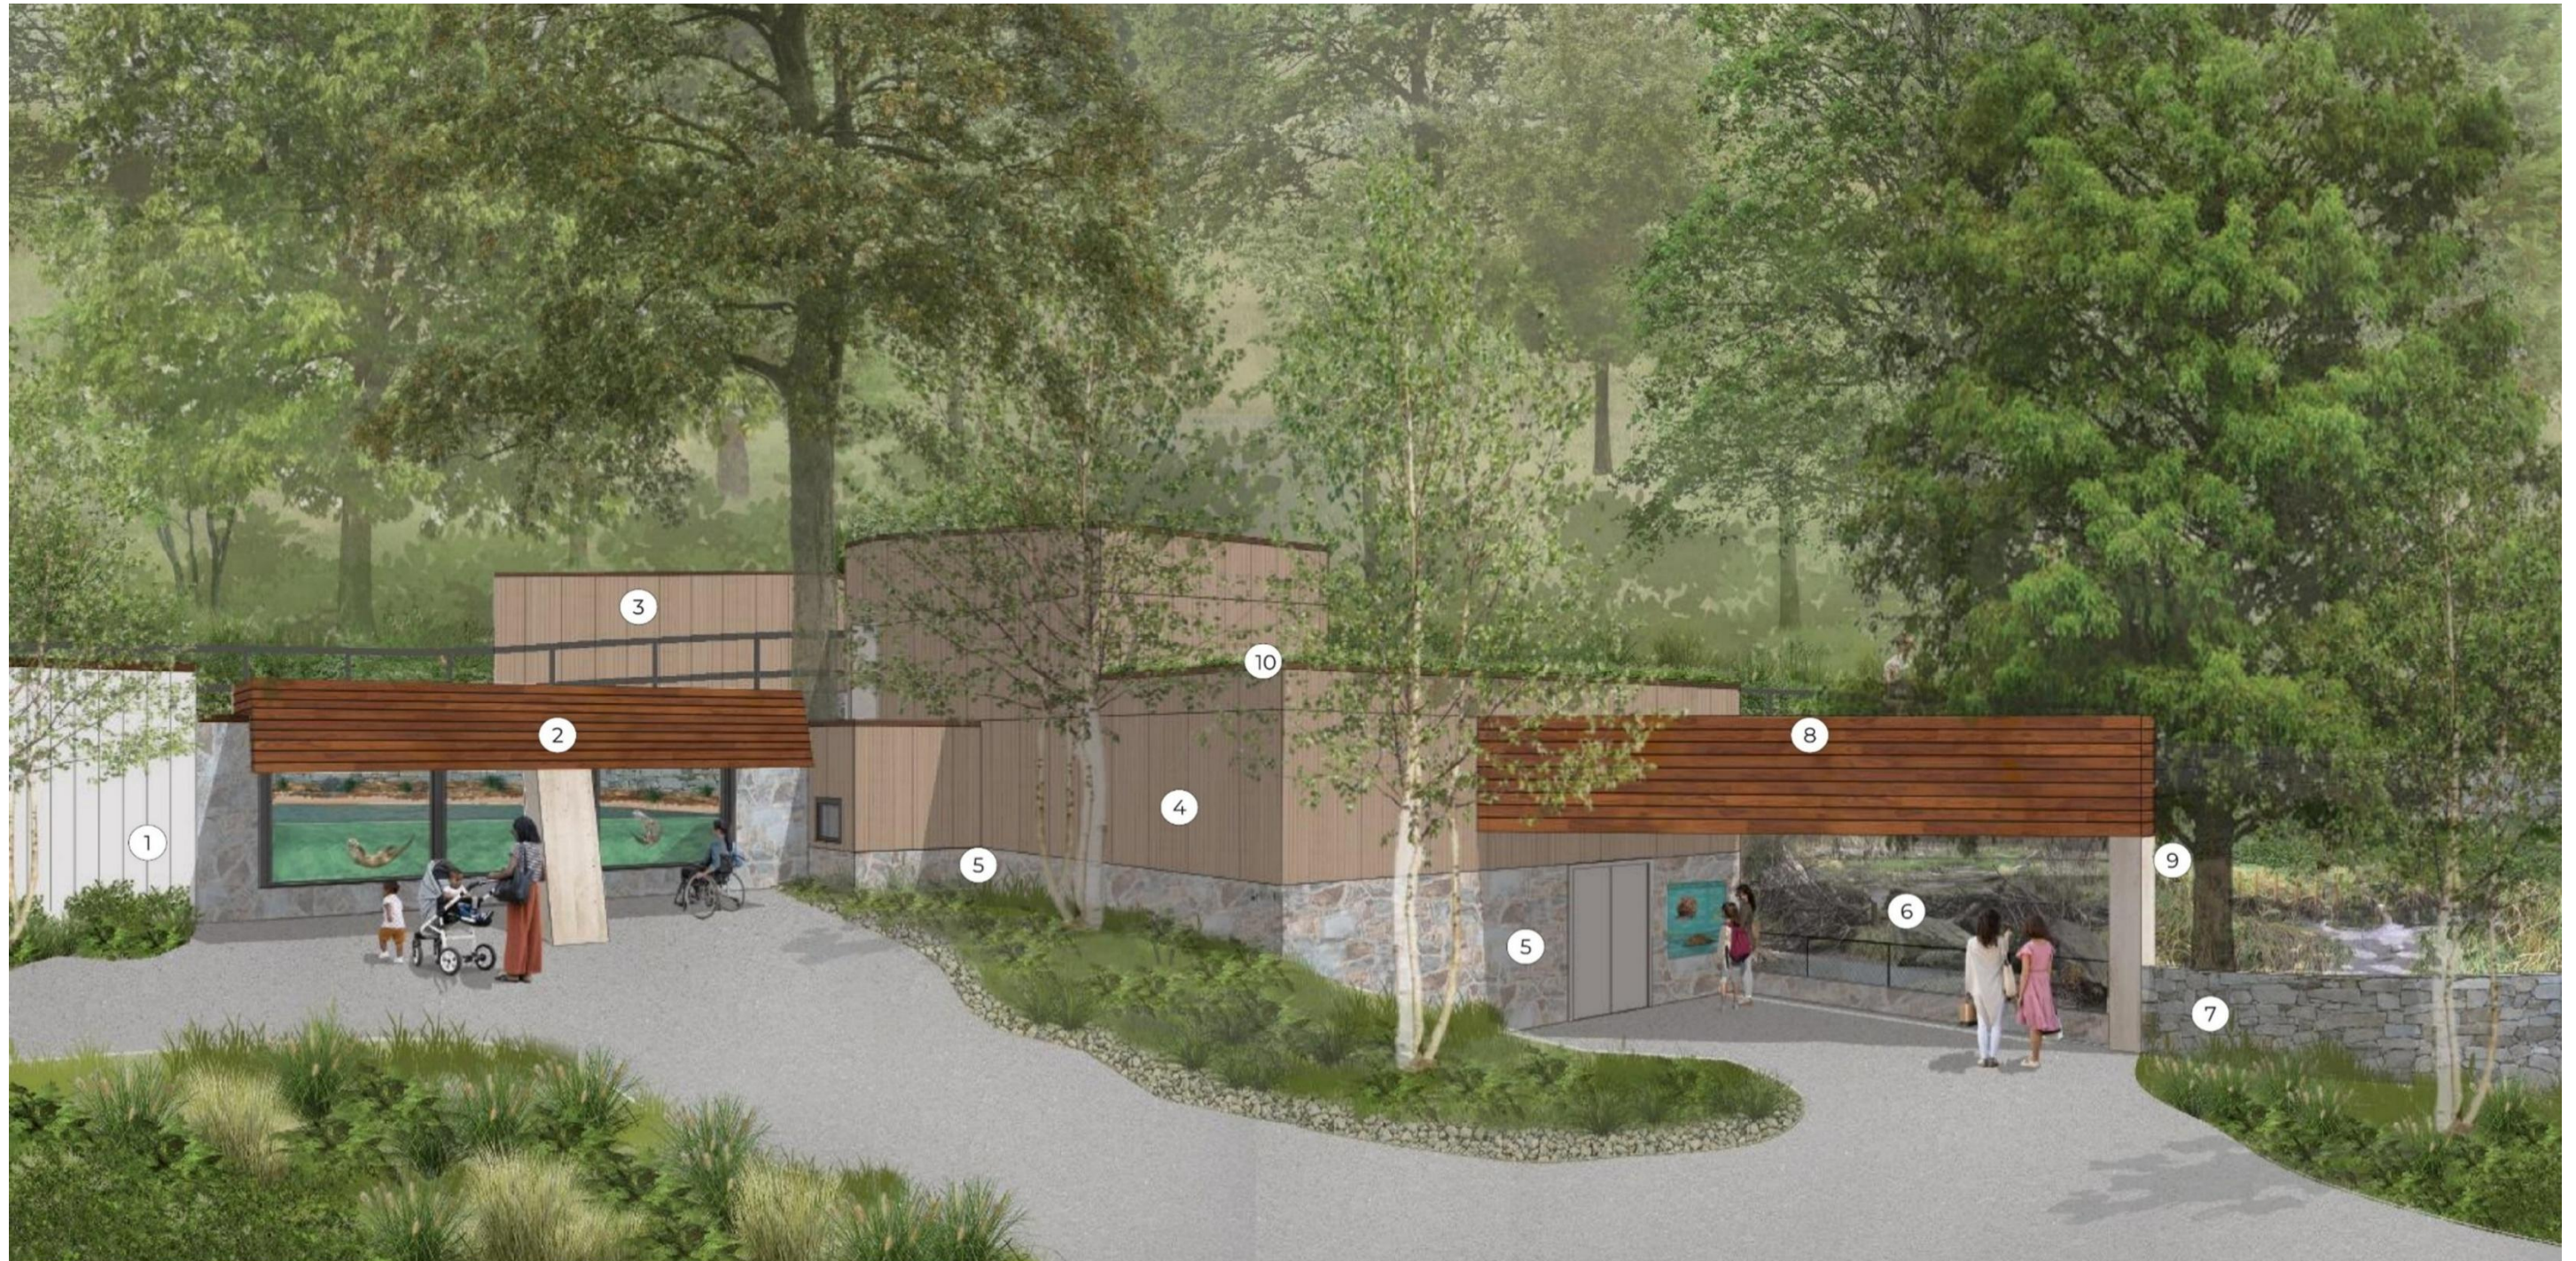
Initial Studies – Cladding Concept One

1. REPLACE DAMAGED FIBER CEMENT BOARD

2. EXISTING CONCRETE CANOPY, CLAD WITH THERMALLY-MODIFIED WOOD

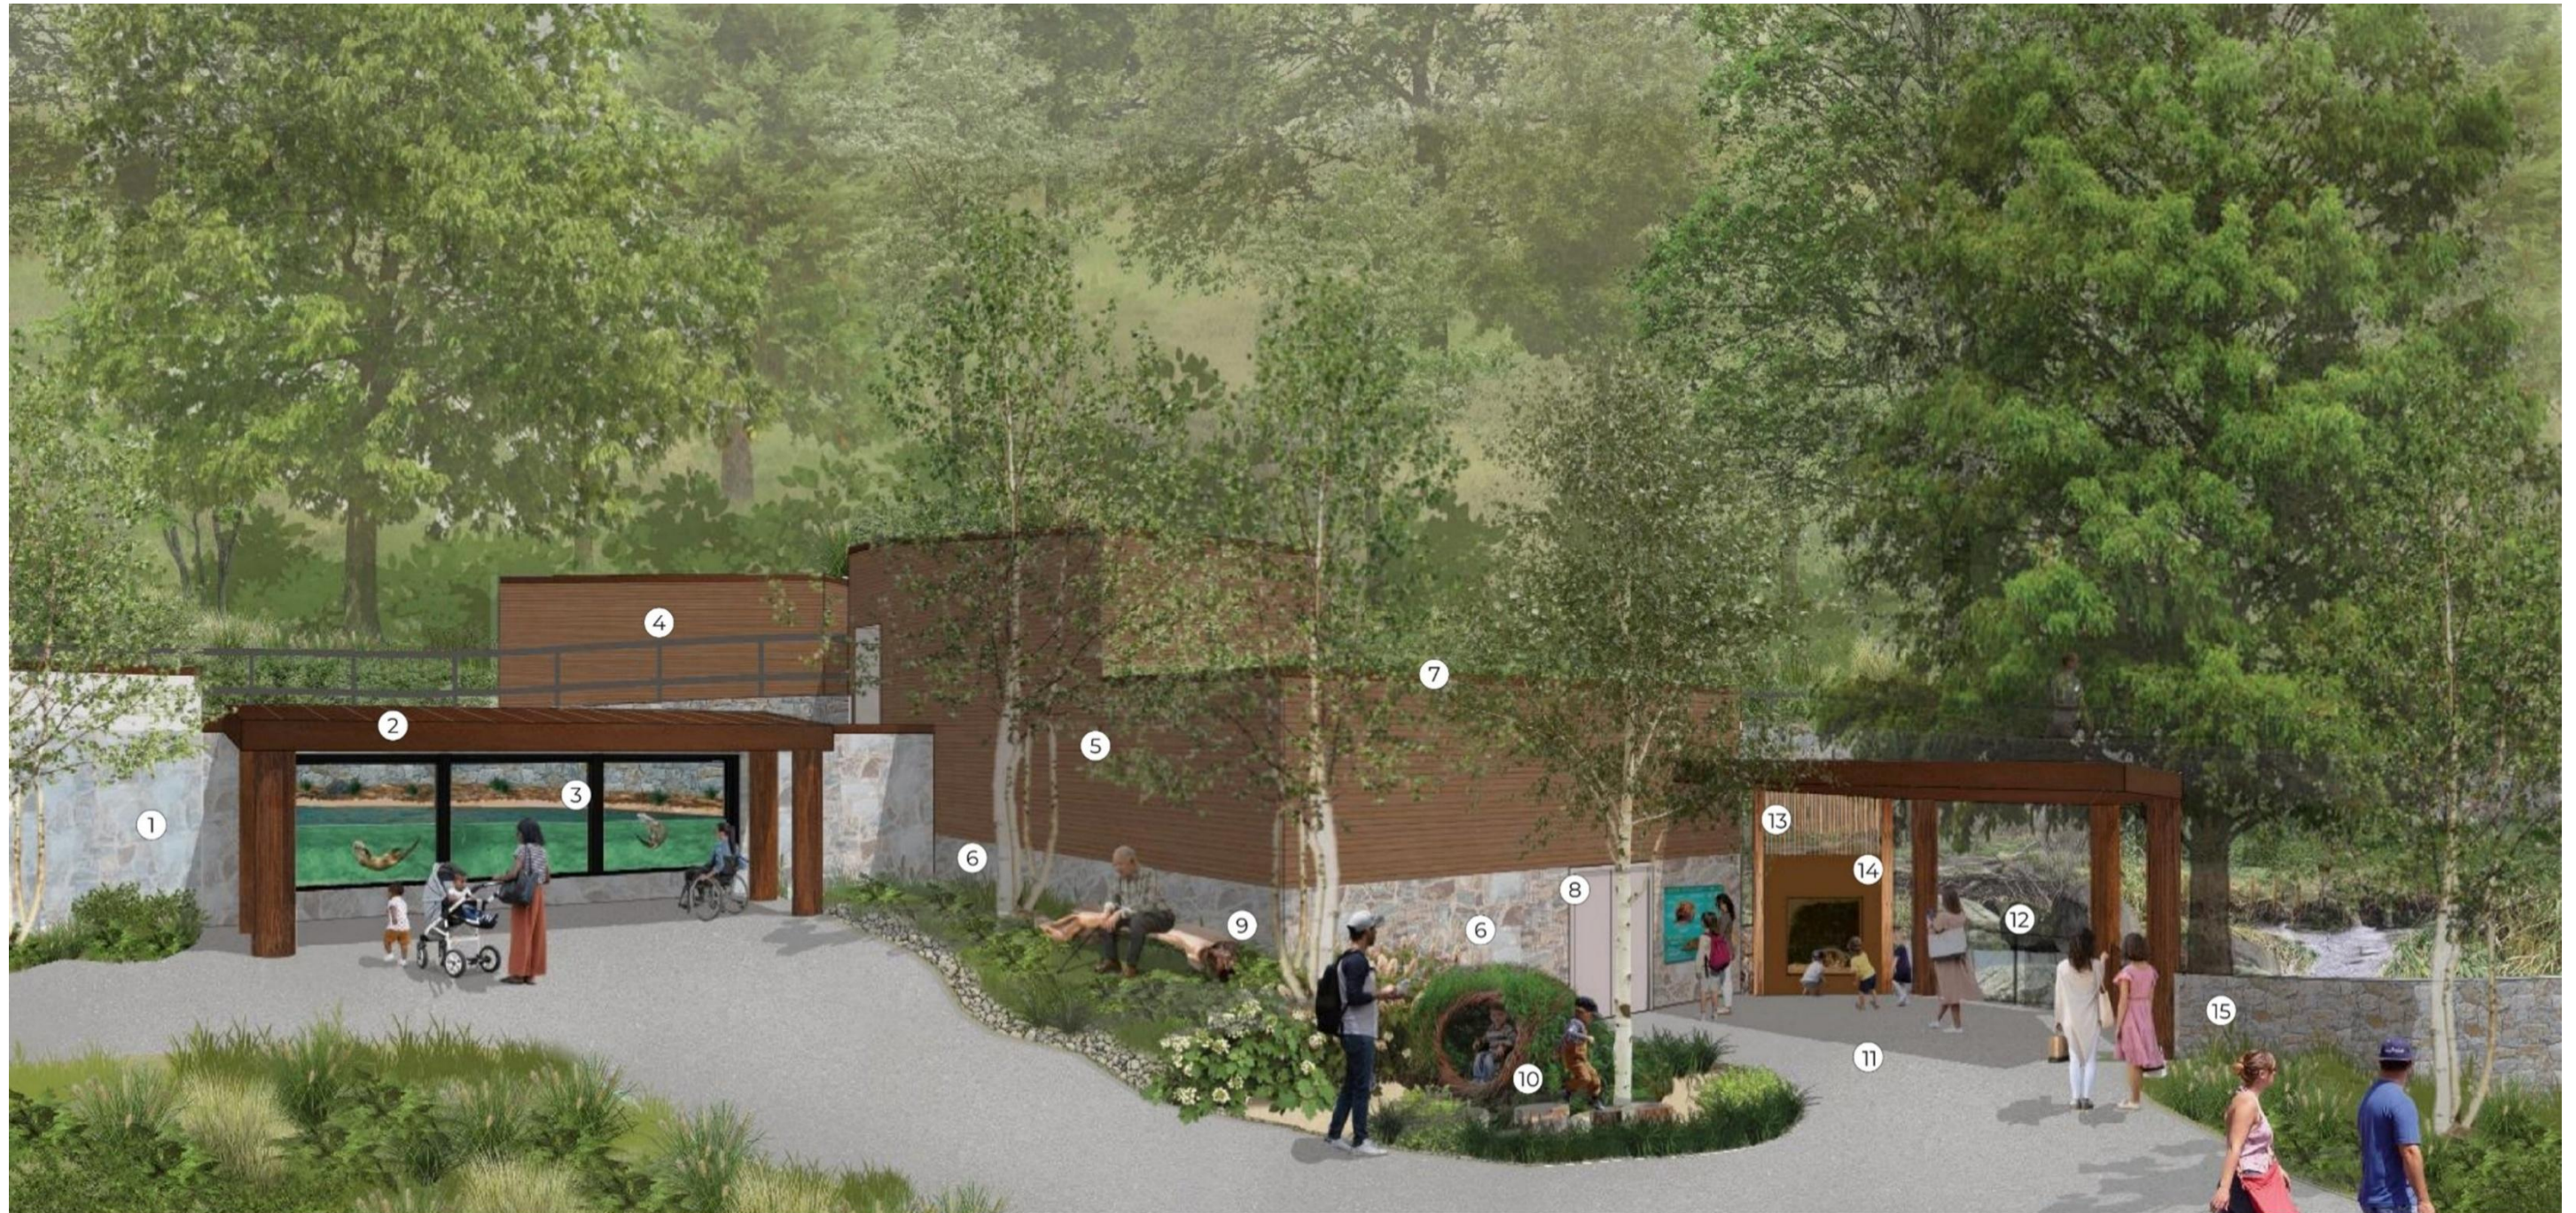
Initial Studies – Cladding Concept Two

1. EXISTING WALL REMOVED OF ALL FIBER BOARD, REPLACED WITH STONE VENEER BLENDED WITH PARGED CONCRETE

2. NEW STANDING SEAM METAL ROOF WITH STRUCTURAL COLUMNS CLAD WITH WOOD (SEE STRUCTURAL) – NEW ACRYLIC WINDOW

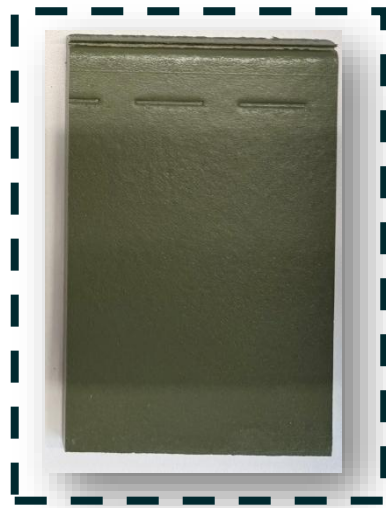
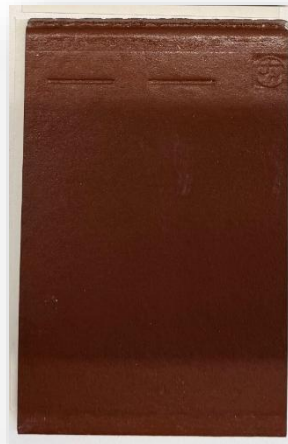
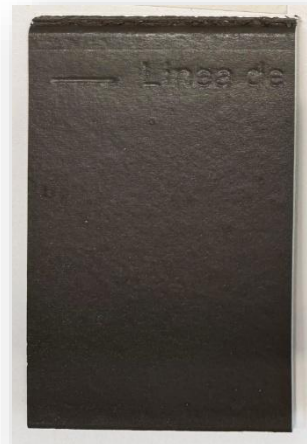
Fiber Cement Color Samples

Three standard fiber cement panel colors were evaluated as potential alternatives for the cladding. Of the options, Mountain Sage is the recommended choice due to its neutral undertone and its compatibility with the existing Seal and Sea Lion gray (a.k.a. “Heather”) color palette. The green hue evokes the lush plantings of the surrounding landscape, while also creating a harmonious contrast to the proposed copper coping and stone veneers.

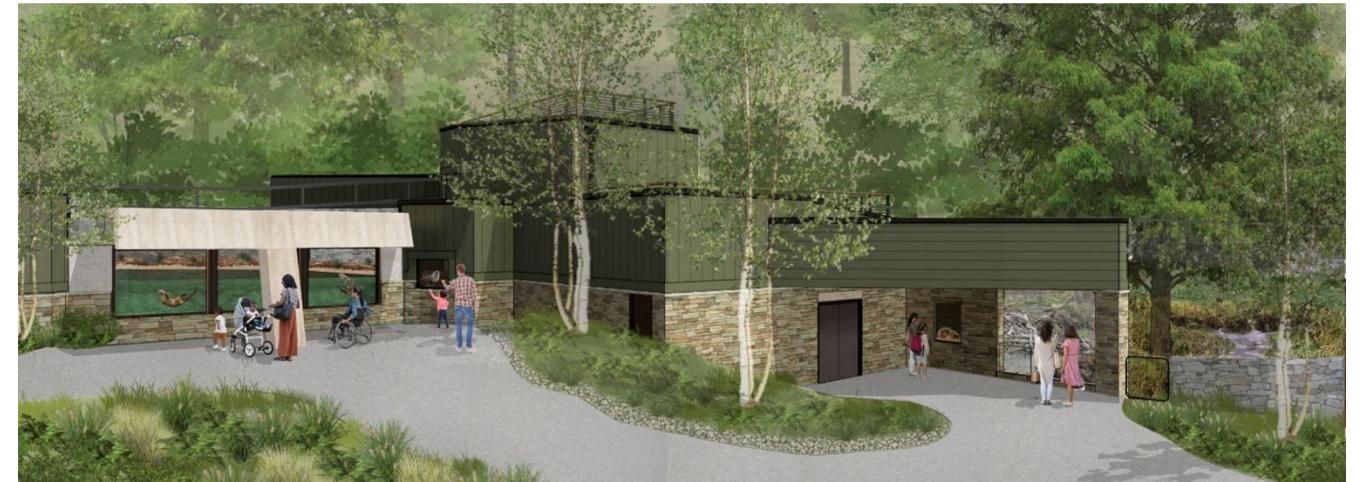
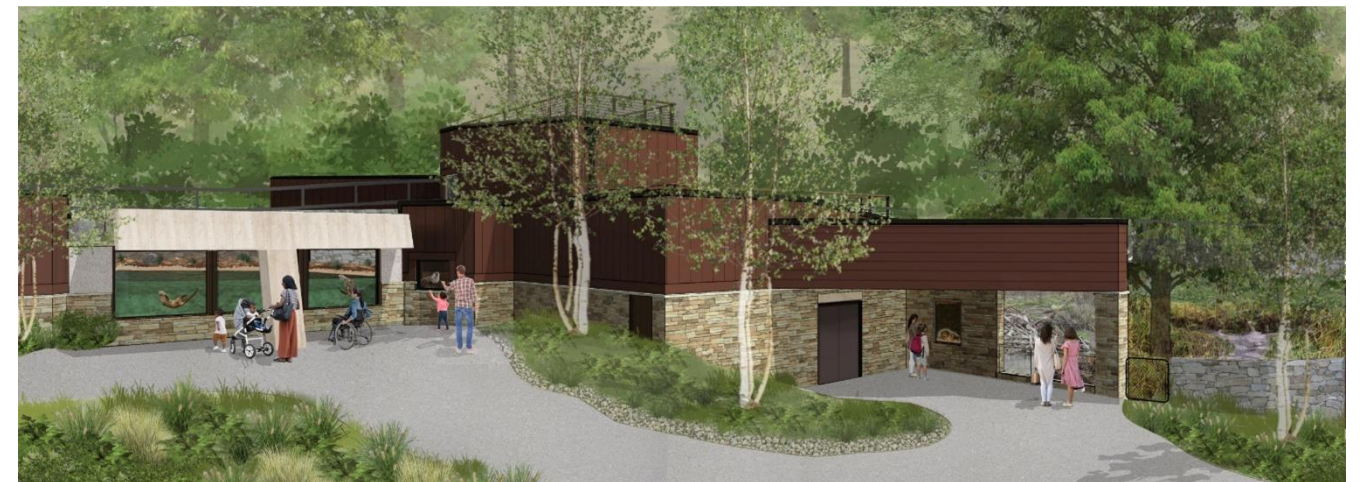
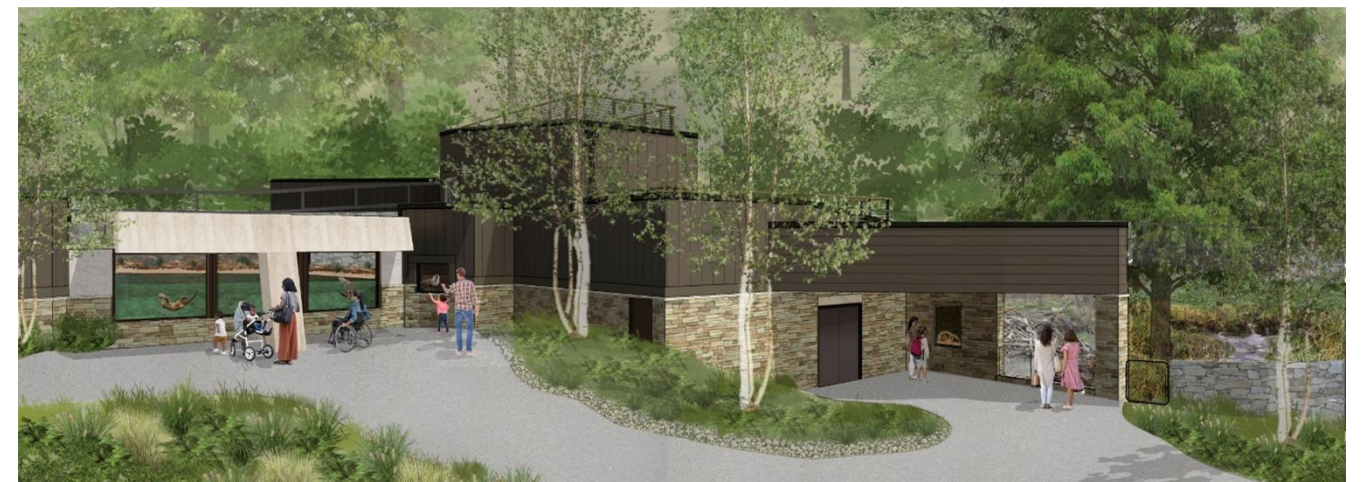
The images to the right illustrate the color studies applied to earlier massing iterations. The selected massing approach establishes consistent horizontal datums at 42 inches above both green roofs for safety. The preferred approach is illustrated on subsequent slides.

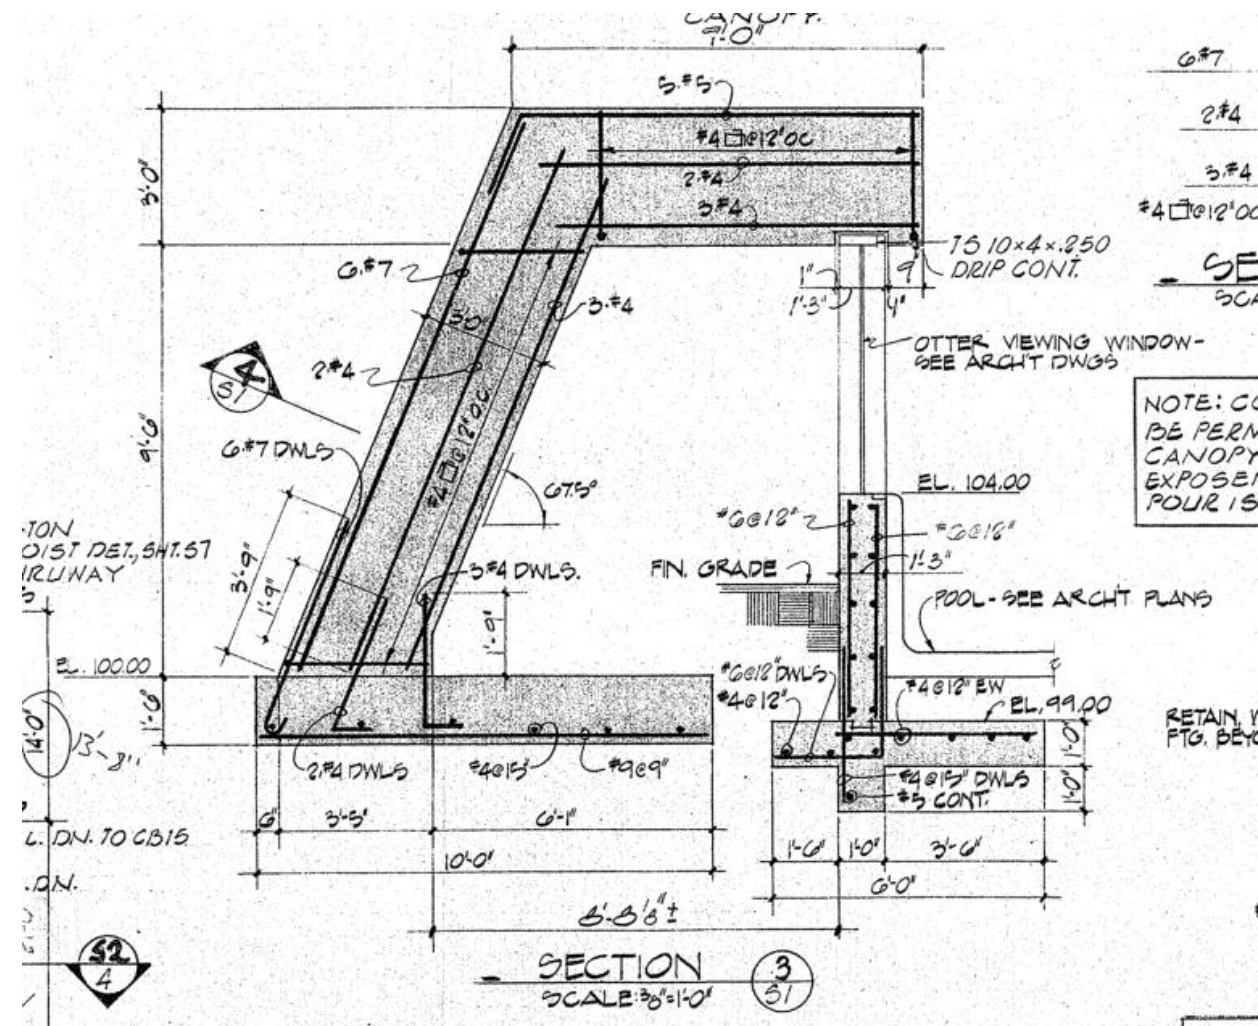
STRUCTURAL DETAIL

Existing Otter viewing concrete canopy. The structure provides support for the viewing glass and pool.

Source: 1977 Beaver Valley construction drawings, Smithsonian

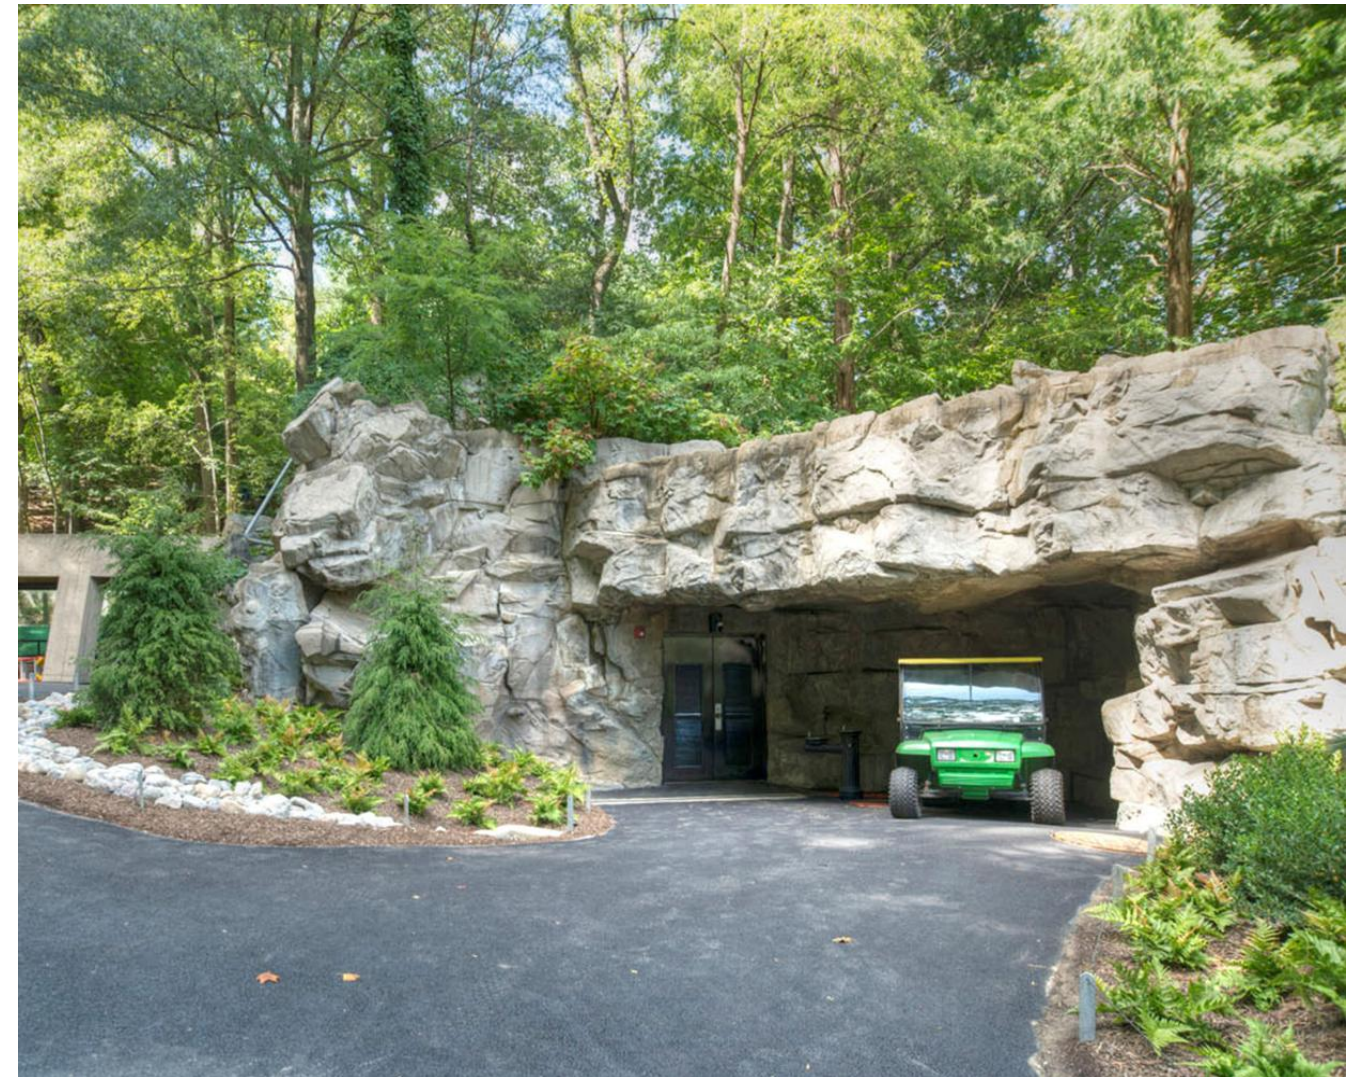
LSS building with volunteer trees growing on existing green roof

The demolition of deteriorating faux rock features across the exhibits will also require removal of several smaller, invasive trees. Above the LSS building, the existing green roof has become dominated by volunteer growth, including three Siberian elms and one Black walnut (#138). These trees pose structural concerns due to their weight and potential impact on roof waterproofing. As part of installing a new, functional green roof system, these species (including the invasive, vine-covered Siberian elms, one of which exhibits poor structure) will be removed.
